GROUP	MODEL
ELE	2023-2024MY Multiple Models w/ AVN5W
NUMBER	DATE
352	July 2024

TECHNICAL SERVICE BULLETIN

AVN 5.0 WIDE NON-RESPONSIVE RADIO ICON (AM, FM, SXM) (SA582)

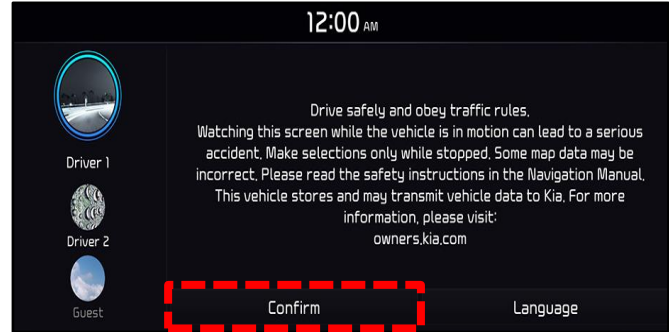
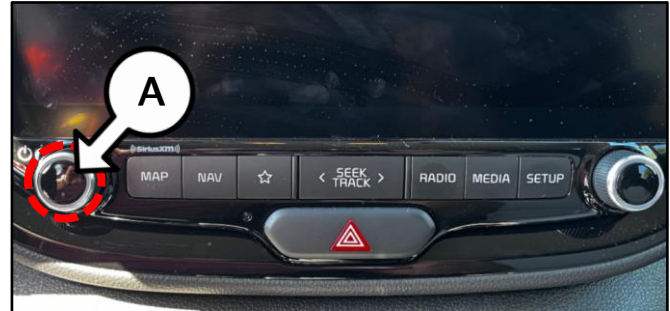
3. Press the 'Power' button (A) to turn the Radio/Media 'OFF'.

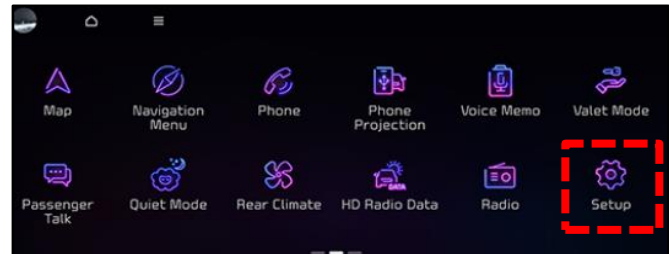
4. Select 'Setup'.

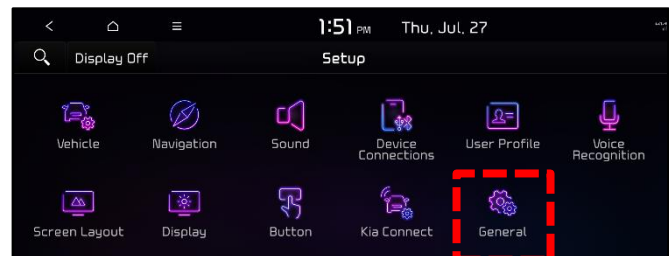
5. Select 'General'.

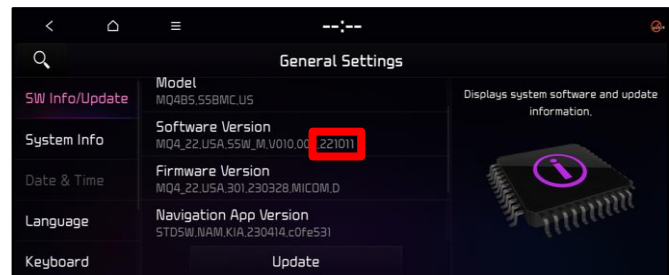
6. Inspect the last six (6) digits of the AVN Software Version displayed in 'General Settings'.

- If the current software version shown in 'General Settings' is included in the software version listed below, then proceed to step 7.
- If the current software version shown in 'General Settings' is not included in the software version listed below, **this TSB does not apply.**

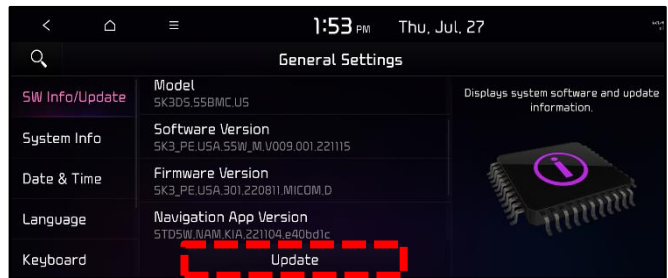
- On the 'General Settings' screen, select 'SW Info/Update', then select 'Update'.

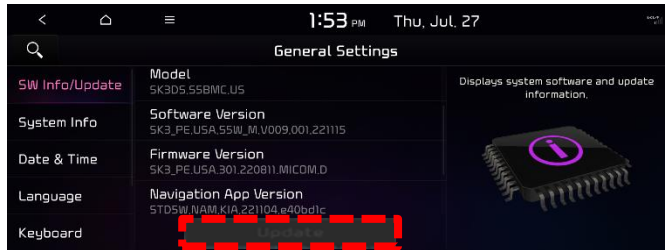
Note: If the USB Flash Drive is not recognized, the 'Update' button will not be activated, as shown. If this occurs, remove the USB Flash Drive and repeat steps 3-7.

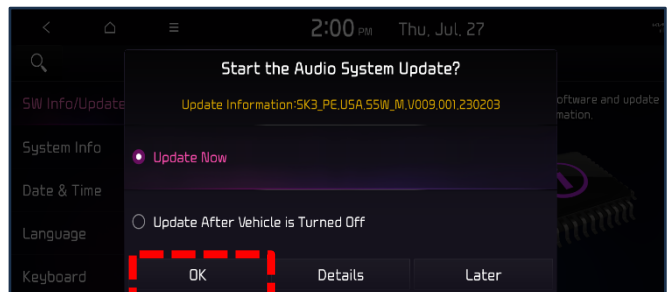
- Select 'OK' on the pop-up screen.

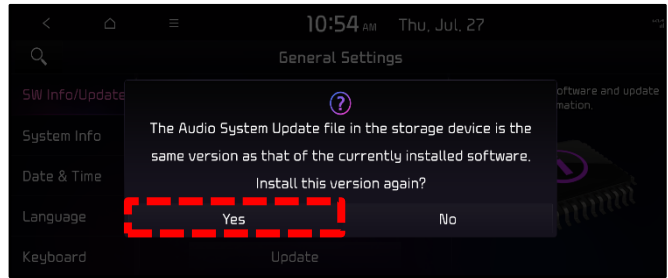
Note: After selecting 'OK', there may be some instances where the pop-up shown may be displayed. Select 'Yes' and proceed to step 10.

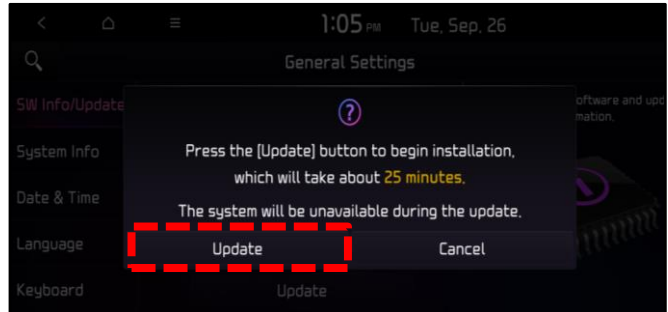
10. Select 'Update' on the pop-up screen.

Note: In some cases, the software update may take up to 2 hours and 30 minutes to complete. During this dwell time, it is acceptable to work on other vehicles.

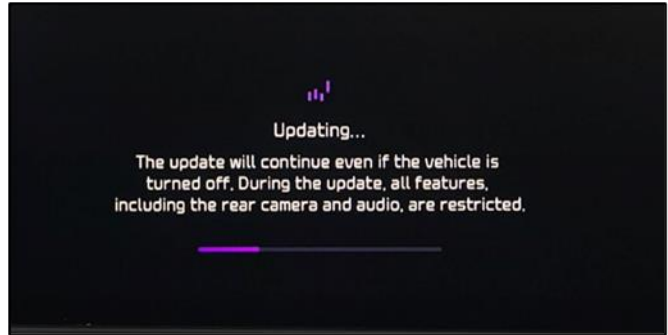
There will be multiple occurrences where the Kia logo will appear, the display will be black during the update process and/or display "Preparing System Update" or "Updating..." for an extended period of time. This is normal.

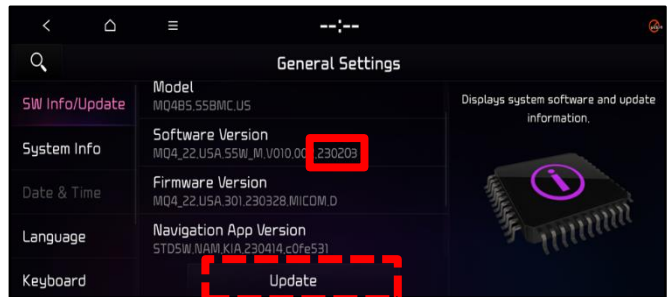
11. Once the update has completed, repeat steps 4-6 to confirm the Software Version has been correctly updated.
