# Service Bulletin

Bulletin No.: 24-NA-005

**Subject: Headlamps Flashing and/or DTC P0606 Set in Lighting Control Module**

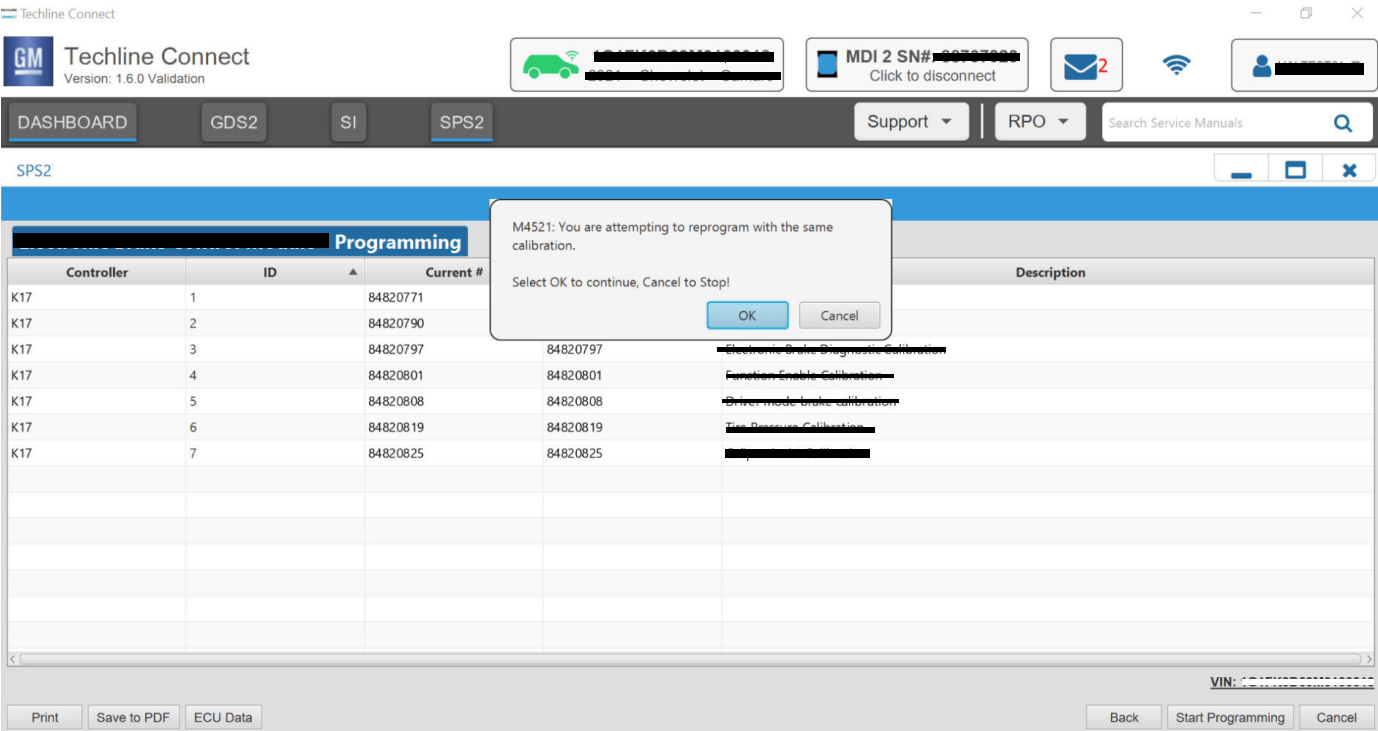
5877000

**Important:** Techline Connect screen shown above.  
**Important:** If the same calibration/software warning is noted on the TLC Summary screen, select OK and follow screen instructions. After a successful programming event, the WCC is located in the Service Programming System dialogue box of the SPS Summary screen. Record the WCC on the job card. No

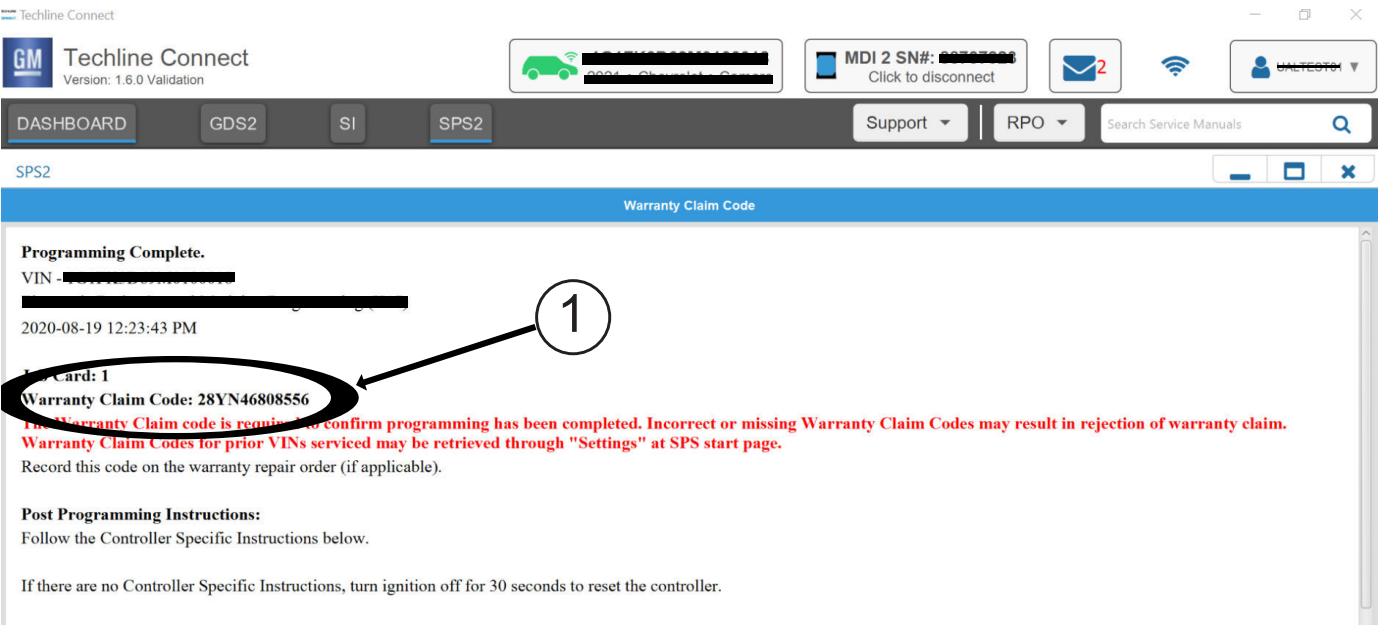
5644478

**Note:** The screenshot above is an example of module programming and may not be indicative of the specific module that is being programmed. Module selection and VIN information have been blacked out.

further action is required. Refer to the Warranty Information section of this bulletin.  
1. Reprogram the Lighting Control Module. Refer to *K219 Lighting Control Module: Programming and Setup*.
