Service Bulletin

Bulletin No.: 24-NA-134

Subject: Intermittent Service Lift System DIC Message on Z06 Models

Brand:	Model:	Model Year:		Build Date:		Engine:	Transmission:
		from	to	from	to		
Chevrolet	Corvette Z06	2024	2024	SOP	June 18, 2024	5.5L (LT6)	Dual Clutch (M1M)

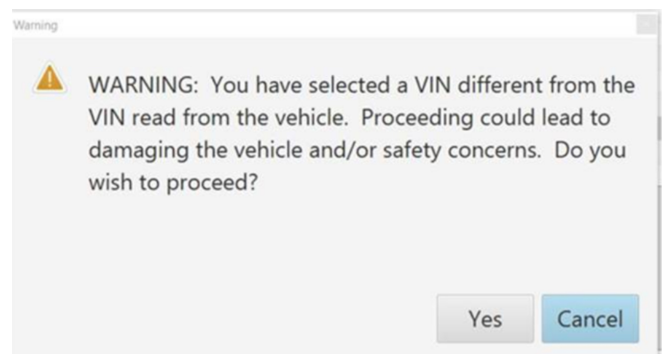
5877000

Important: If the vehicle VIN DOES NOT match, the message below will be shown.

The screenshot shows the Techline Connect software interface. At the top, there is a navigation bar with 'DASHBOARD', 'GDS2', 'SI', and 'SPS2' tabs. The 'SPS2' tab is active. A warning dialog box is displayed in the center, with the text: 'M4521: You are attempting to reprogram with the same calibration. Select OK to continue, Cancel to Stop!'. The dialog has 'OK' and 'Cancel' buttons. Below the dialog is a table with columns: Controller, ID, Current #, and Description. The table contains 7 rows of data for K17 controllers. At the bottom of the screen, there are buttons for 'Print', 'Save to PDF', 'ECU Data', 'Back', 'Start Programming', and 'Cancel'. A VIN field is visible at the bottom right.

Important: Techline Connect screen shown above.
Important: If the same calibration/software warning is noted on the TLC Summary screen, select OK and follow screen instructions. After a successful programming event, the WCC is located in the Service Programming System dialogue box of the SPS Summary screen. Record the WCC on the job card. No
