Service Bulletin

Bulletin No.: 24-NA-138

Subject: Forward Collision Alert Unavailable DIC Message with U3000 SYM44 in Front Camera Module

Brand:	Model:	Model Year:		VIN:		Engine:	Transmission:
		from	to	from	to		
Chevrolet	Corvette	2024	2024	—	—	—	—

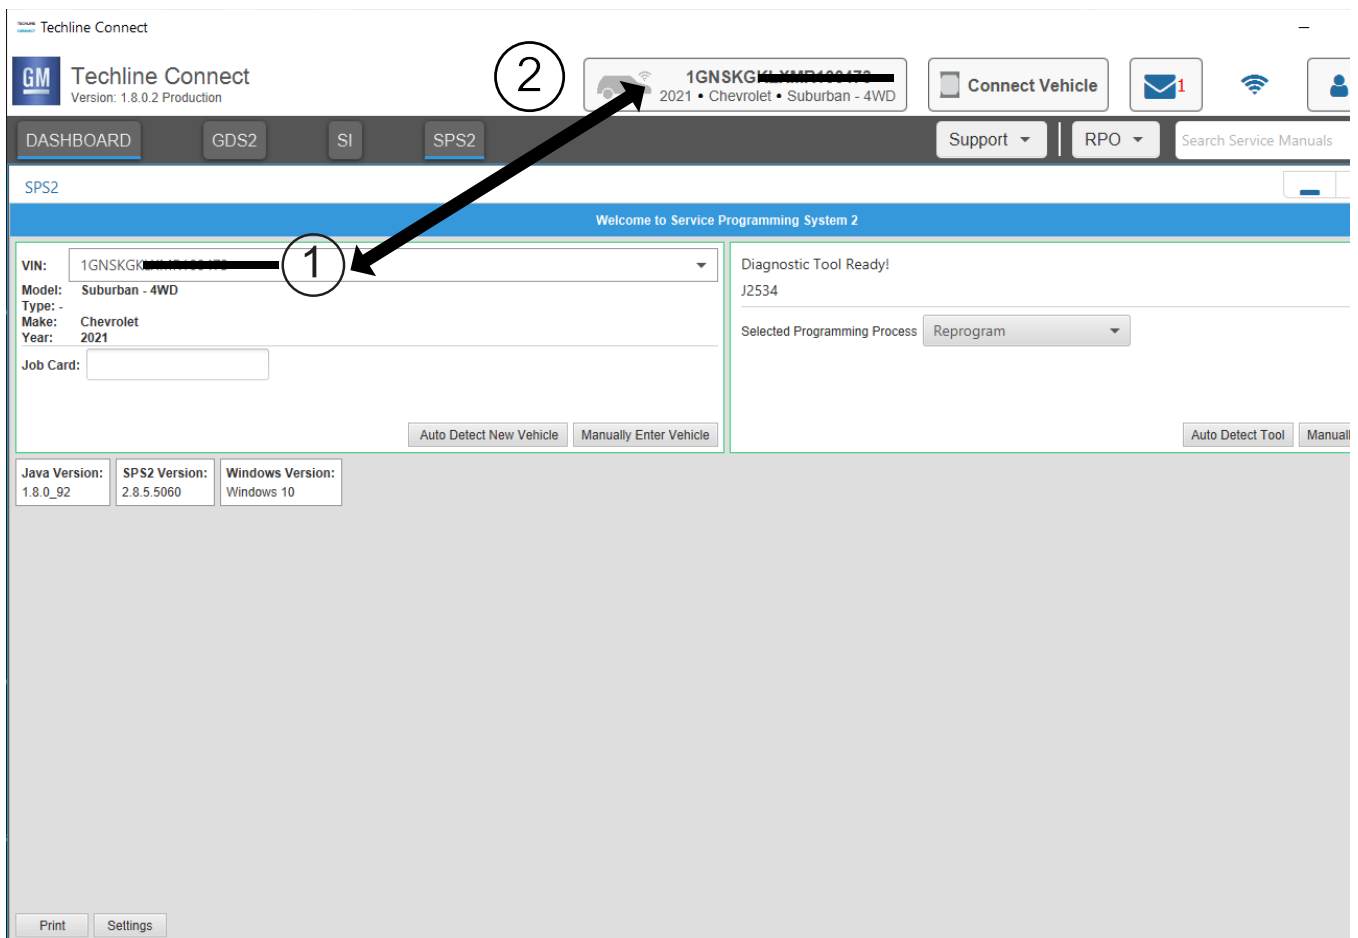
Caution: Be sure the VIN selected in the drop down menu (1) is the same as the vehicle connected (2) before beginning programming.

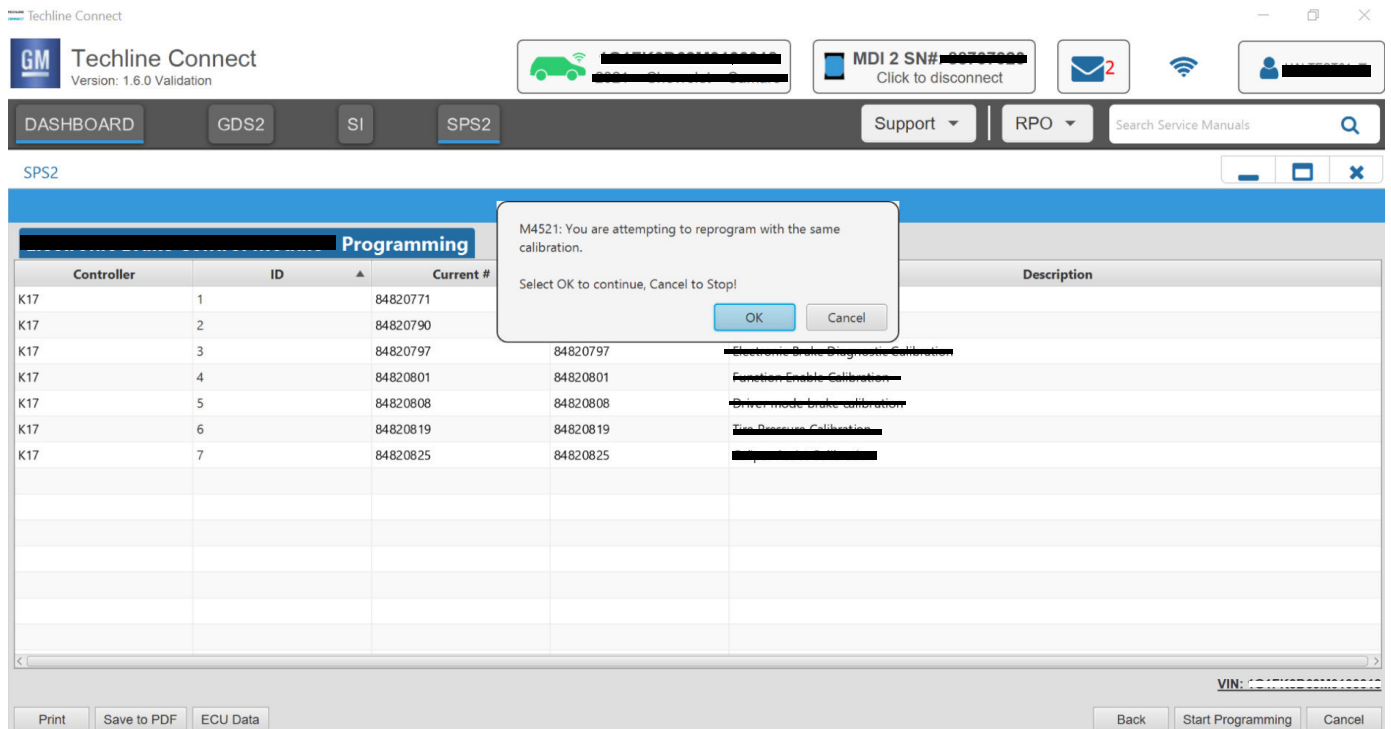
5644477

Important: Techline Connect screen shown above.
Important: If the same calibration/software warning is noted on the TLC Summary screen, select OK and follow screen instructions. After a successful programming event, the WCC is located in the Service Programming System dialogue box of the SPS Summary screen. Record the WCC on the job card. No

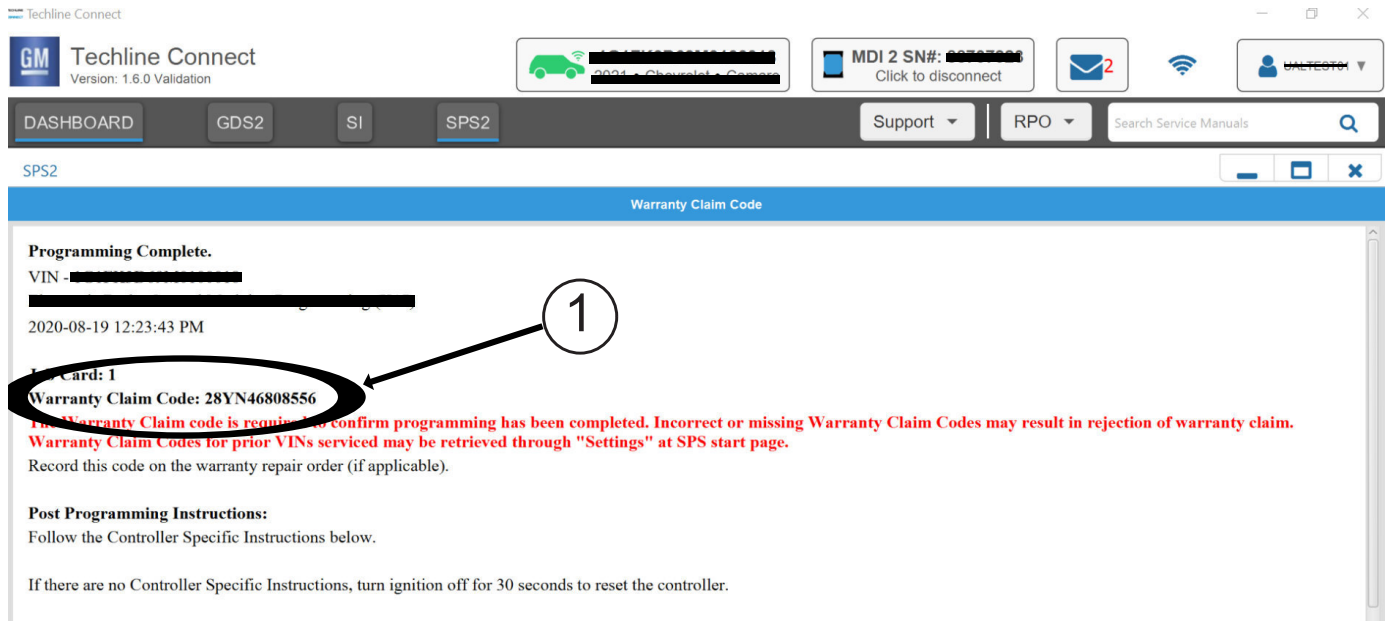
5644478

Note: The screenshot above is an example of module programming and may not be indicative of the specific module that is being programmed. Module selection and VIN information have been blacked out.

1. Reprogram the B174W Front View Camera Module. Refer to *B174W Frontview Camera - Windshield: Programming and Setup* in SI. Then,

perform FCM Service Learn (SPC) using GDS and Clear DTCs to ensure issue is resolved.
