GROUP	MODEL
TRA	2021-2023 MY Sorento (MQ4a), K5 (DL3a) w/2.5L T-GDI w/DCT
NUMBER	DATE
111	July 2024

TECHNICAL SERVICE BULLETIN

SUBJECT: 8-SPEED DUAL CLUTCH TRANSMISSION EOP SENSORLESS LOGIC IMPROVEMENT

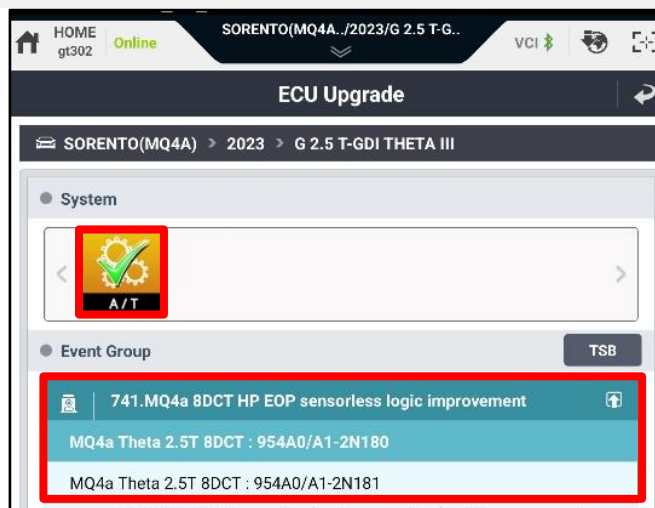
1. **UPGRADE EVENT:**

741.MQ4a 8DCT HP EOP Sensorless Logic Improvement

or

742.DL3a 8DCT HP EOP Sensorless Logic Improvement

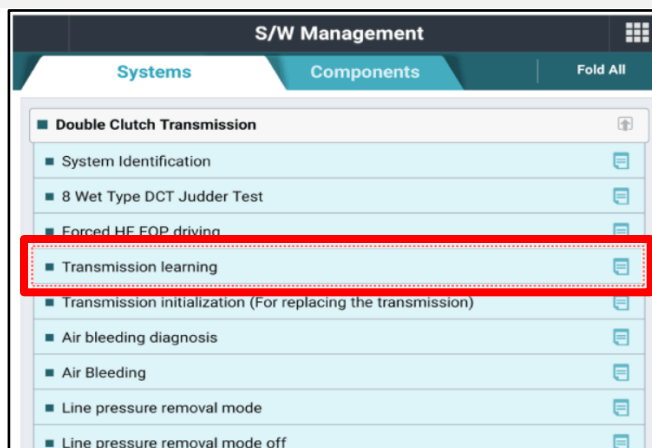
Transmission Learning Procedure:

2. Using KDS, select S/W Management → A/T → Systems → Double Clutch Transmission (or Automatic transmission) → Transmission Learning.
