SERVICE BULLETIN

NUMBER: 15-305-22R

SUBJECT: Reprogramming File Availability for Optimization of Gen 4.5 Denso CP1.5 Infotainment Systems

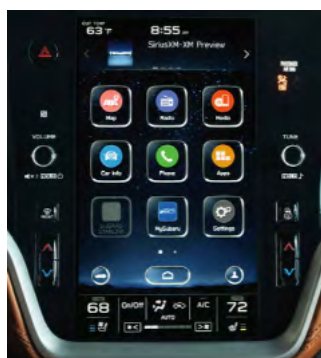
11.6-Inch Display, Mid and High Level Units

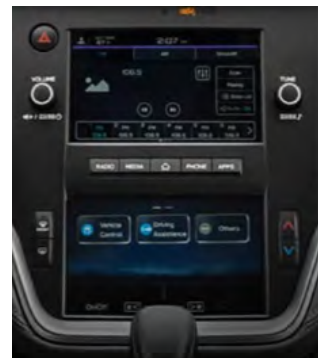
Dual 7.0-Inch Display, Base Level Unit.

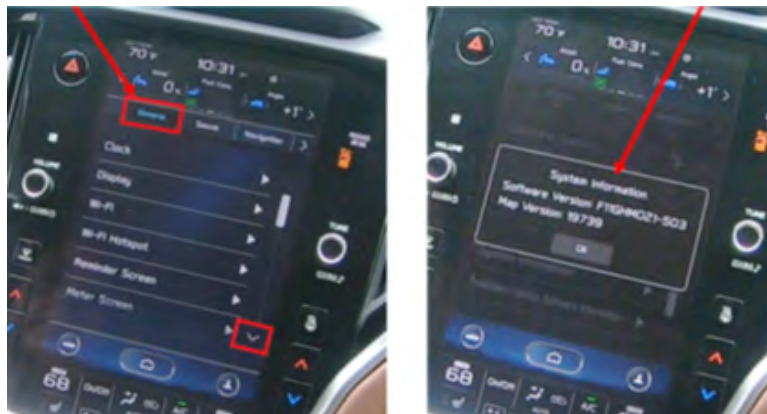
- 1b) Press the **General** button. Use the down arrow to scroll to **System Information** then press to display the System Information / Version information.

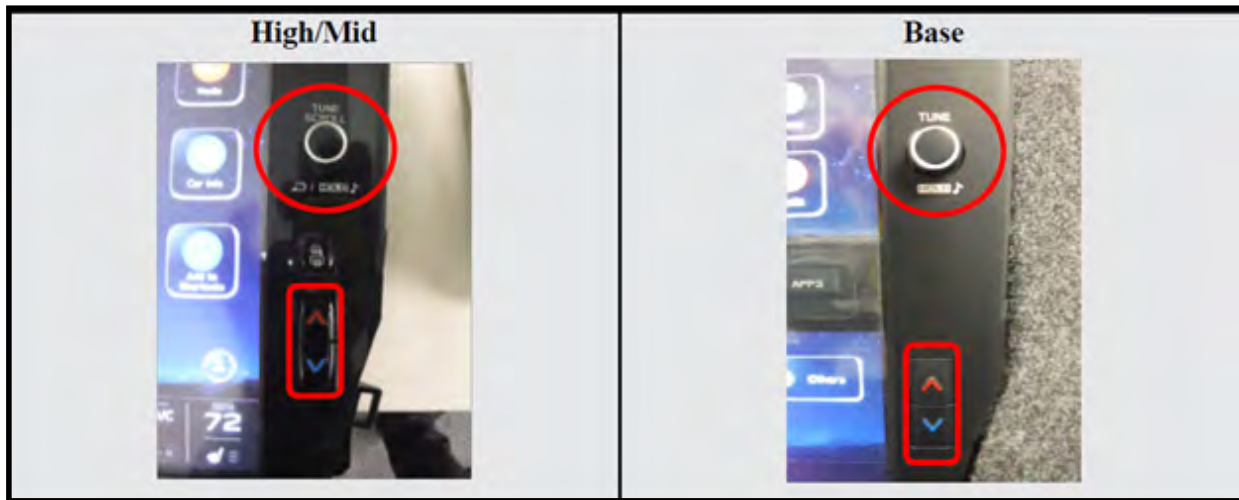
- 4a) PRESS and HOLD the RIGHT-side temperature control buttons (both up and down) and press the Tune / Scroll knob 6 times then release all to display the Dealership Mode Menu.

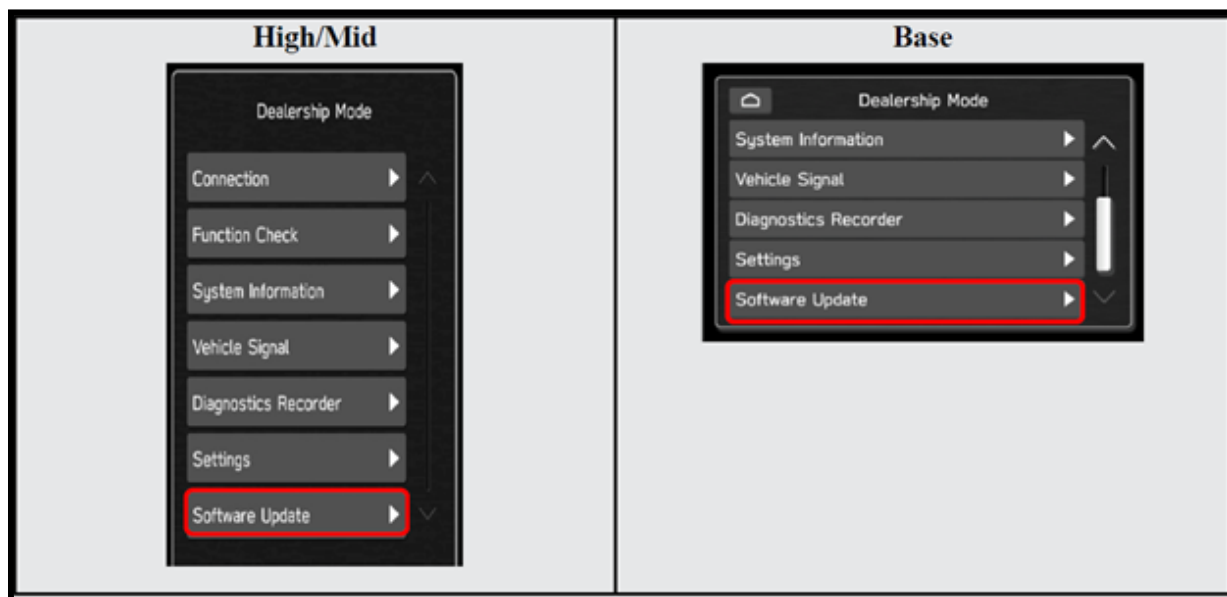
- 4b) Select **Software Update** from the Dealership Mode menu.

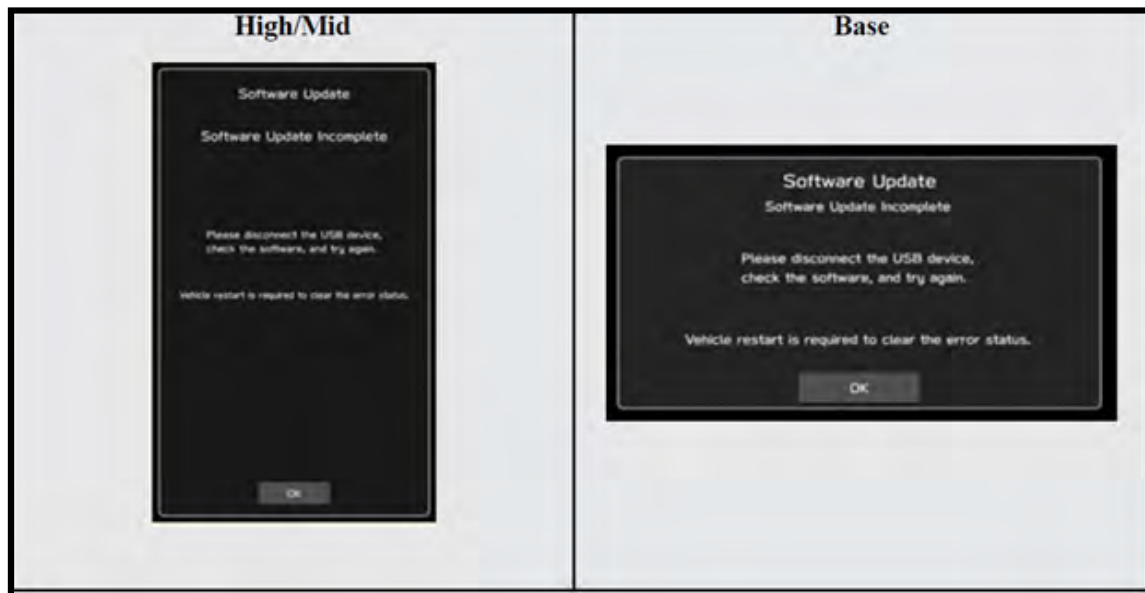
If you get the message **Software Update Incomplete** as shown below, please don't replace the hardware but retry updating the software according to the instructions in [Appendix 6 \(page 29\)](#).

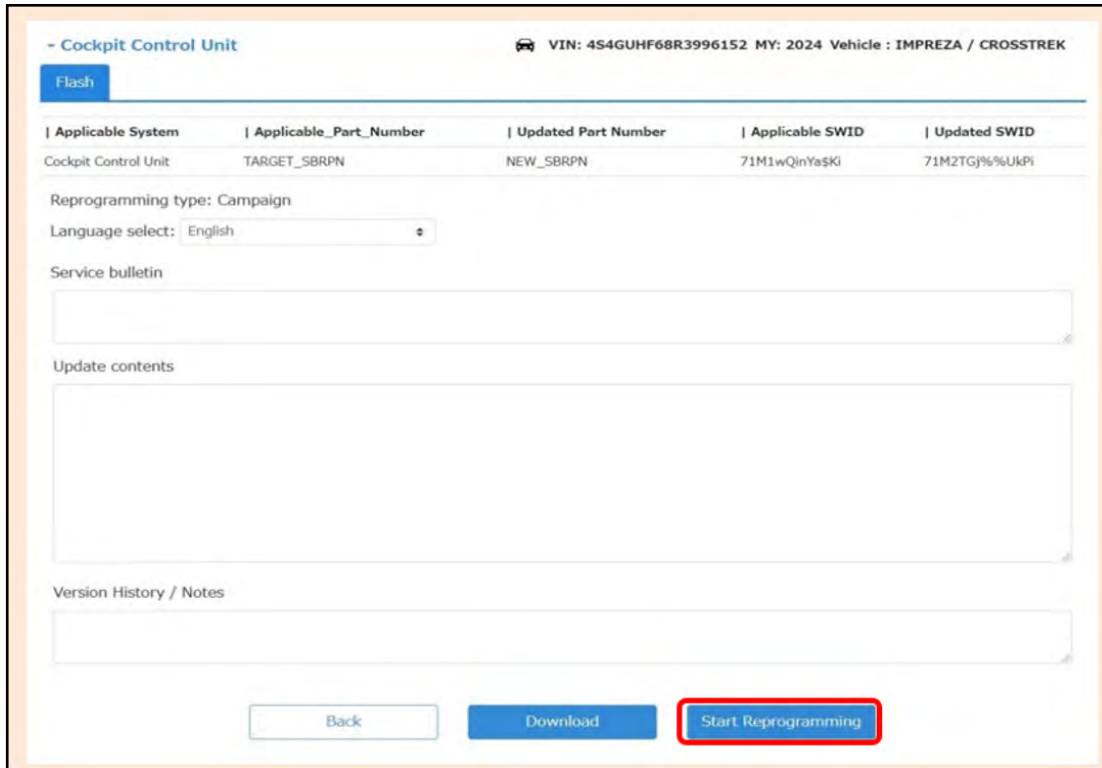
- ii. Insert the USB flash drive containing the update data into the vehicle's USB port and click on [Start Reprogramming] to begin the reprogramming process.

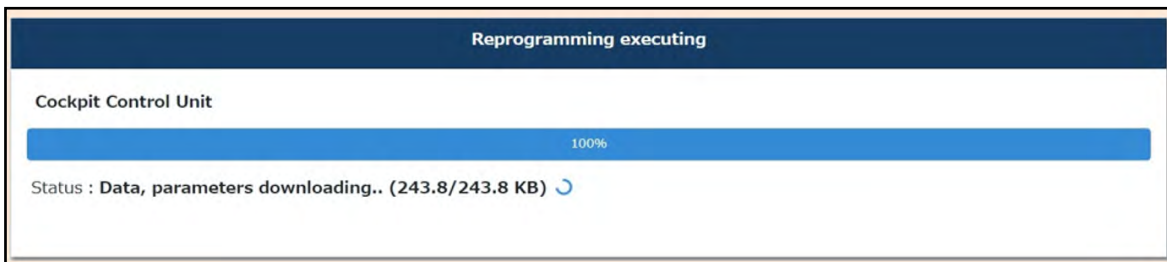
- iii. Follow TSB 14-28-21 “New Software Reprogramming Procedures / SSM5-R” **STEP 12 - STEP 15** to start the software update.
- iv. The following progress bar will be displayed briefly (for a few seconds), and then it will quickly reach 100% and switch to the next screen.

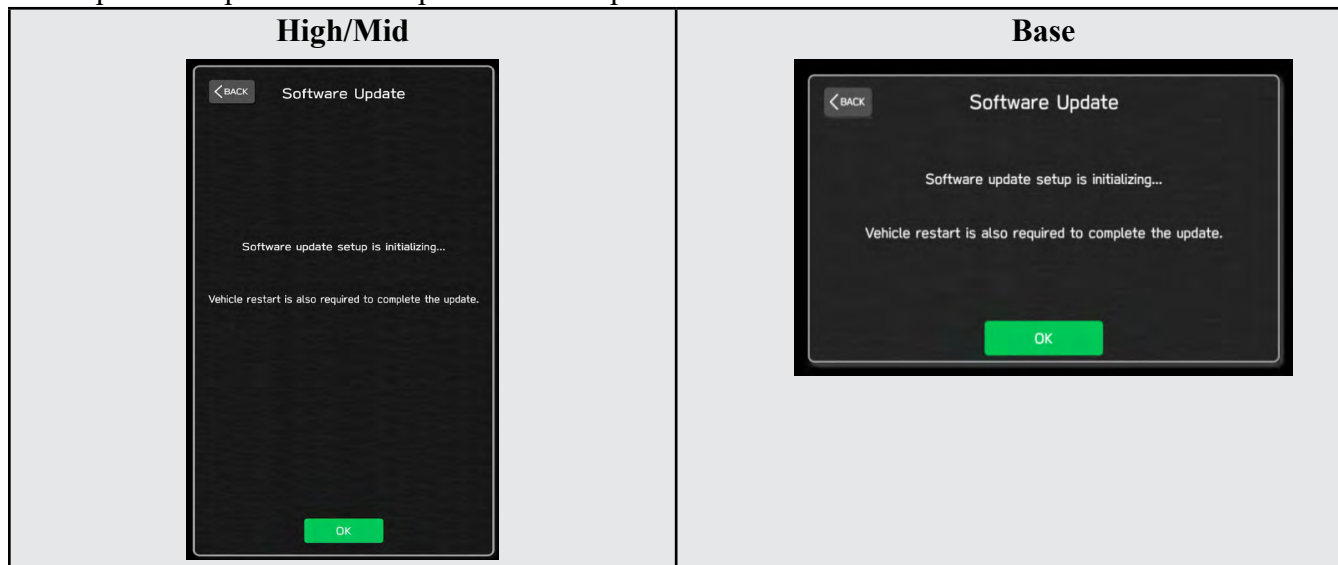
- If the screen shown below appears, **WAIT** for approximately 30 minutes or as long as necessary (waiting for longer than 60 minutes might indicate system malfunction). In that case please perform recovery according to the instructions in [Appendix 6 \(page 29\)](#) to allow the Software update setup initialization process to complete.

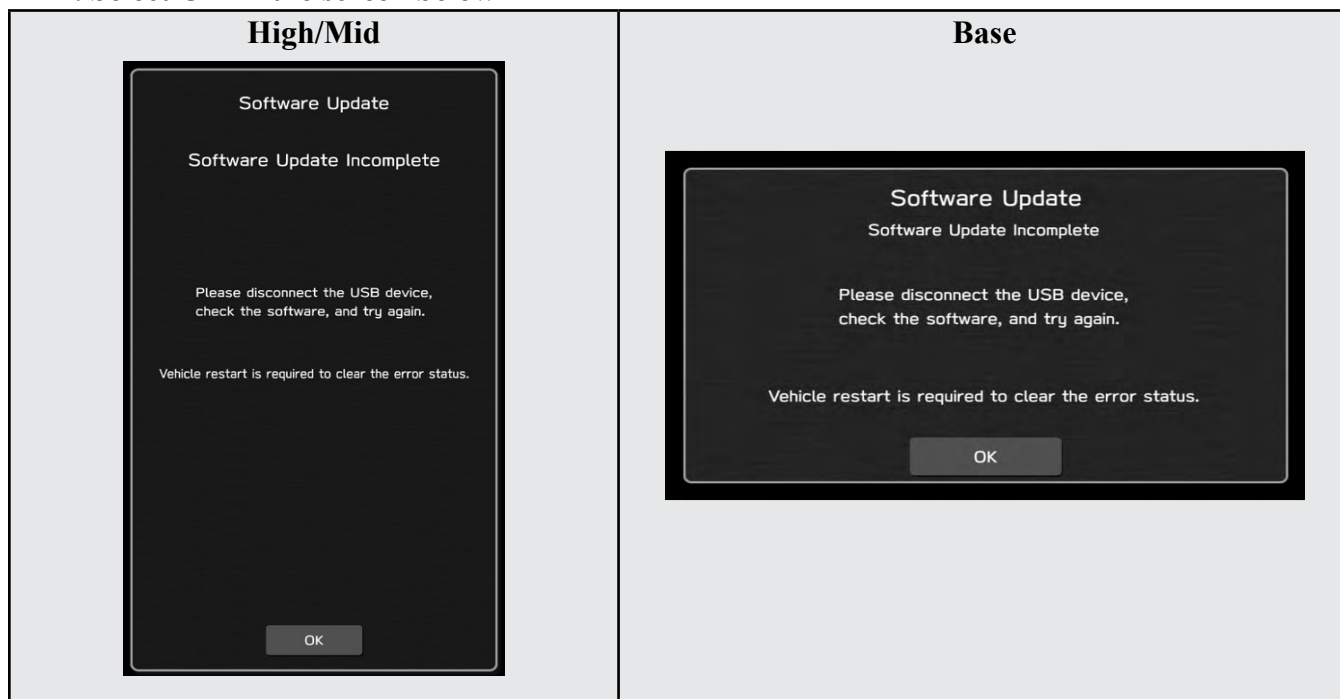
- If the first attempt of update fails with the message below, follow the steps described below 1-2 to 1-8 before retrying the software update.

1-1. Select OK in the screen below

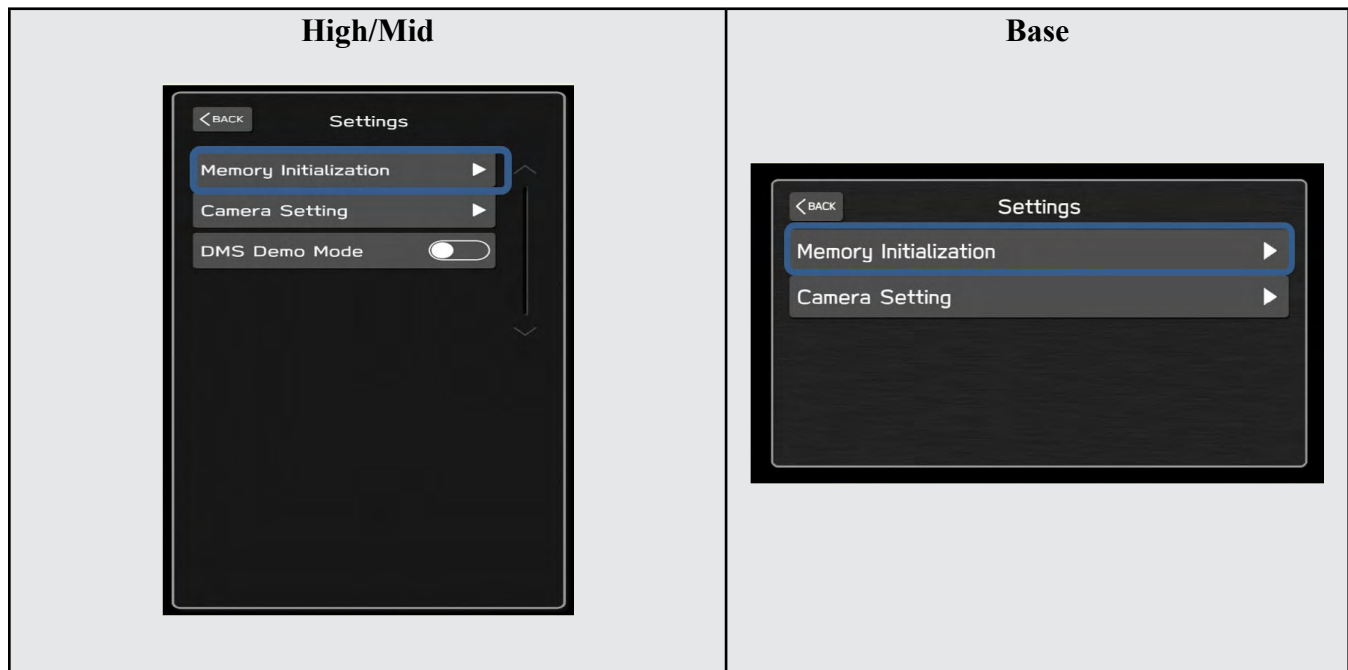
2-2. Select “Memory Initialization”

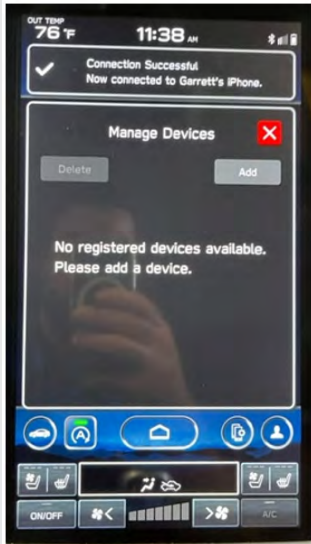
Number	Category	Symptoms to be Improved:
6	Display	<p>The registered mobile device information is not displayed on the Manage Devices screen.</p> <p>(This occurs when the name or device ID of a mobile device contains a character code that cannot be displayed.)</p> <p>(only applicable to HIGH and MID trim)</p>

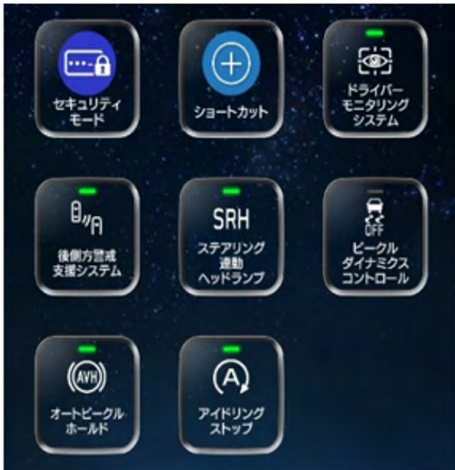
<p>The order of 1.First Name and 2.Family Name in the phone book is set to 1.→2. even if the order is set to 2.→1.</p>
		<p>The message function may become unavailable following repeated page scrolling up and down of the list on the phone's message list screen.</p> <p>(only applicable to HIGH and MID trim)</p>
		<p>When transitioning to the maintenance screen and the setting value is set to AUTO, a popup prompting the user to sign a MySubaru contract is displayed and the setting is switched to Manual.</p> <p>(only applicable to HIGH and MID trim)</p>
		<p>When turning off and on while two or more shortcuts of DMS/SRH/SRVD icons are set on the Home screen, the order of icons changes from DMS to SRVD, SRH, VDC, AVH, and ISS.</p>

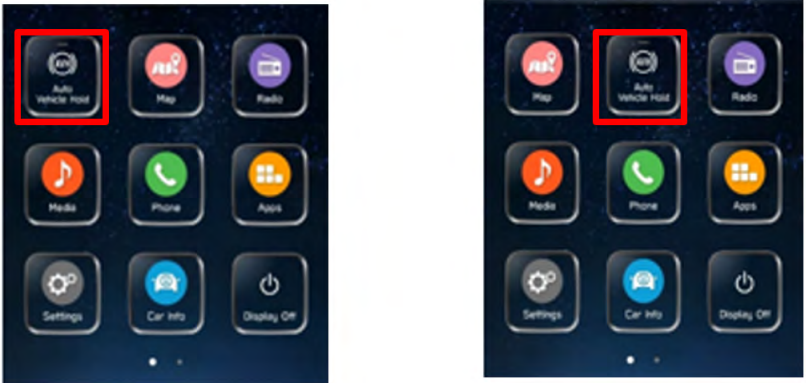
Number	Category	Symptoms to be Improved:
6	Display	<p data-bbox="503 142 1477 294">The AVH icons on the HOME screen are initially lined up next to the Valet-Mode icon. However, in some cases they are placed at the top (upper left corner of the first page) or next to the MAP icon. (only applicable to HIGH and MID trim)</p> <div data-bbox="602 300 1403 680">

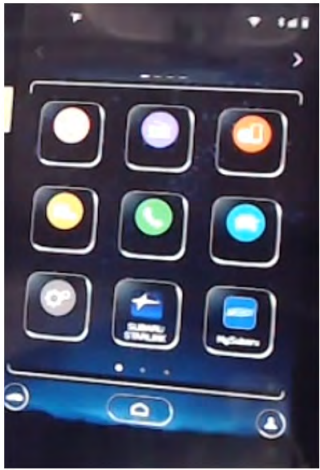
</div> <p data-bbox="503 699 1477 808">After switching the clock function to AUTO, the CID screen display may become distorted. (only applicable to HIGH and MID trim)</p> <div data-bbox="841 814 1159 1281">

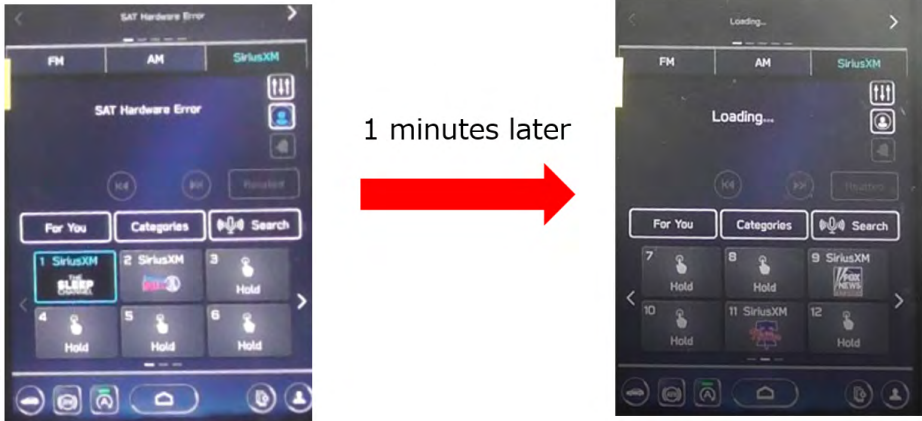
</div> <p data-bbox="503 1297 1356 1333">It may take accessive time to start the CID screen after ignition on.</p>
7	SXM	<p data-bbox="503 1371 1477 1480">The first time ignition on after the CCU software update added the SXM360 functionality, the SXM playback screen may remain at “Loading...” after the CCU software update.</p> <div data-bbox="540 1493 1456 1911">

<p data-bbox="898 1602 1105 1633">1 minutes later</p> </div>

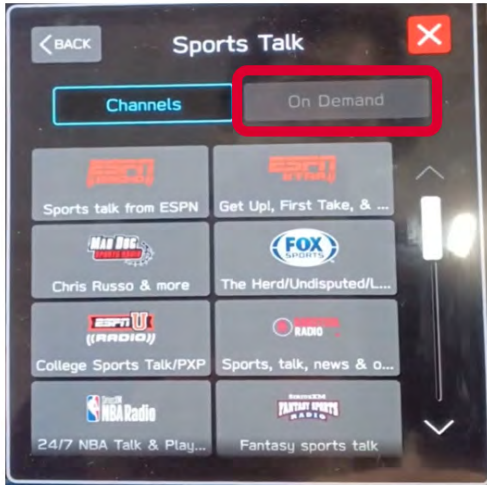
Number	Category	Symptoms to be Improved:
7	SXM	<p>In the SXM screen, the On Demand button in the upper right corner is grayed out and cannot be operated in the Sports→ Sports Talk screen. (only applicable to HIGH and MID trim)</p>

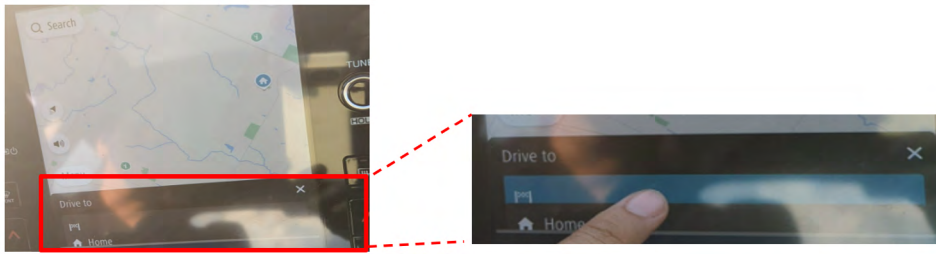
8	Navi	<p>After booting, the Map screen may not appear even if the Map icon on the Home screen is pressed. (only applicable to HIGH trim)</p> <p>Three destination suggestion displays in the navigation system are sometimes displayed overlapping each other. Originally, up to three destination suggestions are displayed at the bottom of the screen when the navigation system is started. (only applicable to HIGH trim)</p>

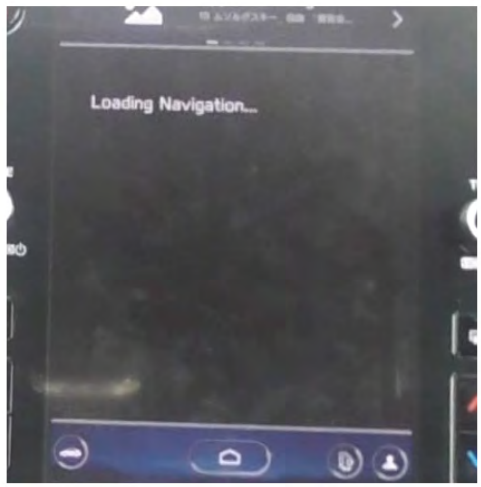
Number	Category	Symptoms to be Improved:
8	Navi	<p>When turning ignition off and on while the Map screen is displayed, the message ""Loading Navigation..." may remain on the screen, and the Map screen may not be displayed. (only applicable to HIGH trim)</p>

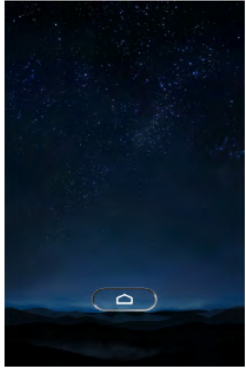
Number	Category	Symptoms to be Improved:
1	Black Display	-After turning ignition ON, the "CAUTION" screen is displayed for 2 minutes. After the "CAUTION" screen is displayed, a reset may occur.
		-During Bluetooth audio playback, the CID screen may turn to a black screen.
		-When shifting from R to any other gear immediately after starting the engine, the CID screen takes some time to return to the home screen, displaying only a background (only applicable to HIGH trim)
		-Right after starting up, the CID displays only background without icons and no further operation can be done (not applicable to WRX)

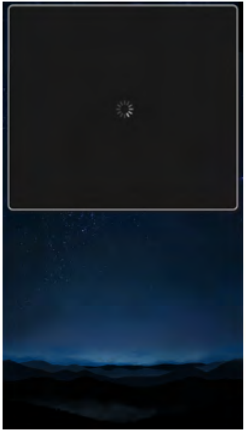
<p>After engine starts, only the black frame of the Caution screen display may remain on the CID screen.</p> <p>The rear view camera can be displayed by shifting to shift R.</p>

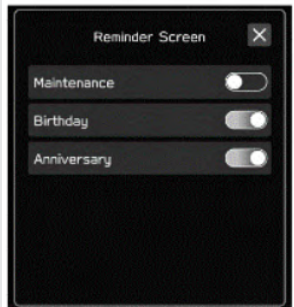
- When multiple reminders for maintenance dates, birthdays, and anniversaries are set and nearing, a series of pop-up notifications appear on the CID screen after starting the engine. If you try to delete a reminder right before it switches to the next one, the CID screen may reboot (not applicable to WRX)

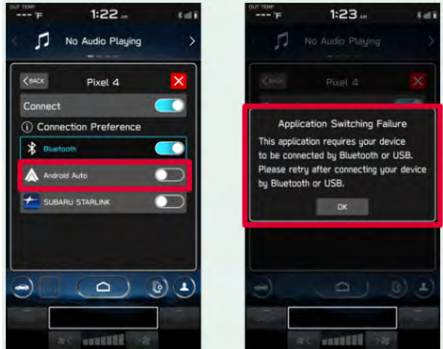
<p>- When you toggle on Android Auto from the Manage Device screen in CID while the Android device is not connected via USB, there may be a failure to start Wireless Android Auto (not applicable to BASE trim)</p>

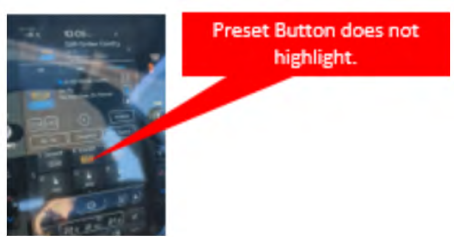
Number	Category	Symptoms to be Improved:
7	Bluetooth	<ul style="list-style-type: none"> - Address vulnerabilities in the Bluetooth encryption mechanism (only applicable to BASE trim) - If the Bluetooth connection fails due to the loss of the link key in the phone, the following message should be changed to be displayed. Before: Connection unsuccessful Please try again later After: Connection unsuccessful Please try deleting and then re-pairing your device
8	Radio	<ul style="list-style-type: none"> - When pressing a preset button for a registered radio channel, you can play the channel. But the button you pressed does not highlight, and you cannot operate through presets using the steering wheel controls (not applicable to WRX)

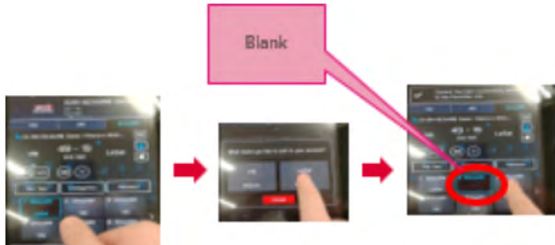
<p>- When registering SXM sports team channels to the radio preset buttons if a team for which logo image cannot be captured is registered, the channel short name will not be displayed on the registered button and the button will be blank (not applicable to BASE trim)</p>

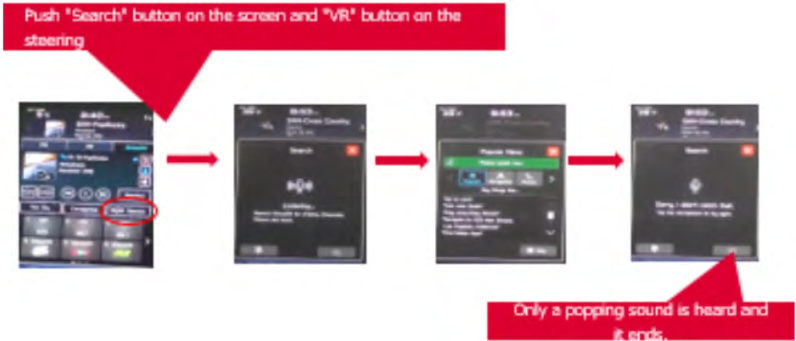
<p>- The voice recognition function encounters an error and ends, when initiating the SXM Search feature simultaneously with the activation of the CCU unit's voice recognition</p>

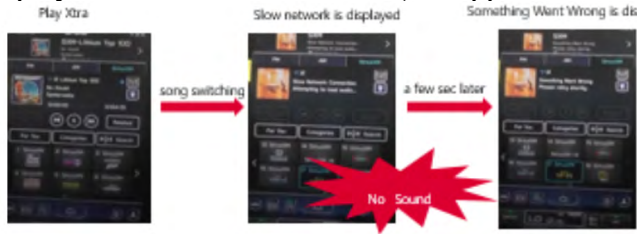
Number	Category	Symptoms to be Improved:
9	SXM	<p>- SXM sound stops sounding after conditions listed below:</p> <ol style="list-style-type: none"> 1. Register FM station A, an SXM sports channel that is not in the middle of a game, and FM station B in the order in which they are listed in the radio presets. 2. Use the steering wheel switch to switch from FM station A to FM station B, skipping the SXM sports channel that is not in the middle of a game. 3. Just before the playback of FM station B starts, operate the steering switch seek to return to the previous channel. <p>- While playing SXM's Xtra channel, "Slow Network" --> "Something Went Wrong" is displayed and no sound is heard (not applicable to BASE trim)</p>

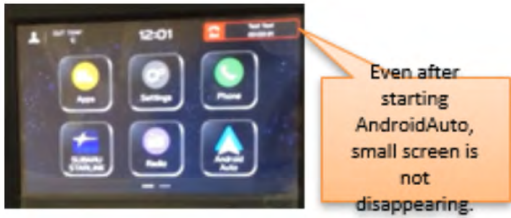
Number	Category	Symptoms to be Improved:
11	Display Appearance	<p>- The call screen reduction appears in the Status Bar while connected to Android Auto. Originally, when Android Auto is activated during a hands-free call, the call screen reduction should disappear (only applicable to BASE trim).</p>

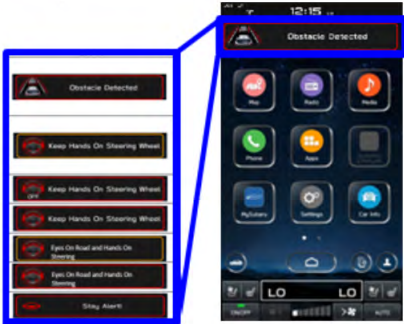
<p>- If the language setting of the CID is changed while an alarm message by the Driver Monitoring System(DMS) is displayed on the CID, the alarm will be hidden (not applicable to BASE trim)</p>

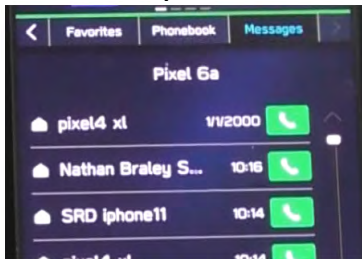
</div> </div>
		<p>- The date for the message is displayed as 1/1/2000 instead of the correct date. This occurs on some models of phones with Android OS 13 or later.</p>

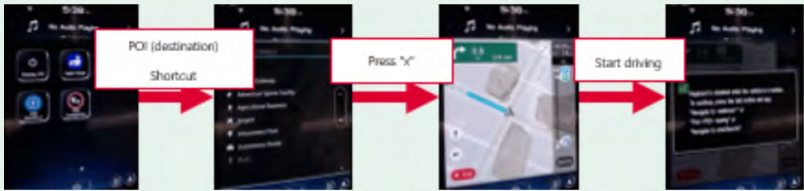
Number	Category	Symptoms to be Improved:
13	Navi Operation	<p>- "Keyboard is disable while the vehile is in motion"" is displayed on the screen when performing the steps below (only applicable to HIGH trim) :</p> <ol style="list-style-type: none"> 1. Press the POI (destination) Shortcut on the home screen to display the list of destinations. 2. Press "x" to clear the list. 3. Start driving with the Map screen displayed.

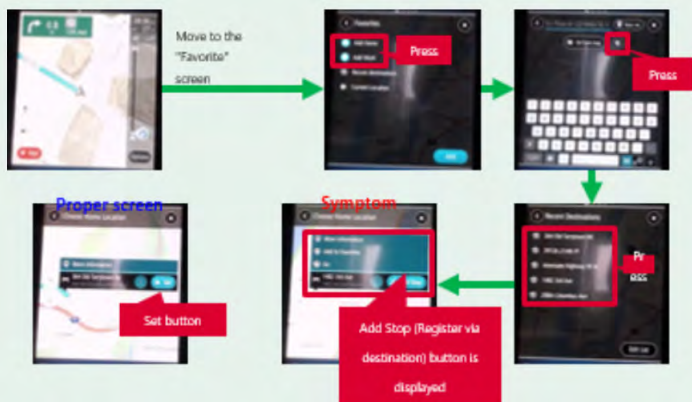
<p>- Add Stop (Register via destination) button is displayed instead of Set button and Favoirte registration for Home/Work cannot be done after performig the steps below moving to the ""Favorite"" screen with the navigation destination set (only applicable to HIGH trim) :</p> <ol style="list-style-type: none"> 1. Press Add Home/Work 2. Select a location from the Destination History screen

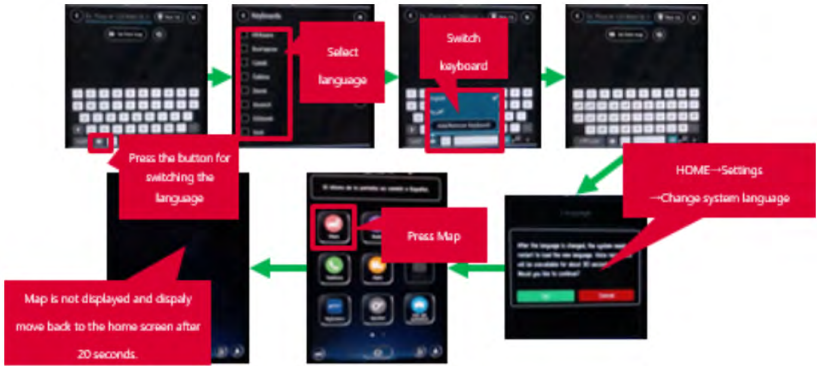
<p>- Map is not displayed when Map is pressed from the home screen if switch- ing the language used for the text input keyboard on the search screen of the navigation application (only applicable to HIGH trim)</p>

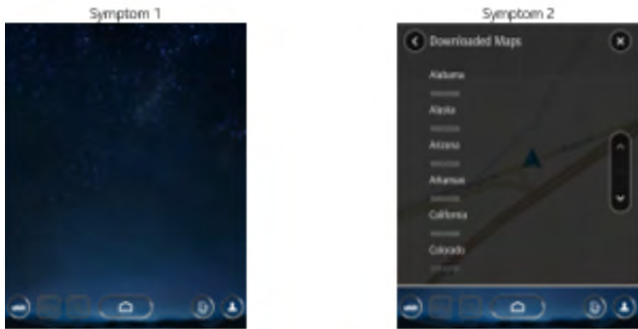
Number	Category	Symptoms to be Improved:
13	Navi Operation	<p>- When you set a navigation destination and drive repeatedly triggering rerouting by deviating from the route and start a map update via Wi-Fi, then wait for about 30 minutes on a screen other than the navigation screen (like the HOME screen) before transitioning back to the navigation screen the following symptom occur (only applicable to HIGH trim):</p> <p>symptom 1: The map is not displayed.</p> <p>symptom 2: The download start button is not displayed on the map update screen.</p> <div data-bbox="683 457 1317 783">

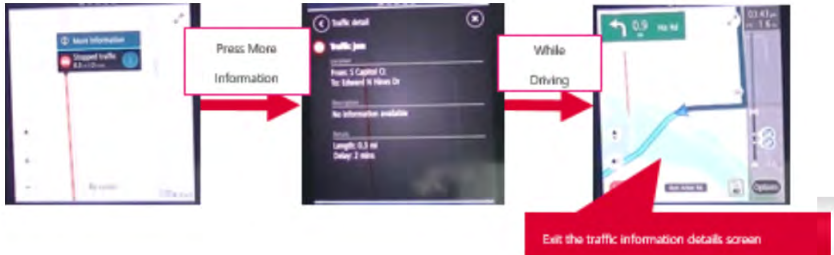
<p>- While parked or driving, touch the traffic information icon on the map or the traffic information icon on the route bar and display the traffic information details screen. If you start driving with this screen displayed, it will exit the traffic information details screen and transitions back to the map screen (only applicable to HIGH trim)</p> <div data-bbox="586 1199 1414 1451">

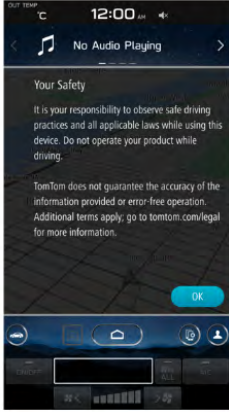
Number	Category	Symptoms to be Improved:
13	Navi Operation	<p>- The requirement to press ""OK"" on the Your Safety screen during the initial navigation launch sometimes wasn't displayed (only applicable to HIGH trim).</p> <p>Before the change: If the navigation app was launched for the first time from any icon other than the Map icon on the Home screen (e.g., through a rest suggestion feature) the Your Safety screen would not appear and navigation functionality could not be initiated.</p> <p>After the change: Even if the navigation app is launched for the first time from an icon other than the Map icon on the Home screen, the Your Safety screen will be displayed.</p>

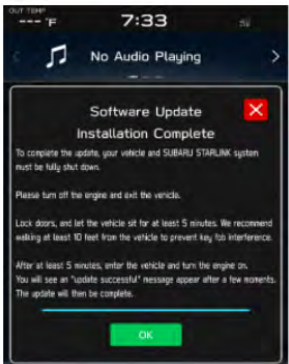
26	Software Update	<p>- When the engine is turned off at a specific moment just before the completion of the CCU software update via FOTA, the expected completion notification screen does not appear when the engine is turned on next time (not applicable to BASE trim)</p>

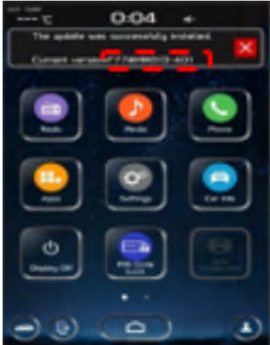
<p>- After the installation of software updates via OTA (Over-the-Air), the "Current Version" field in the popup screen that appears during the next IGN-ON may be blank or empty (not applicable to BASE trim)</p>

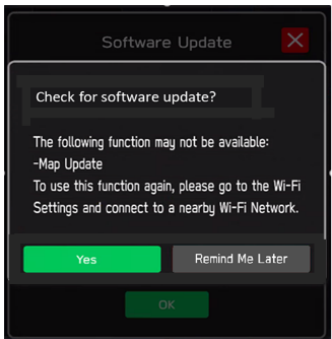
Number	Category	Symptoms to be Improved:
26	Software Update	<p>- To use FOTA (Firmware update Over The Air) for CCU software update via DCM (Data Communication Module) it is necessary to switch from the Wi-Fi communication settings for MapUpdate to the DCM communication settings. To notify the customer about this switching, the below message screen pops up a new CCU software becomes available from the server. (not applicable to BASE trim)</p>

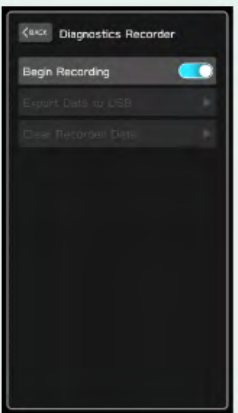
10	Update against vulnerability in security of Bluetooth connection.
11	<p>When getting CCU USB logs at the Diagnostics Recorder screen in the Dealership Mode, it was necessary to turn off ""Begin Recording"" to ""Export Data to USB.""</p> <p>And after the log acquisition, it was necessary to turn ""Begin Recording"" ON again.</p> <p>The system interface is improved so that ""Begin Recording"" is automatically switched ON after log acquisition has been accomplished.</p>

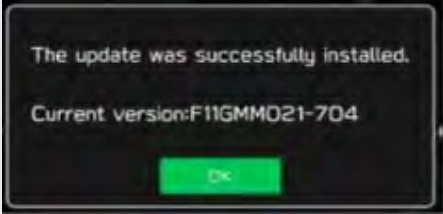
13	After the destination is set on Navi screen, voice recognition command of “Find <POI category> along route” is made, search results are not given in order of distance.
14	When “Call” button is pressed in “Confirm Destination” screen of Navigation system (to call the destination site,) the call can be made but the screen does not transit to phone call screen.
15	Popup of “The update was successfully installed” is not displayed after reboot (IG-OFF and ON) operation of FOTA (Firmware Over The Air) update.

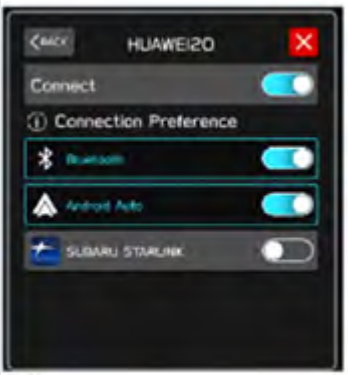
2	<p>On the “Manage Devices” screen Bluetooth cannot be selected as connection preference.</p>

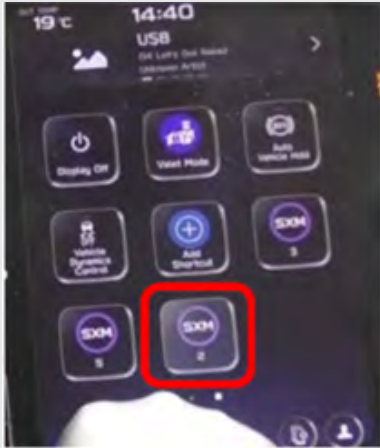
Number	Symptoms to be Improved:
6	<p>SXM station shortcut created by the customer does not work when the SXM has not been used as audio source after the Ignition Switch was turned on in the ignition cycle.</p>

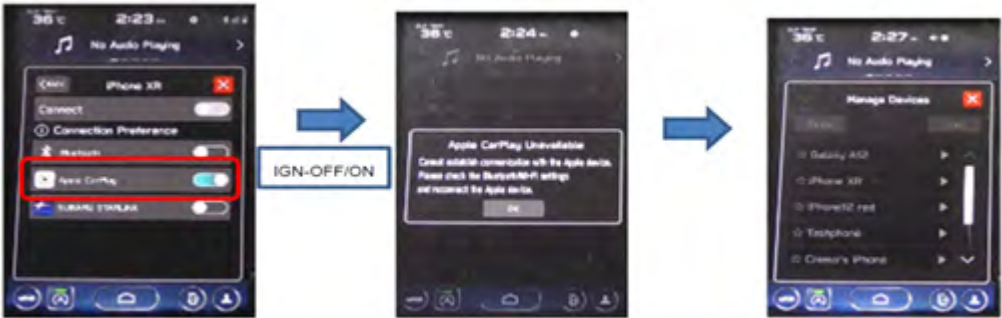
7	<p>Manage Device Screen becomes dark and inoperative when Ignition Switch is turned Off and On while starting CarPlay by CID operation.</p>

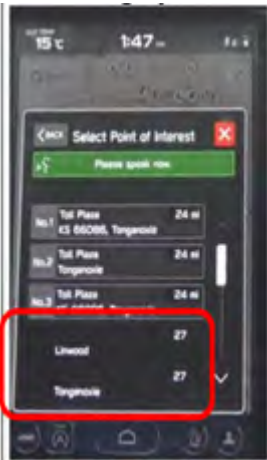
8	<p>Cannot connect to CarPlay via wireless connection. This symptom possibly occurs after the Ignition Switch was turned Off and On abruptly.</p>
9	<p>POI Search Result shows only city names and distances (without unit) when voice recognition POI search with Category name like “Find toll gate” is used.</p>

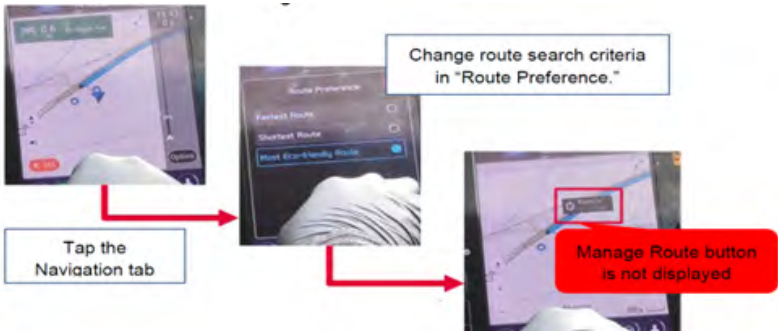
Number	Symptoms to be Improved:
10	Navigation restarts itself, when the letters are rashly entered or deleted using keyboard function to search destination.
11	<p>“Manage Route” button is not displayed when touching the route line on Navigation system, when the route search criteria got changed in the Route Preference Screen after a route had been searched.</p>

<p>Tap the Navigation tab</p> <p>Change route search criteria in "Route Preference."</p> <p>Manage Route button is not displayed</p>
12	<p>“Manage Route” button is not displayed and buttons on the Current Route Screen become unselectable (turns to grayish fill) when the Navigation system is operated in the sequence of “Manage Route” > “Avoid Blocked Road” (in the Current Route Screen) > “Back.”</p>

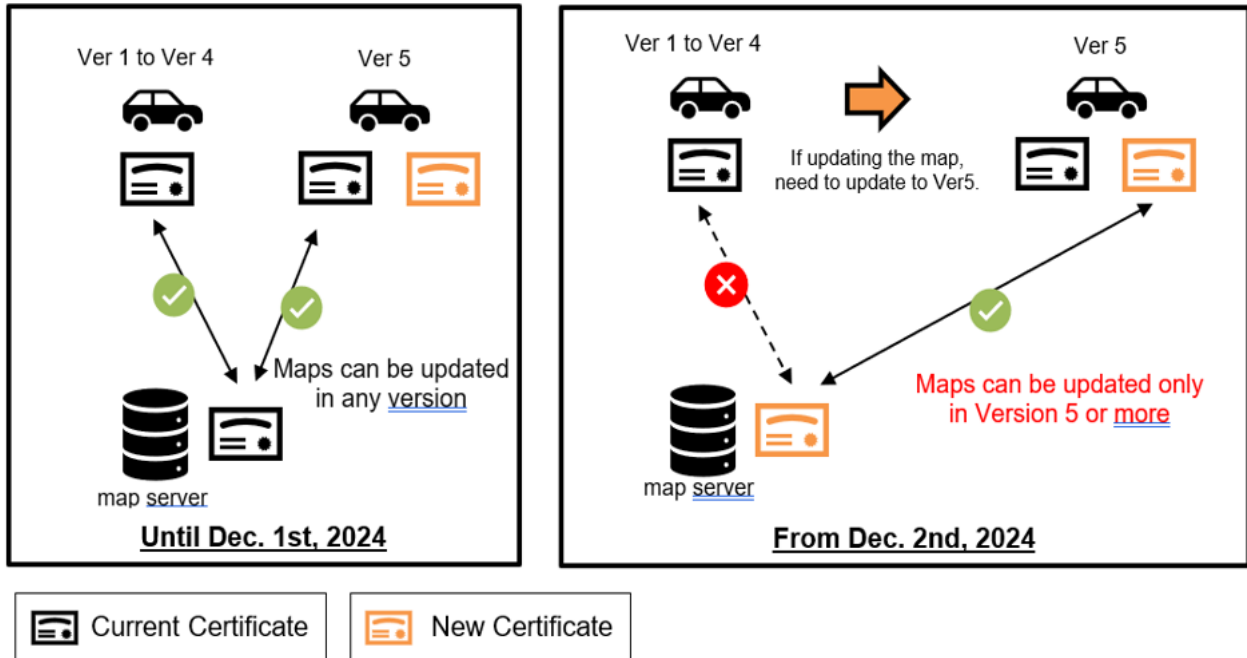
APPENDIX 10

IMPORTANT NOTE: The certificate of the data distribution server for the map update service by Map OTA (MOTA) will be changed **from Dec 1st, 2024**, and the previous server certificate will no longer be eligible after **2nd December, 2024**. To get the MOTA service on and **after Dec 2nd, 2024, Ver. 5 software that includes new server certificate should be installed in advance.**
