S-Series

2.0 Medallion Instrument Cluster Software Update - High Transmission Temperature

Date: July 16, 2024
Bulletin Name: FDM-SVC-039
Model: Oshkosh S-Series
Units Affected: 2.0 Front Discharge Mixers VIN 788727-829556

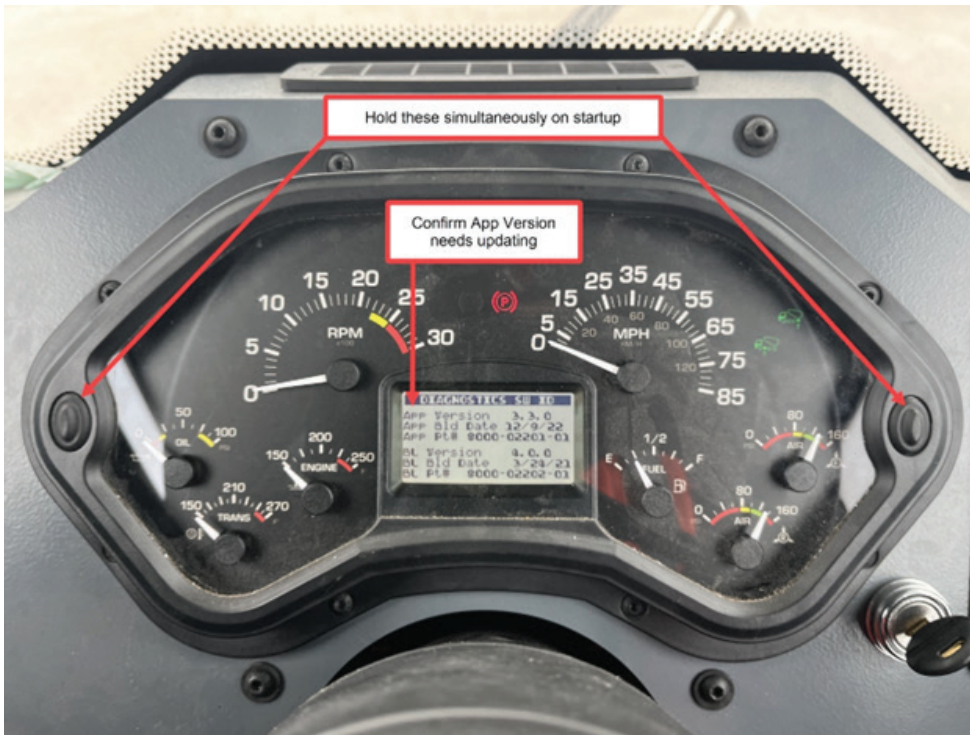
Figure 2

3. Turn vehicle battery disconnect switch ON.
4. Turn vehicle ignition switch to IGNITION position.
5. Press and hold the left and right instrument cluster side buttons when the instrument cluster lights up and the Oshkosh logo is displayed to enter the Diagnostics screen. See Figure 2.
6. Confirm a software update is needed by looking at the App Version number. Verify software update compatibility before updating software. **Installing incompatible software version will cause the instrument cluster to brick and be inoperable.**

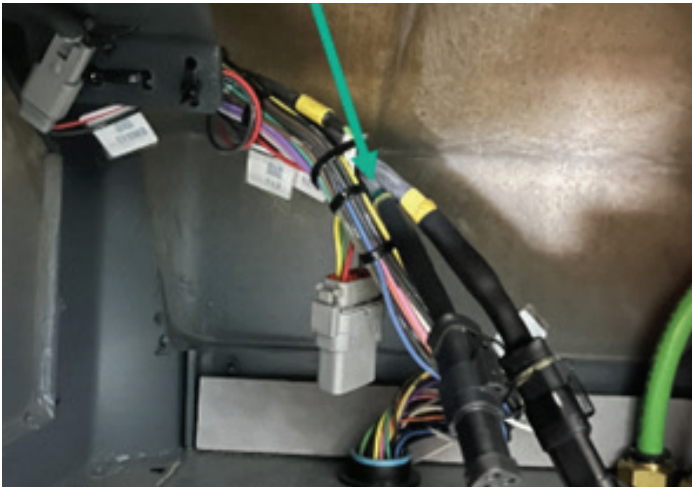
Figure 4

8. Turn vehicle ignition switch to OFF position.
9. Plug the PCAN-USB adapter cable into truck and laptop.
 - a. **MY22 and older:** Locate cab harness connector C12F (green tape) under the dashboard by the driver's left foot. See Figure 4. Remove the terminating resistor from connector C12F and install PCAN-USB adapter.

14. Disconnect PCAN-USB harness from connector C12F under dashboard and reinstall terminating resistor removed in Step 9.

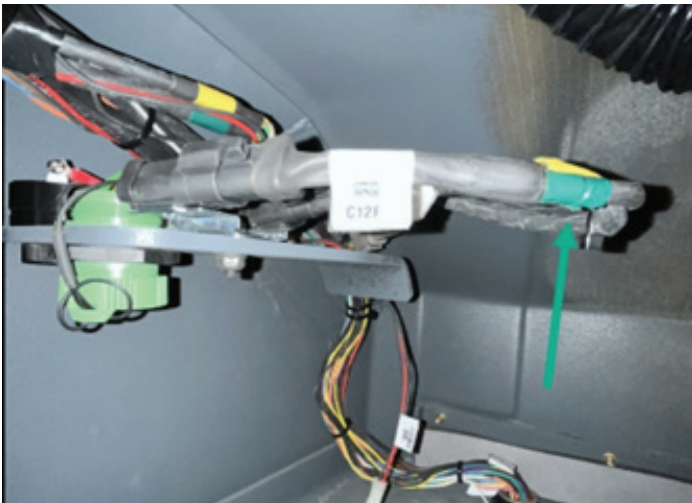
Figure 5

- b. **MY23 and newer:** Locate cab harness connector C12F (green tape) under the dashboard by the driver's left foot. See Figure 5. Remove the terminating resistor from connector C12F and install PCAN-USB adapter.

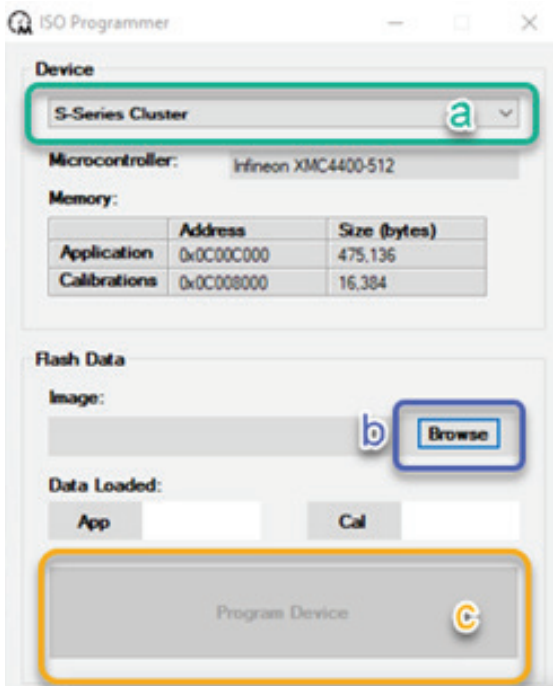
Figure 6

11. Open ISO Programmer program on laptop. If ISO Programmer fails, turn vehicle's ignition switch to OFF position and start over at Step 10. This happens occasionally and is not unusual.
12. Use ISO Programmer to update software.
 - a. Select S-Series Cluster from the Device drop down menu. See Figure 6.
 - b. Select Browse button in the Flash Data portion of ISO Programmer window. See Figure 6. Browse to location where updated cluster software hex file from engineering is saved on the laptop.
 - c. Click the Program Device button at the bottom of the ISO Programmer window. See Figure 6.
