SSPD7 - CX-30 (DM) and Mazda3 (BP) - Body Control Module (BCM) and Vehicle Control Module (VCM) software concern

Section B: Repair Procedure

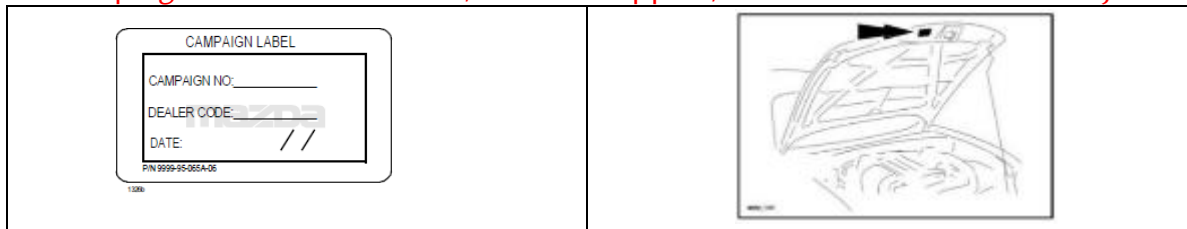
eMDCS - Warranty Vehicle Inquiry Results

2. Perform an eMDCS Warranty Vehicle Inquiry and inspect the vehicle for a Campaign Label with **SSPD7** attached to the vehicle's hood, driver door or firewall.

NOTE: Always be sure to verify the campaign number as the vehicle may have multiple campaign labels on the hood, radiator support, and firewall or driver door jamb.

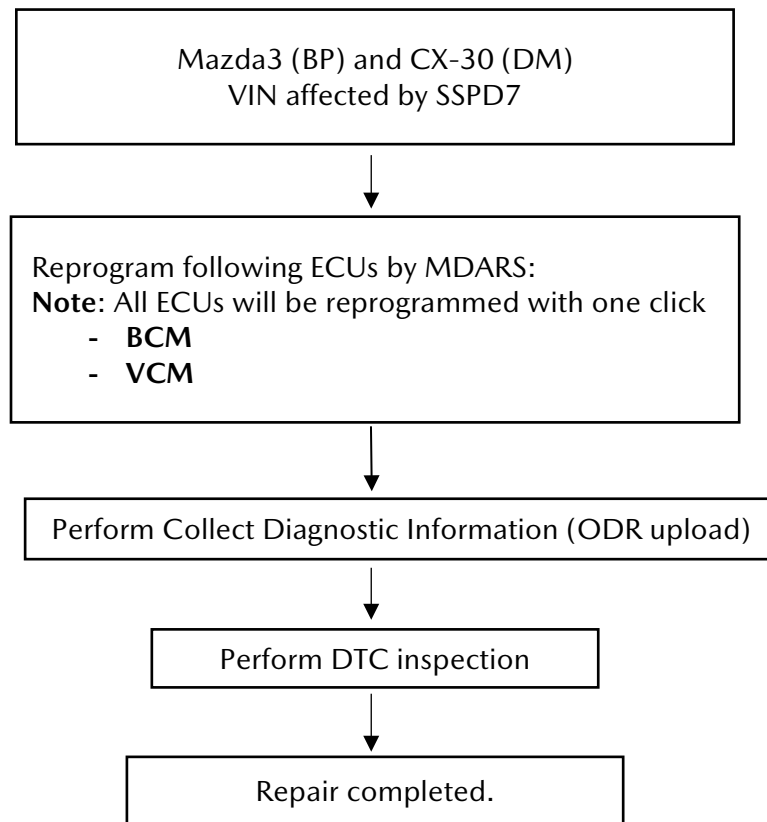
Section A: Flow Chart

NOTE: You must clear any DTC's (diagnose and repair) before performing any campaign repair. Any campaign repair will NOT fix/clear a DTC issue. Once the DTC issue is repaired, then start the repair process for campaigns.

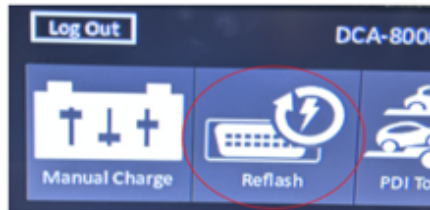
During reprogramming, connect battery charger to the vehicle to stabilize voltage fluctuation. If missing, it may cause damage to ECUs due to decreasing voltage. 7th generation vehicle will control to turn on headlight forcibly during reprogramming due to change CAN communication. Please use the "Refresh" setting in the charger, which will keep the voltage stable. The setting voltage must be between 12 -13V.

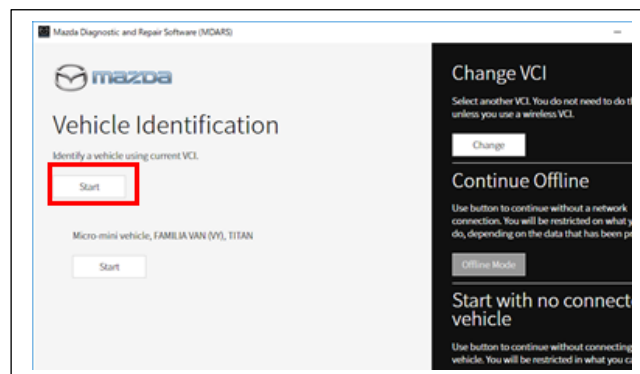
2. Click the "Start" button.

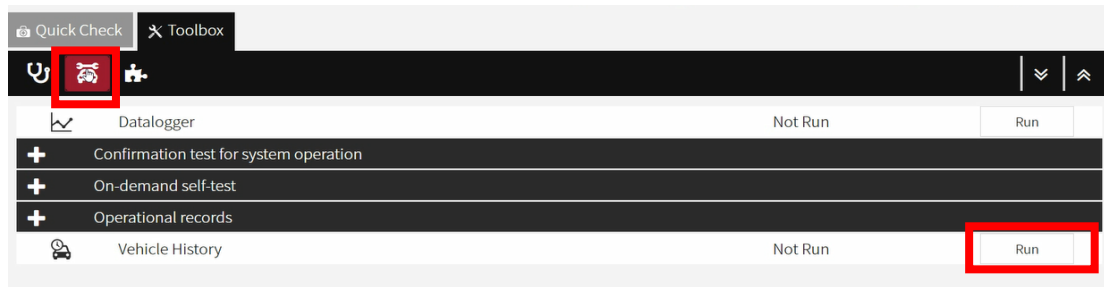
A. Open the vehicle history on toolbox tab.
