| <br><b>Technical Service Bulletin</b> | <b>GROUP</b><br><b>CAMPAIGN</b> | <b>NUMBER</b><br><b>24-01-052G</b> |
| <b>SUBJECT:</b> LH/RH OUTSIDE MIRROR CONTROLLER SOFTWARE UPDATE<br>(SERVICE CAMPAIGN T49G) | | |

**Description:** Certain 2023-24MY GV60 (JW1) vehicles may exhibit a condition where the outside mirrors do not correctly fold/unfold. Follow the procedure in this bulletin to update the LH/RH outside mirror controllers.

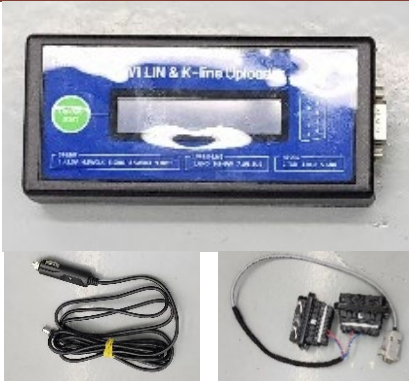
| Tool Name | Tool # | Figure | Remarks |
|---|---|---|---|
| LIN<br>COMMUNICATION<br>TOOL | SVCT49GSST | | 1 tool has been provided to each EV certified Genesis retailer. |

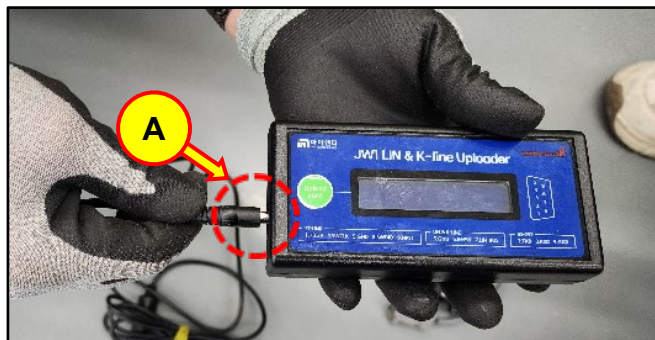
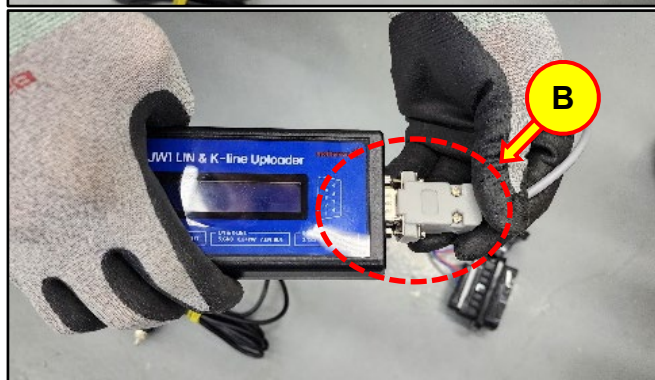
1. Turn the IG switch OFF to start procedure.
2. Install the power cable (A) and data connector (B) to the supplied LIN communication tool.

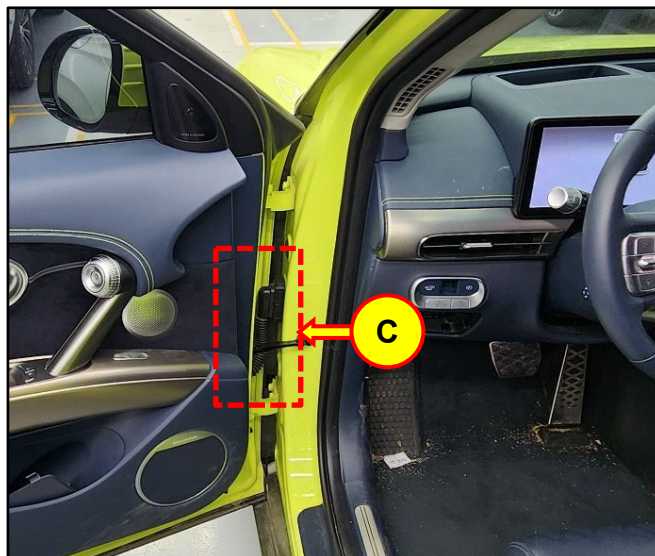
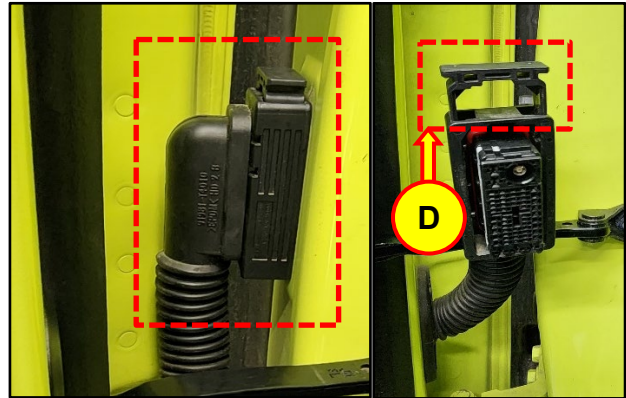
3. Disconnect the LH door connector (C) by pulling up on the tab (D).

Remove the RH door connector when updating the RH outside mirror controller software.

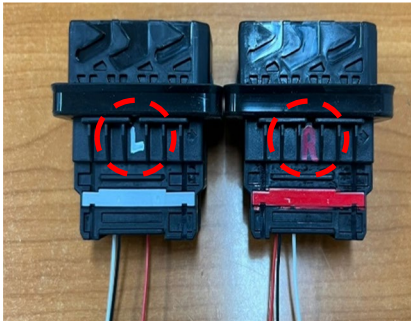
4. Connect the data connector (E) of the LIN communication tool to the door connector (F) and push tab down to secure connection.

Connect the connector marked 'L' on the data connector of the LIN communication tool to the **LH** door connector.

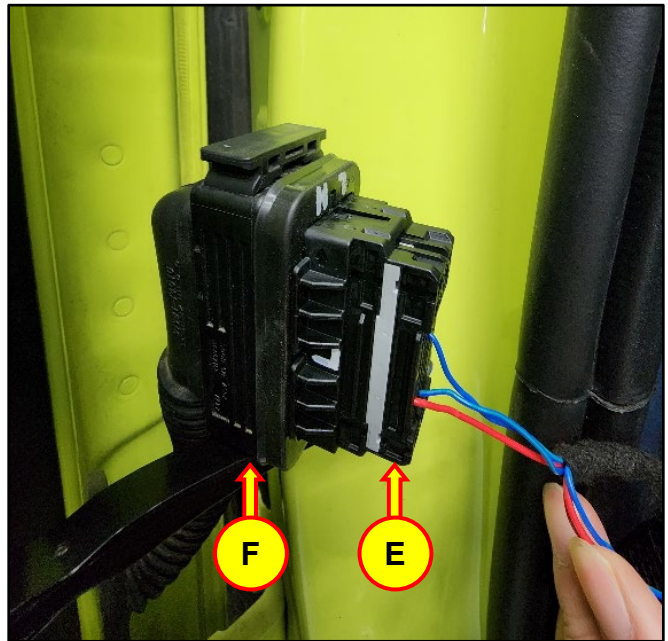
When updating the RH outside mirror controller software, attach the 'R' marked connector to the **RH** door connector.

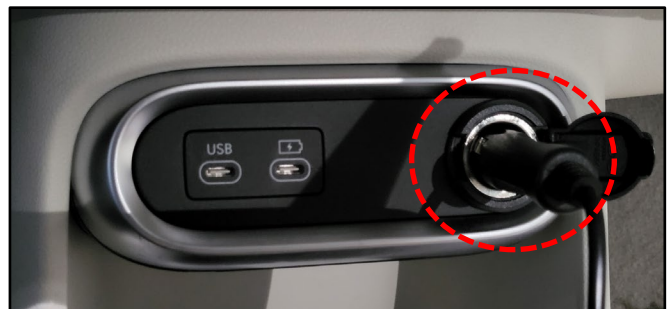
5. Attach the power cable of the LIN communication tool to the 12V outlet.

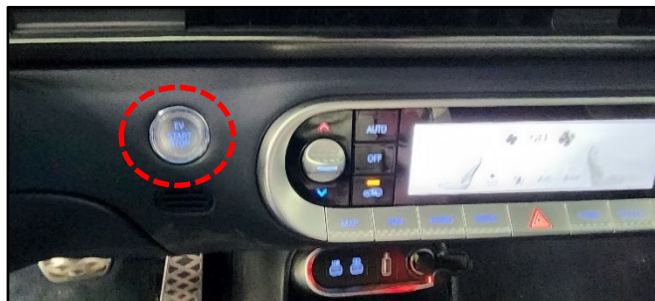
6. Turn the IG switch ON (Accessory mode) and check the LIN communication tool powers ON.
7. Press the 'Upload start' button (G) on the LIN communication tool to update the LH outside mirror controller software.

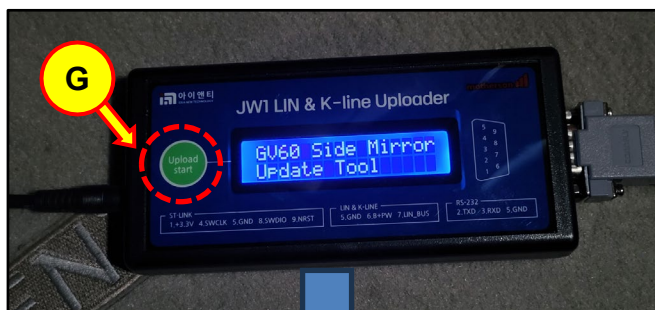
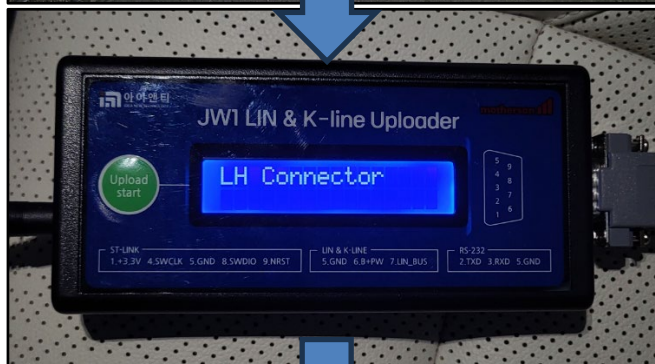
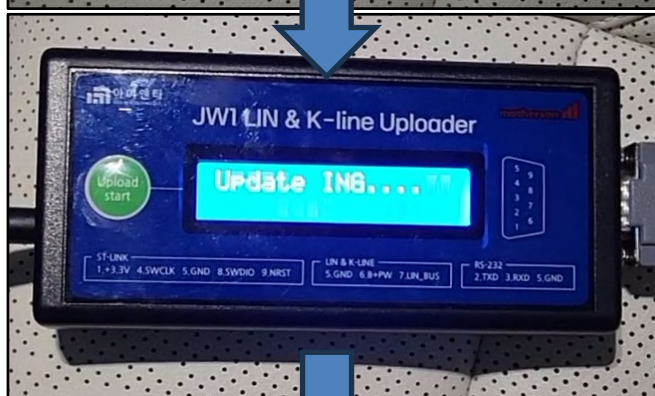
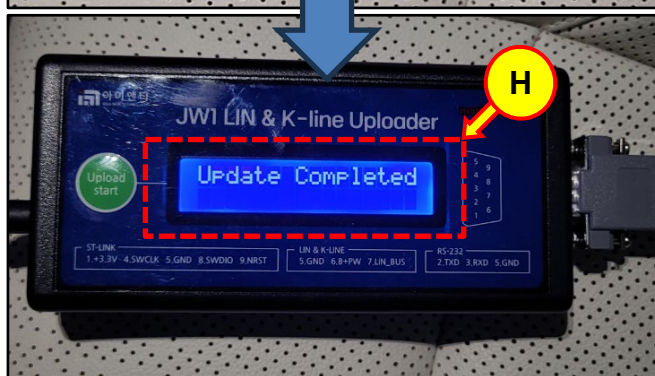
'Update Completed' (H) message is displayed on the LIN communication tool when the software update is completed.

Press 'Upload start' button again (G) to check the final software version (Ver 2.10) (I).

If message 'Check Connector Try Again' appears, check the cable connections, and confirm the tab is pushed in, securing the connection. Then press 'Upload Start' button again to retry.

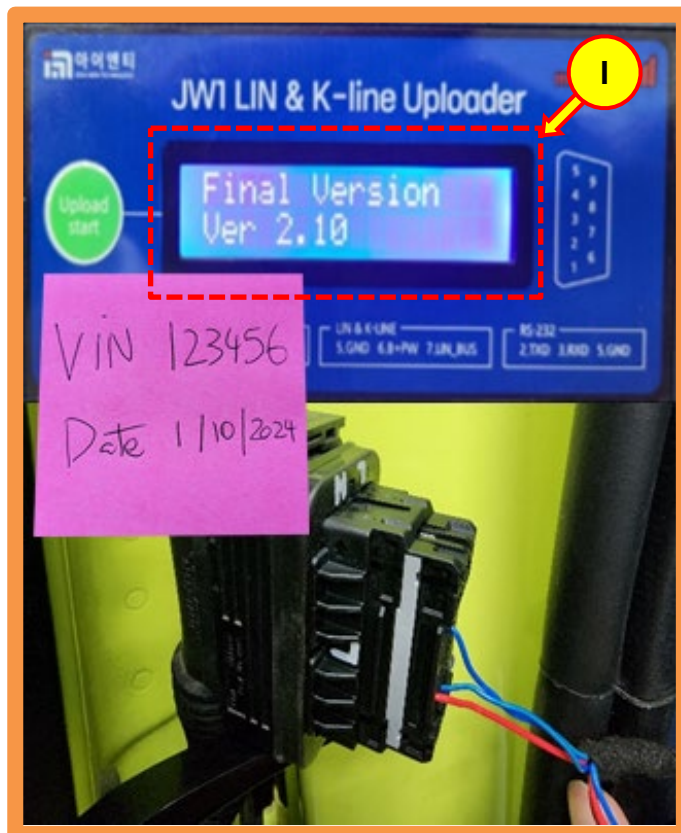
Using STUI, take a photo of the tool displaying the final version while being connected to the door connector with the last 6 digits of the VIN and the date of repair on a piece of paper.

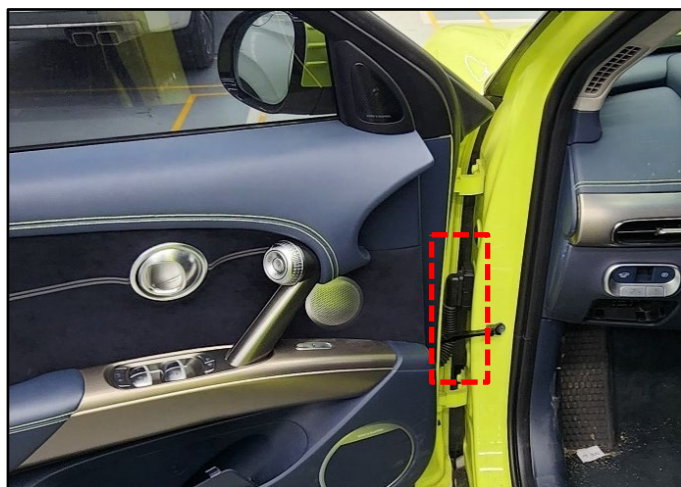
8. After update, turn IGN switch OFF.

Remove the LIN communication tool and install door connector onto the vehicle's wiring.
