Technical Service Bulletin

GROUP CAMPAIGN	NUMBER 24-01-054H
DATE JULY 2024	MODEL(S) SEE BELOW

SUBJECT: BMS SOFTWARE UPDATE FOR DTC P1BB20: 12V BATTERY OVER VOLTAGE WARNING (SERVICE CAMPAIGN 9B4)

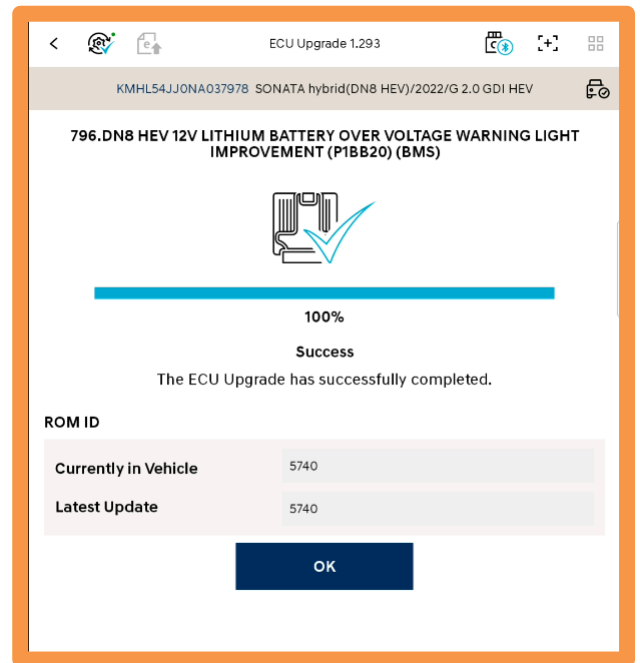
Take a screenshot of the “ECU Update Complete” screen using your tablet and upload to STUI.
