SERVICE CAMPAIGN BULLETIN

SUBJECT		No: SC-24-001REV	
LANE KEEP ASSIST REPROGRAM FOR ADAS ECU - SERVICE CAMPAIGN - REVISED		DATE: July 2024	
		MODEL: Outlander	
CIRCULATE TO:	<input type="checkbox"/> GENERAL MANAGER	<input checked="" type="checkbox"/> PARTS MANAGER	<input checked="" type="checkbox"/> TECHNICIAN
<input checked="" type="checkbox"/> SERVICE ADVISOR	<input checked="" type="checkbox"/> SERVICE MANAGER	<input checked="" type="checkbox"/> WARRANTY PROCESSOR	<input type="checkbox"/> SALES MANAGER

This bulletin provides instructions to reprogram the ADAS ECU software on 2022 *and* 2023 Model Year Outlander. ◀

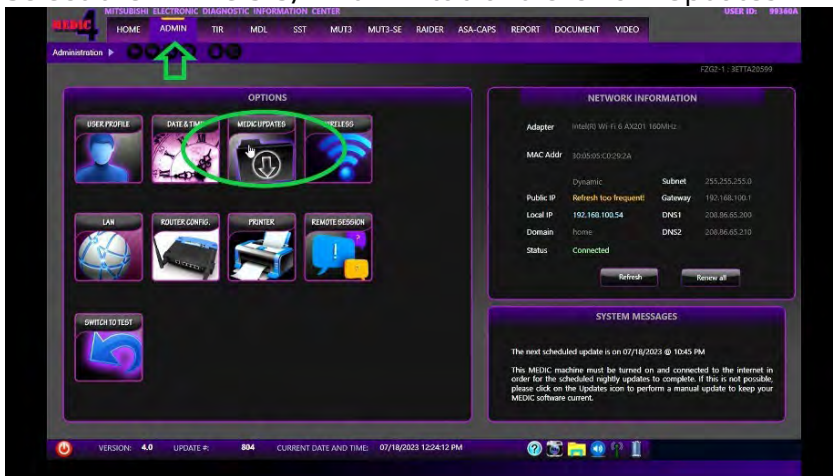
3. Select the MEDIC 3.5/4 Admin tab and click on "Updates".

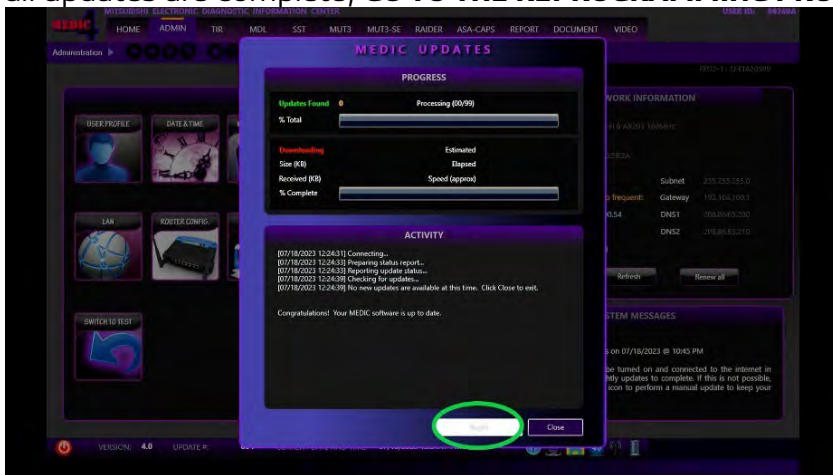
4. If the MEDIC update screen advises updates are available, click the "Begin" button. After all updates are complete, **GO TO THE REPROGRAMMING PROCEDURE.**

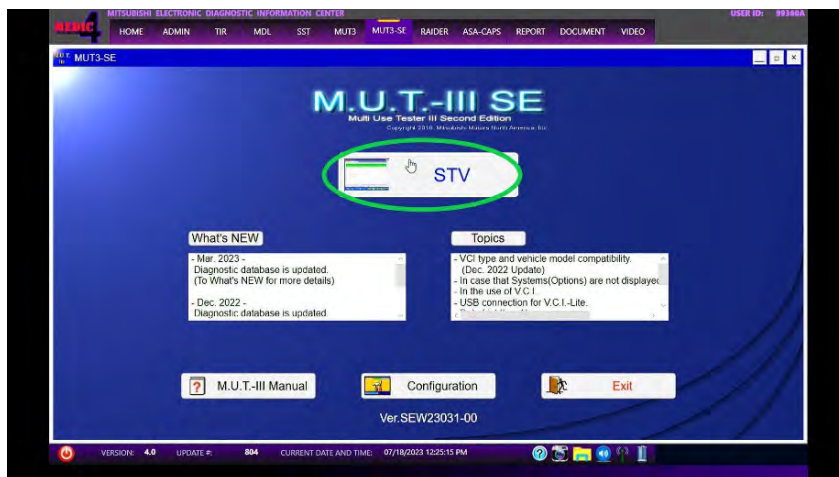
a. Press the MUT-III SE STV icon.

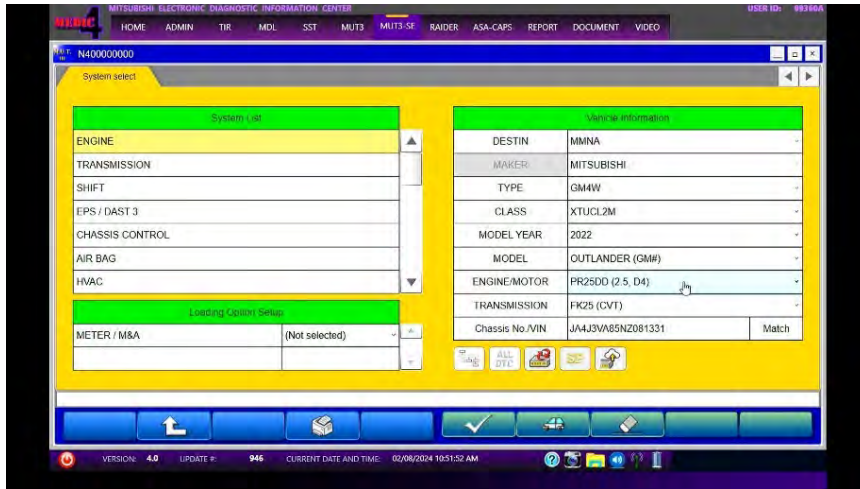
- b. Confirm the vehicle information displayed is complete/correct and press Reprogramming button.

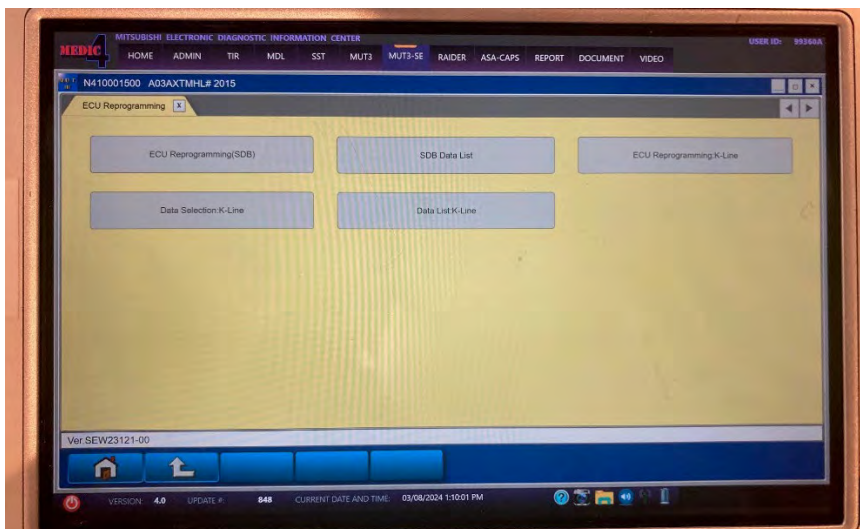
- c. Select "SDB Data List" button.

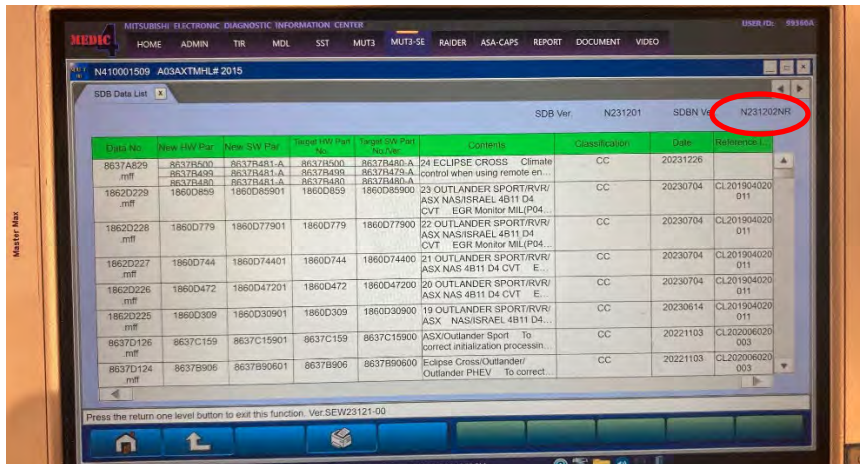
- d. Confirm that the database number displayed (upper right) is SDBN N231101NR or higher.

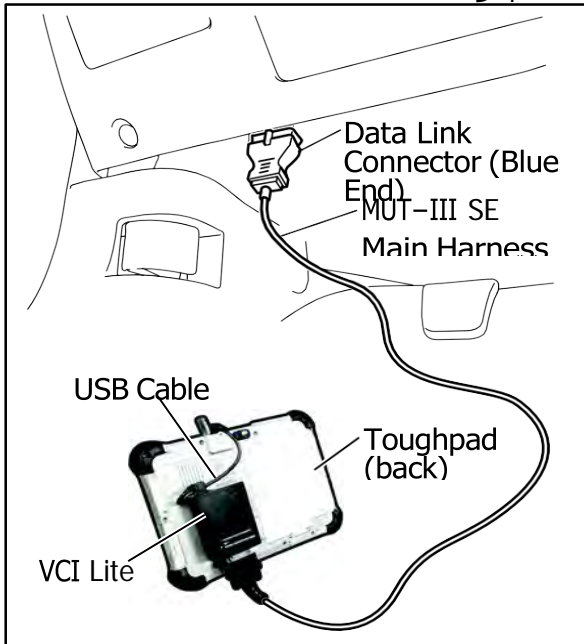
1. Connect the equipment as follows:

NOTE: VCI Lite and MEDIC 4.0 Toughpad shown for illustration purposes only.

- Turn the MEDIC PC/tablet on. If the battery indicator in the lower right hand corner of the screen does not show a full charge, it is recommended that either the battery be charged prior to beginning or be used with the A/C power adaptor connected.
- Connect the USB cable to the VCI/VCI Lite. When the laptop/tablet displays the MUT-III SE main screen, connect the USB cable to the device.
- Connect the MUT-III SE main harness with the blue DLC connection to the VCI/VCI Lite. Connect the blue connection of the MUT-III SE main harness to the vehicle's data link connector.
- For VCI only: Turn the VCI power switch ON. Verify that the indicator lamp in the upper right corner of the screen is green.

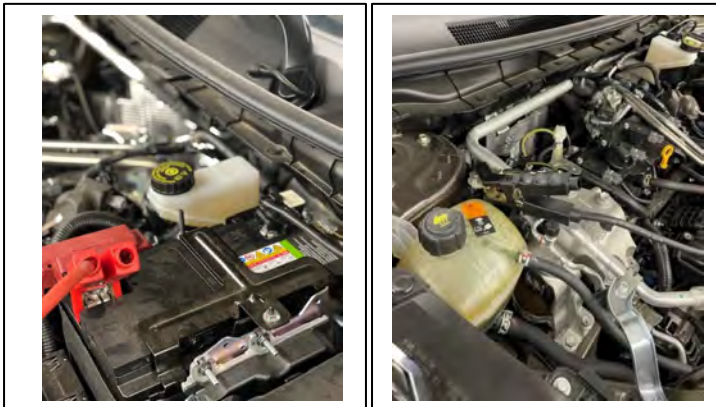
NOTE: Due to limited space it may be easiest to connect battery charger cable onto ground point.

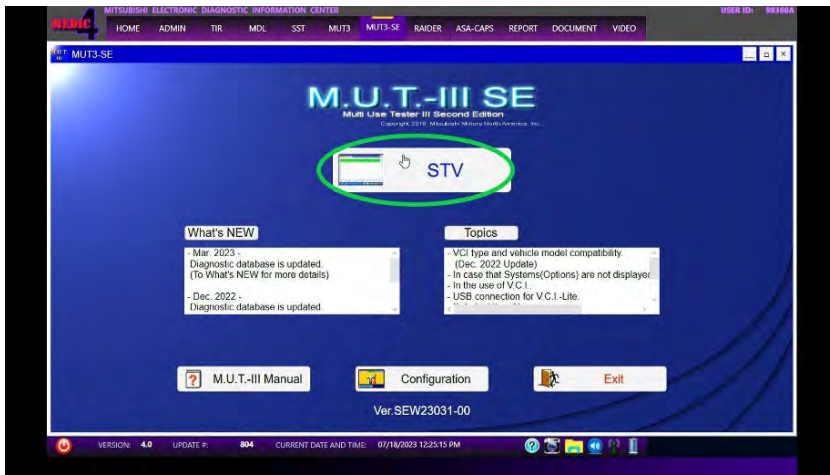
2. Turn the ignition switch to the "ON" position.
3. Turn on flashers to prevent vehicle from shutting/powering down.
4. Press the MUT-III SE STV button.

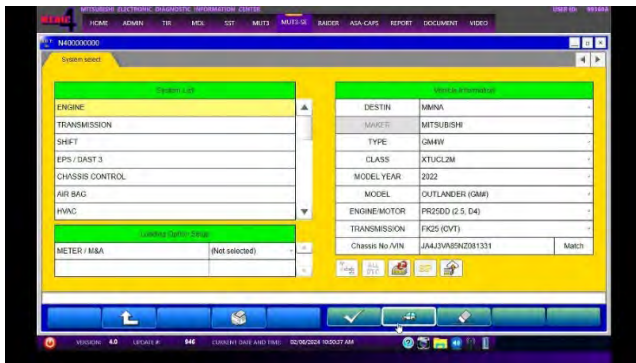
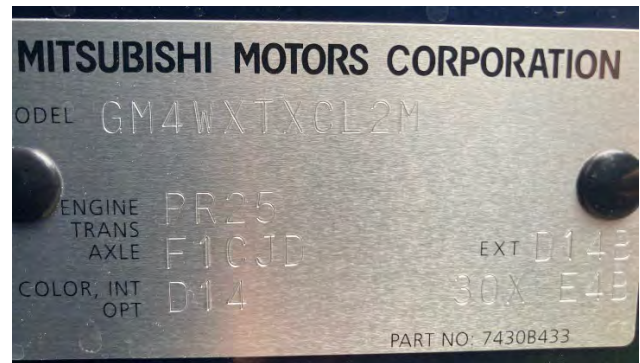
5. Press the model information display button (car icon) and verify all vehicle information. Look at the label on the passenger side B pillar to identify the appropriate class. (See B pillar label below; class is labeled as "model"). Select the correct class from the Loading Option Setup drop-down list.

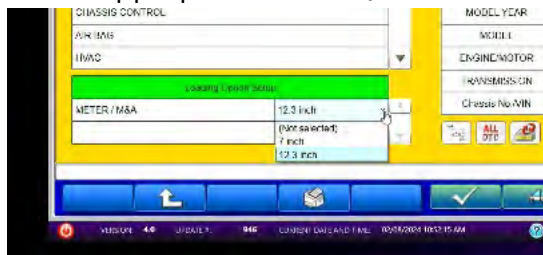
6. Verify that the ECU has not already been updated with the latest S/W number.
 - a. Select appropriate "Meter / M&A" from Loading Option Setup drop-down..

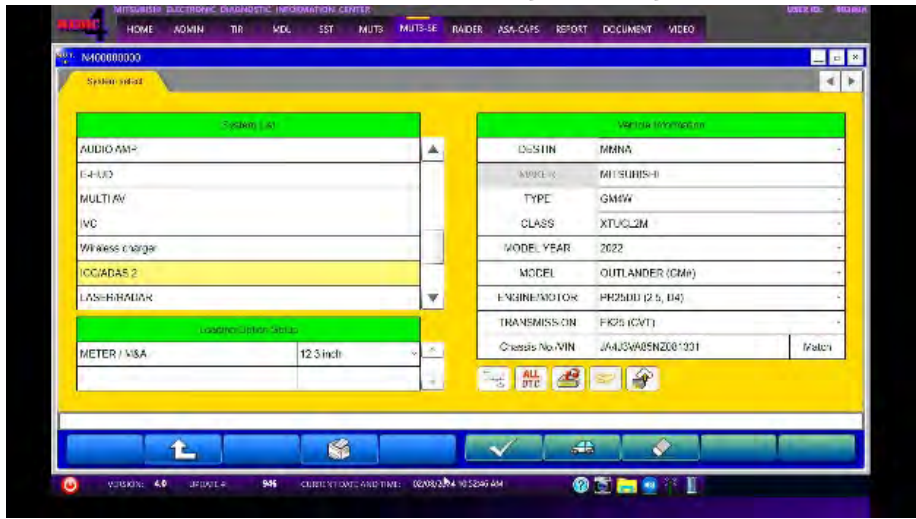
b. Select "ICC/ADAS 2" and press the programming icon button.

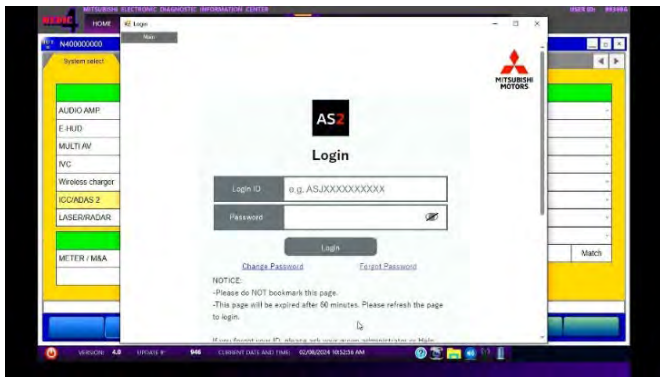
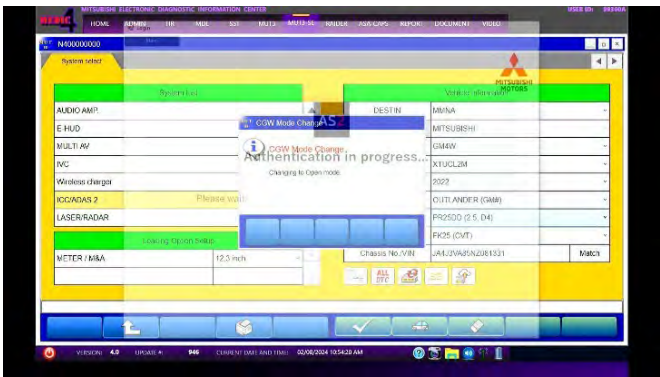
c. Log into AS2.

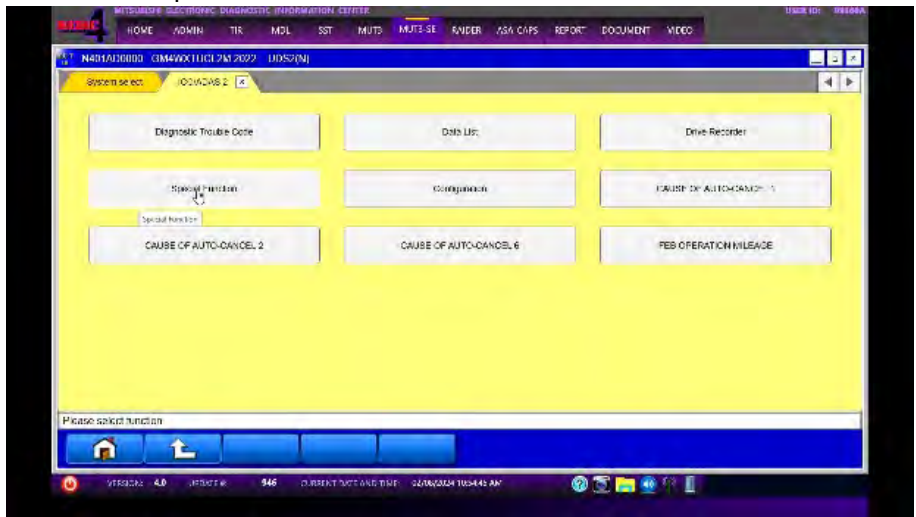
d. Press the "Special Function" button.

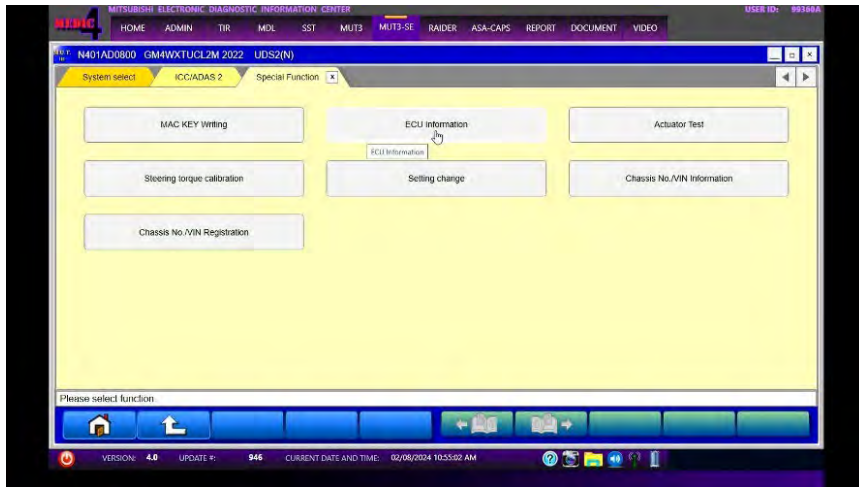
e. Select the "ECU Information" button.

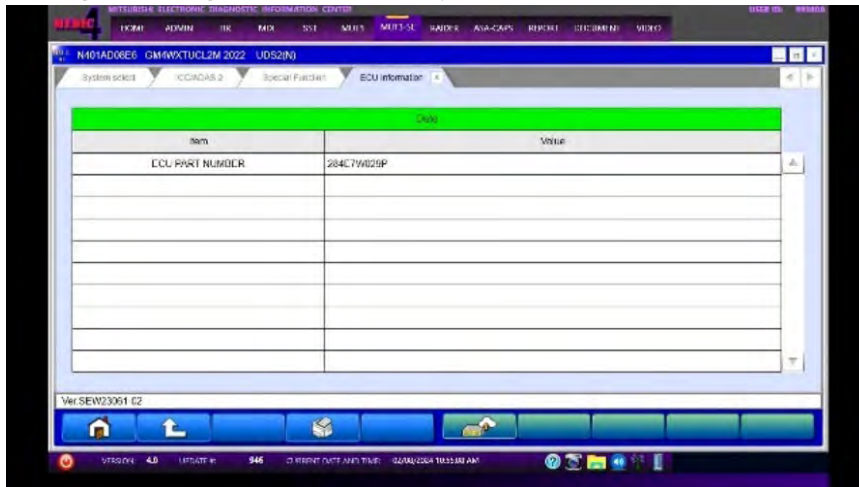
f. The current ECU Part Number will be displayed. If the ECU is at the latest level, reprogramming **is not** necessary.

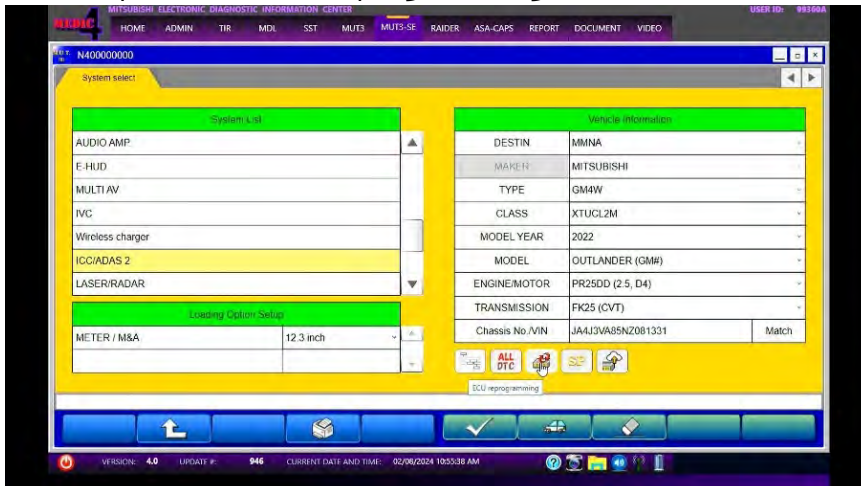
7. If reprogramming is necessary, proceed with the following steps. Return to the "System Select" tab and press the "ECU reprogramming" button.

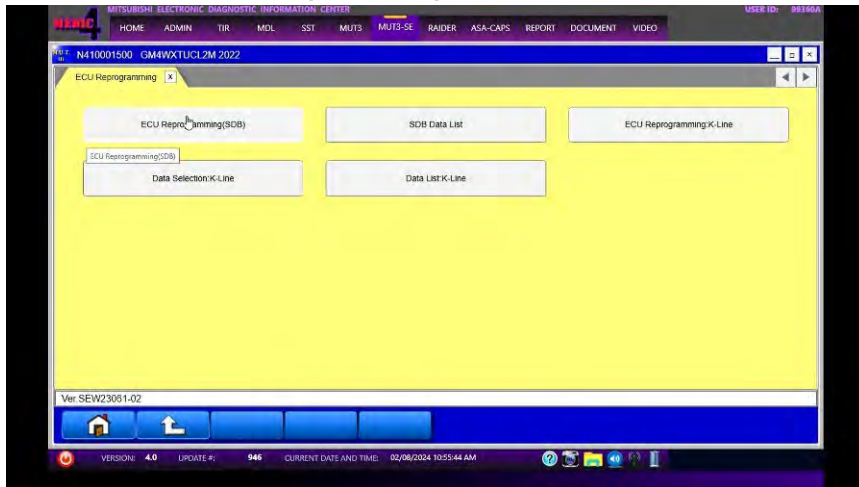
a. Select the "ECU Reprogramming(SDB)" button.

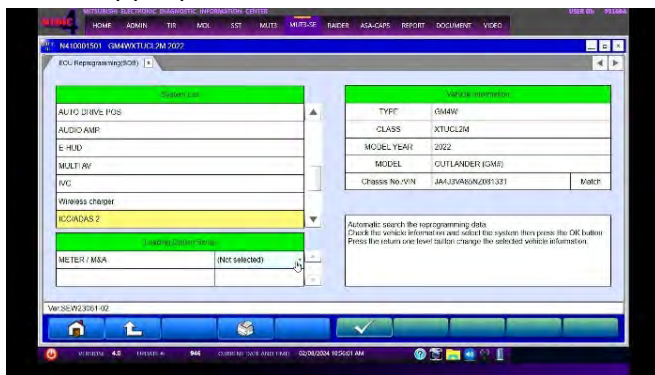
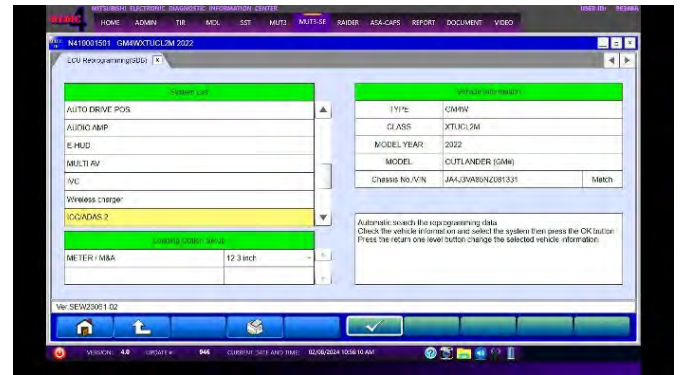
b. Select appropriate "Meter / M&A" and select the OK button.

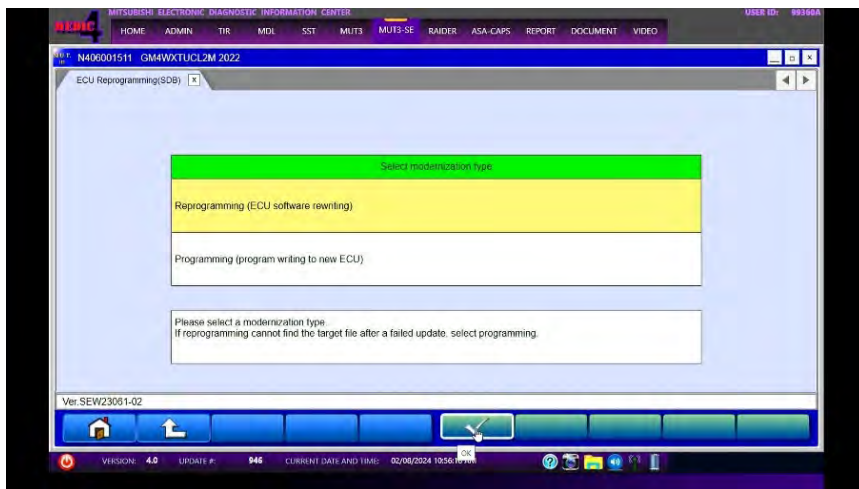
c. Select a modernization type - "Reprogramming (ECU software rewriting)" button and select the OK button.

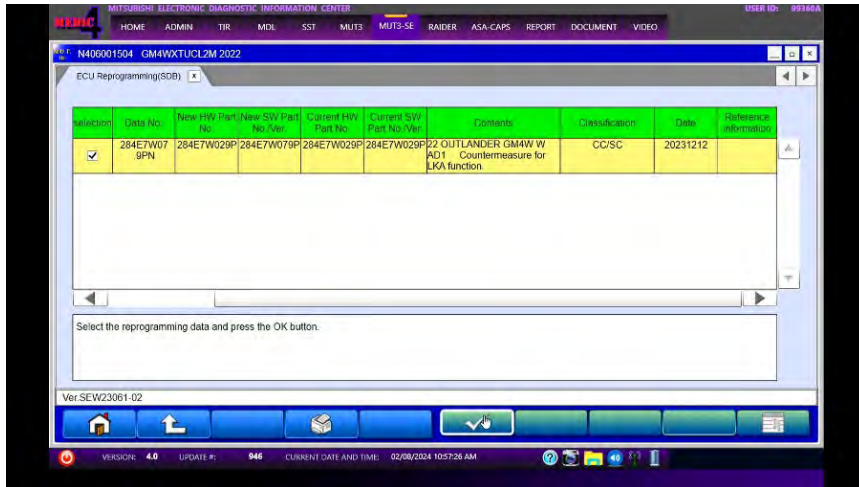
d. Select the reprogramming data and press the OK button.

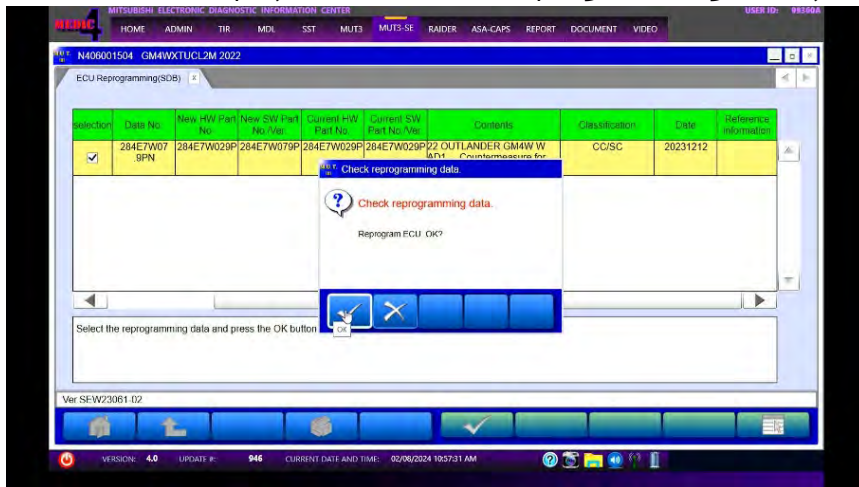
e. Confirm data displayed and confirm reprogramming ECU by selecting the OK button.

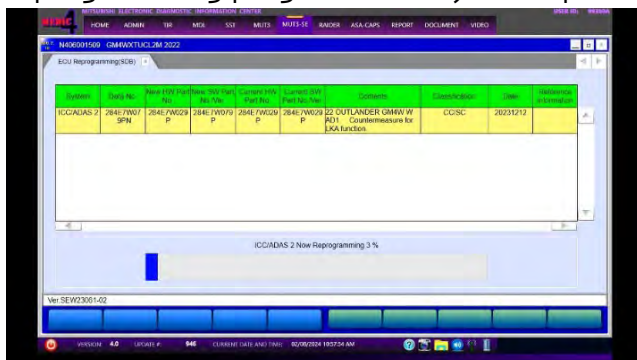
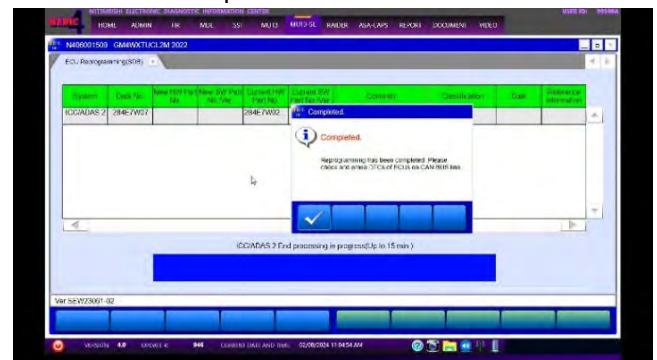
f. Once the reprogramming is initiated the screen (shown below) will indicate the reprogramming progress. It may take up to 15 minutes to complete.

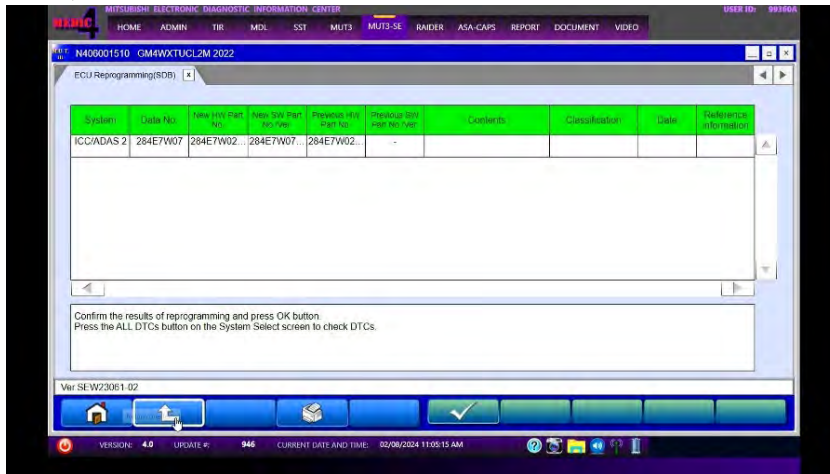
g. Verify that the software version has been updated to the new data number.

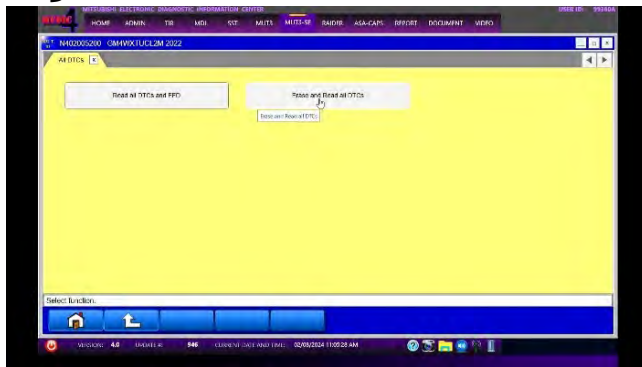
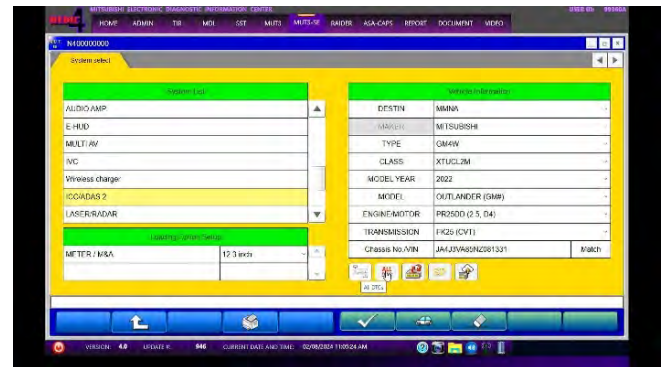
a. Return to the System Select screen. Press " ALL DTC " button to initiate the " Erase and Read all DTCs ". **IMPORTANT: The " Erase and Read all DTCs " must be performed since DTCs may be generated and stored.**

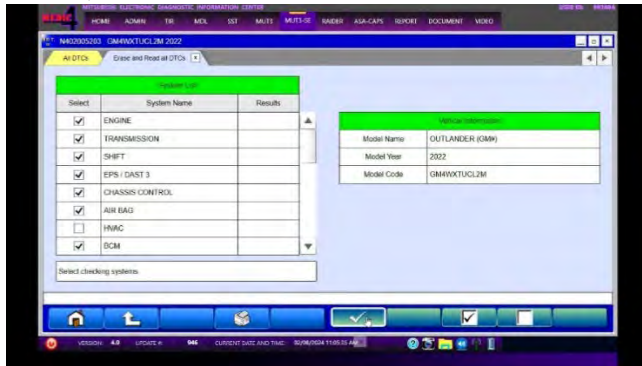
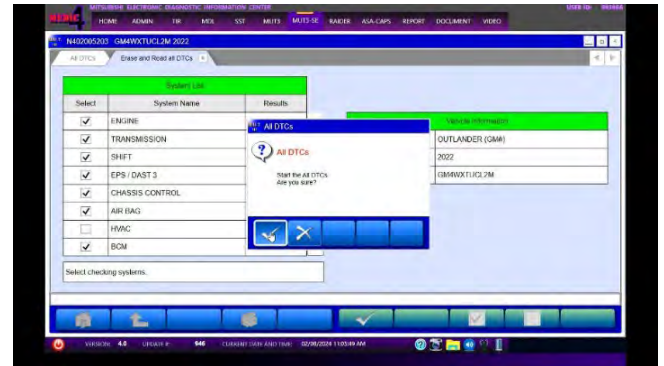
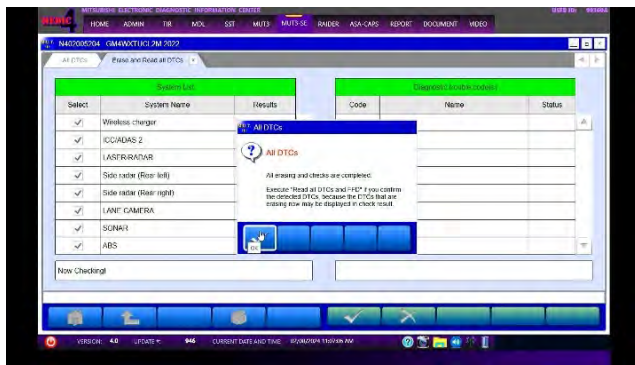
- b. Press OK to initiate erasing all DTCs. When completed, a confirmation message will be displayed. Click the OK Button.
