Technical Service Bulletin

SUBJECT:		No: TSB-16-54-001REV	
FUSE HANDS FREE LINK SYSTEM: UNSTABLE BLUETOOTH® CONNECTION - REVISED		DATE: July 2024	
		MODEL: See below	
CIRCULATE TO:	<input type="checkbox"/> GENERAL MANAGER	<input checked="" type="checkbox"/> PARTS MANAGER	<input checked="" type="checkbox"/> TECHNICIAN
<input checked="" type="checkbox"/> SERVICE ADVISOR	<input checked="" type="checkbox"/> SERVICE MANAGER	<input checked="" type="checkbox"/> WARRANTY PROCESSOR	<input checked="" type="checkbox"/> SALES MANAGER

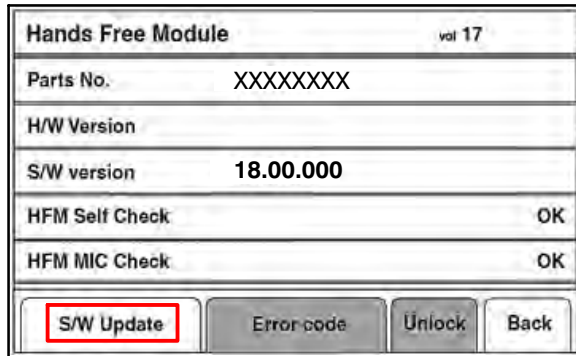
6. If update software is available the "S/W Update" button is displayed. Touch the button to continue.

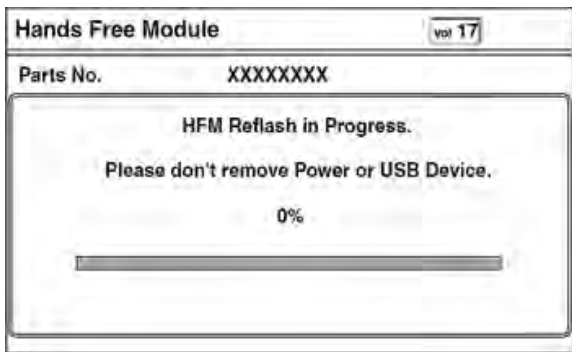
9. If you entered the correct code, a progress screen will display.

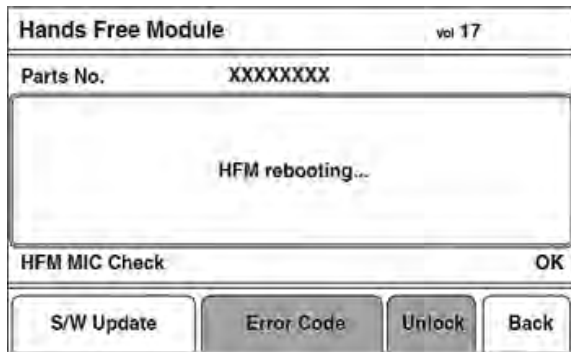
10. Do NOT press any audio control buttons while this screen is displayed.

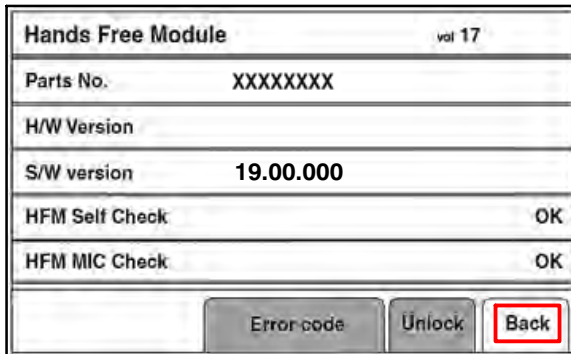
12. Confirm the software version is 19.00.000.

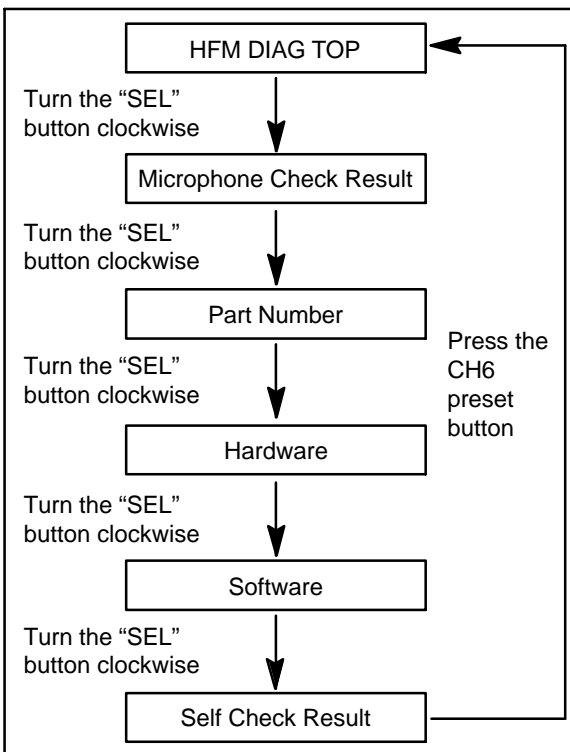
6. Confirm the software version as follows: Turn the "SEL" button clockwise to display the software version. The Software Version should be less than Ver. 19.00.000
7. Press the CH6 preset to return to "HFM DIAG TOP" after confirming the S/W version
8. With "HFM DIAG TOP" displayed, press the SEL button. If the system recognizes there is a software update to be applied, "Delete HFM" will be displayed.
9. The radio display will change to "CODE."
10. Press in order: CH1 preset, CH2 preset, CH3 preset, CH4 preset
