# Technical Service Bulletin

| SUBJECT:<br><b>SOFTWARE UPDATE FOR SMARTPHONE LINK<br/>DISPLAY AUDIO - REVISED</b> | | No: <b>TSB-19-54-013REV</b> | |
| | | DATE: <b>July 2024</b> | |

A software update is now available for the Smartphone Link Display Audio built by JVC Kenwood. This update resolves several issues that may occur in various models, as listed below.

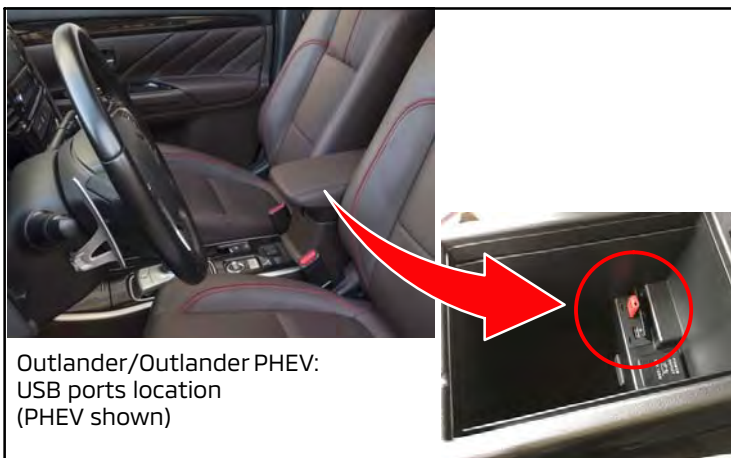
1. **For Outlander and *Outlander Sport/RVR* vehicles:** Turn vehicle ON, and keep the engine idling for the entire update procedure.  
**For Outlander PHEV:** Put vehicle in READY mode for the entire update procedure.
2. Plug in the USB flash drive containing the ***CORRECT software update file\* for that vehicle*** into the vehicle's USB port (either port may be used for the update).
  - For Outlander and Outlander PHEV, two USB ports are located inside the center console.
  - *For Outlander Sport/RVR, two USB ports are located in the front lower dash.*

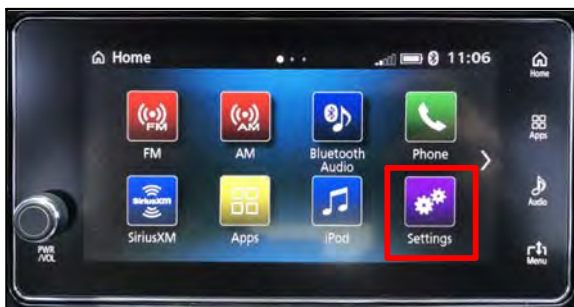
3. Before starting the update process, confirm the current software version.
  - a. Touch the "Settings" icon on the Home screen.

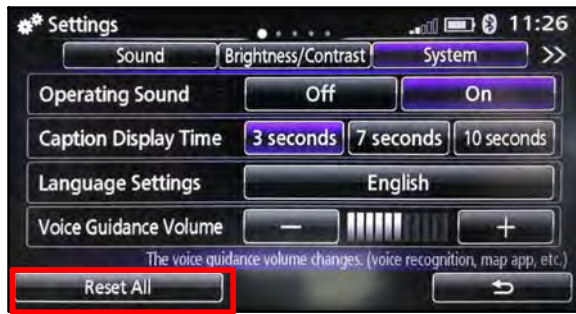
- c. Touch the "Reset All" button.

**NOTE: The "Reset All" function deletes all the customer's settings. Be sure the customer has been informed of this beforehand.**

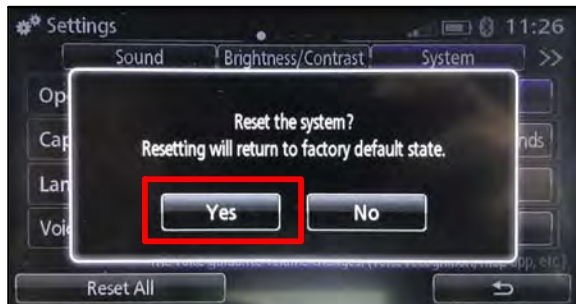
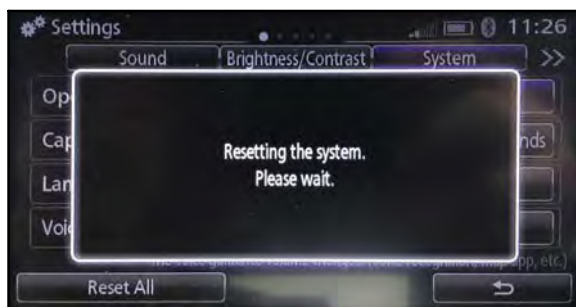
- d. Touch "Yes" on the next 2 screens to continue resetting the system.

The system will reboot one more time after resetting.

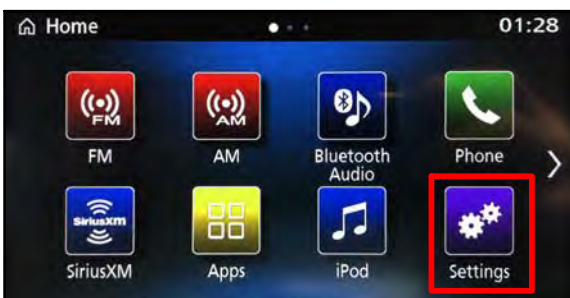
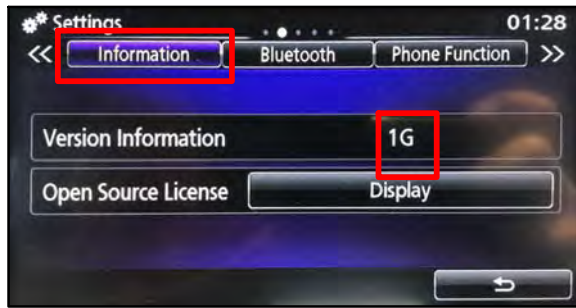
- a. Go back to the Home screen, and touch the "Settings" icon.

- b. On the Settings screen, touch the "Information" tab and check the Version Information. **NOTE: If necessary, scroll to the right or left to see the Information tab.**
- c. Verify that the version shown matches the "New" version for the applicable model in the **"Display Audio Software Version Chart,"** on page 2 of this TSB.

NOTE: Updated Version information for Outlander and Outlander PHEV shown at left.

Updated Software Version for Outlander Sport/RVR: U.

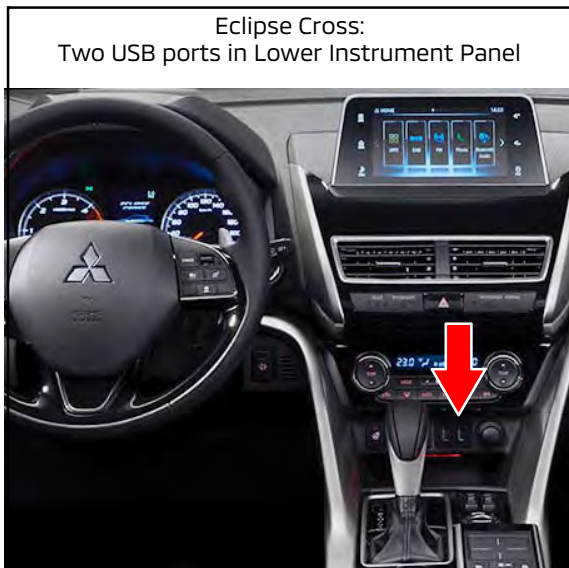
2. Plug in the USB flash drive containing the **CORRECT software update file\* for Eclipse Cross** into the vehicle's USB port (either port may be used for the update).

Two USB ports are located in the lower part of the center instrument panel.

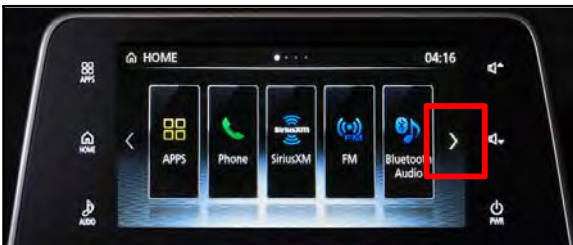
- a. On the Home screen, touch the right arrow to get to the Settings icon.

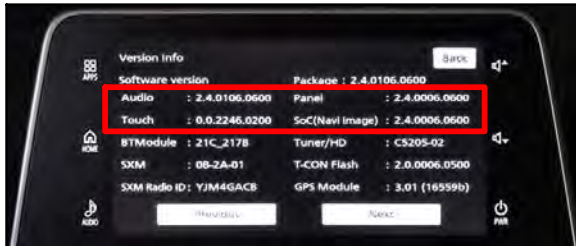
f. Confirm the software version has been updated and matches the New version shown in the **"Display Audio Software Version Chart,"** on page 2 of this TSB.

**Updated Version info for 2018 Eclipse Cross:**  
**2.4.0106.0600**

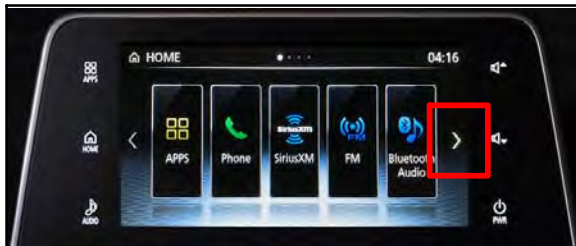
a. On the Home screen, touch the right arrow to get to the Settings icon.

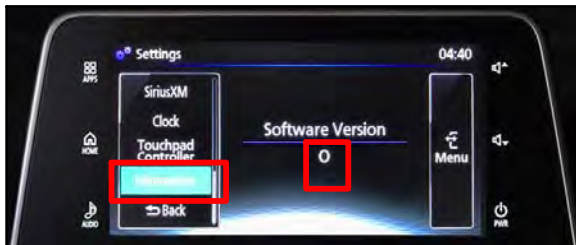
c. On the Settings screen, touch the "Information" tab and check the Version Information.

**NOTE: If necessary, scroll to the right or left to see the Information tab.**
