Technical Service Bulletin

SUBJECT:		No: TSB-21-54-002REV	
SOFTWARE UPDATE FOR SMARTPHONE LINK DISPLAY AUDIO - REVISED		DATE: July 2024	
		MODEL: See below	
CIRCULATE TO:	<input type="checkbox"/> GENERAL MANAGER	<input checked="" type="checkbox"/> PARTS MANAGER	<input checked="" type="checkbox"/> TECHNICIAN
<input checked="" type="checkbox"/> SERVICE ADVISOR	<input checked="" type="checkbox"/> SERVICE MANAGER	<input checked="" type="checkbox"/> WARRANTY PROCESSOR	<input type="checkbox"/> SALES MANAGER

A software update is now available for the Smartphone Link Display Audio (SDA). This update resolves several issues that may occur in various models equipped with SDA, as listed below.

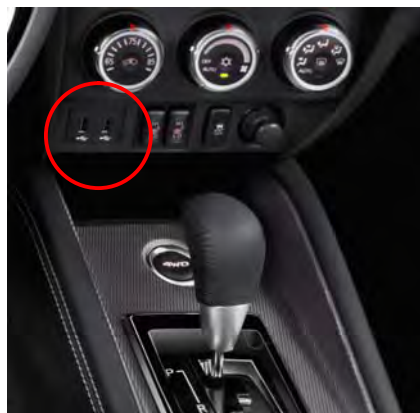
Outlander Sport / RVR: USB port location:

1. **For Outlander and Outlander Sport / RVR vehicles:** Turn vehicle ON, and keep the engine idling for the entire update procedure.
For Outlander PHEV: Put vehicle in READY mode for the entire update procedure.
2. Plug in the USB flash drive containing the **CORRECT software update file* for that vehicle** into the vehicle's USB port (either port may be used for the update).
***Refer to step 4 of "B. Transfer Files to USB Flash Drive" in this TSB for correct file identification.**
 - For Outlander and Outlander PHEV, two USB ports are located inside the center console.
 - For Outlander Sport / RVR, two USB ports are located in the front lower dash.

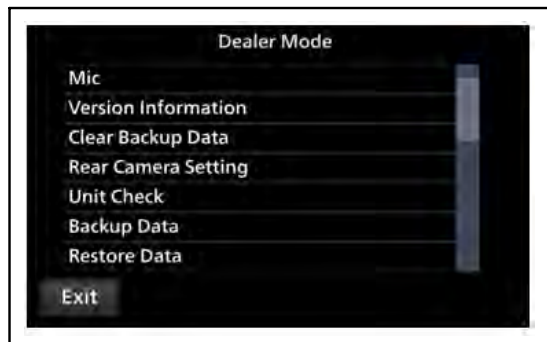
3. Before starting the update process, confirm the current software version.
 - a. Push both [MEDIA] + [⏻] at the same time and hold for 3 seconds.

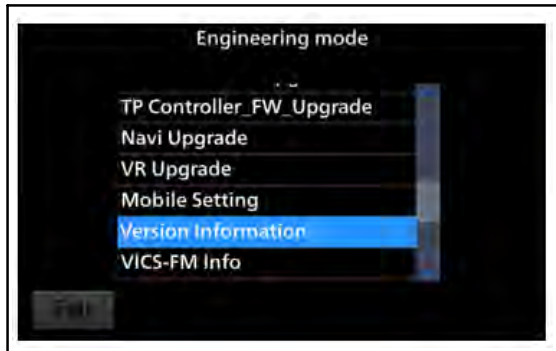
c. The Engineering Mode screen will appear.

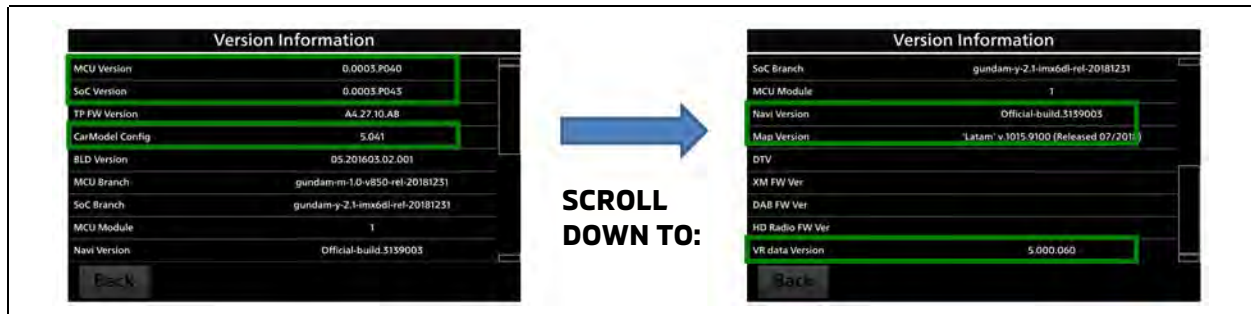
d. Scroll down to "Version Information" and push "next page".

e. Confirm the version is old by referring to the **"Display Audio Software Version Chart"** found on page 2 of this TSB. Proceed to the following page to update the software.

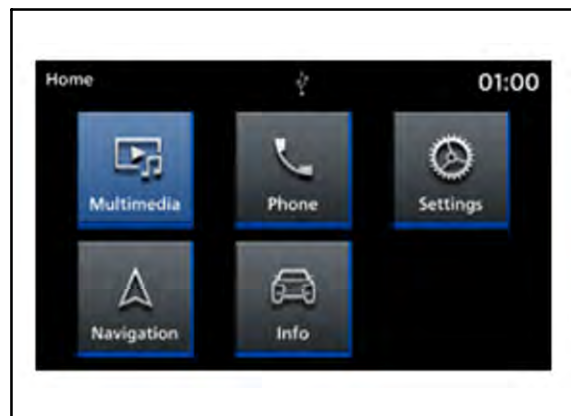
- a. ACC on.
- b. Press "OK" and wait for the Home Screen to appear.

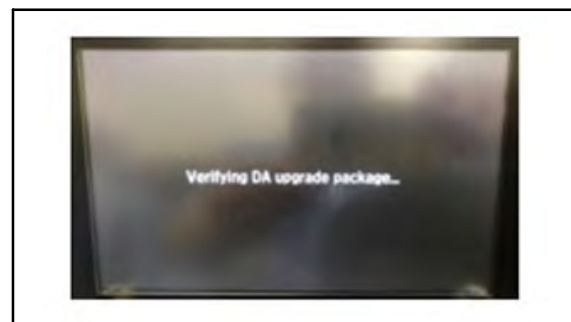
- c. Insert USB flash drive into the vehicle USB port.
- d. The software auto update will begin.

If the software update doesn't start automatically, please push "OK" on the disclaimer screen.

Note: The update will take approximately 13 minutes to complete.

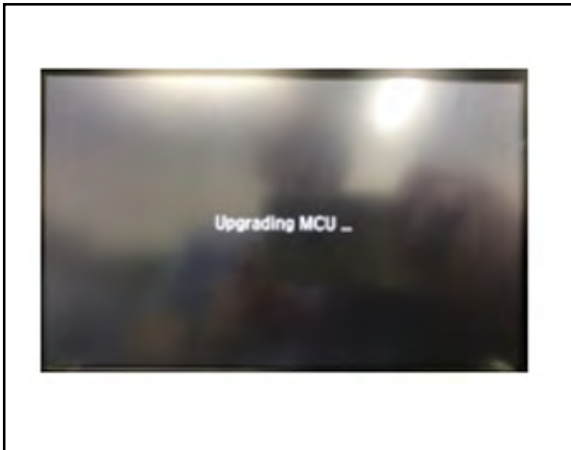
- e. This screen will be displayed for approximately 1 minute.

NOTE: Do NOT turn the power OFF, remove the flash drive or add another flash drive during the update.

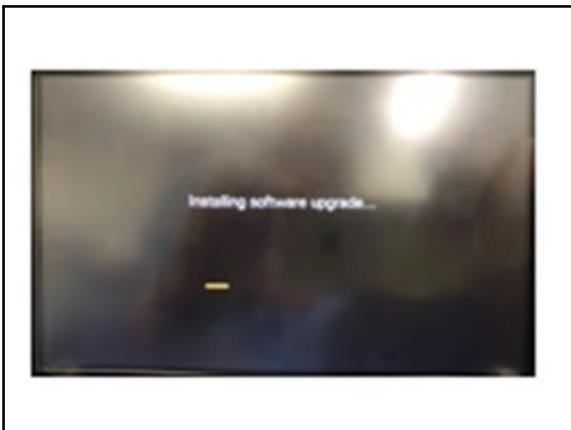
f. This screen will be displayed for about 4 minutes.

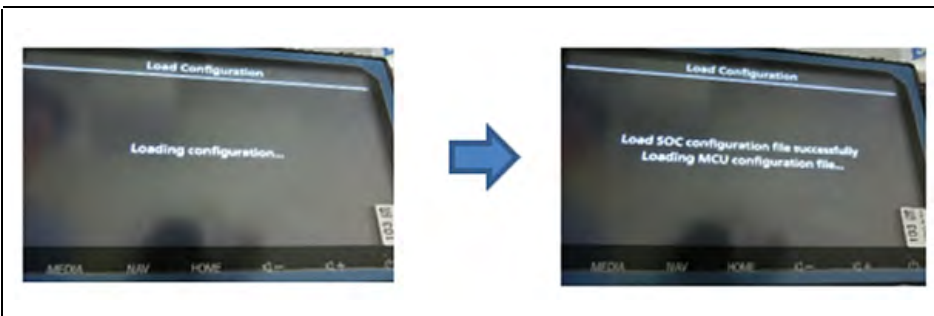
g. This screen will be displayed for about 4 minutes.

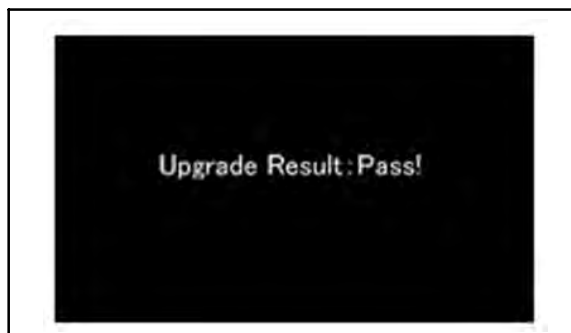
h. These screens may or may not appear. If they appear, it will be for approximately 3 minutes, total.

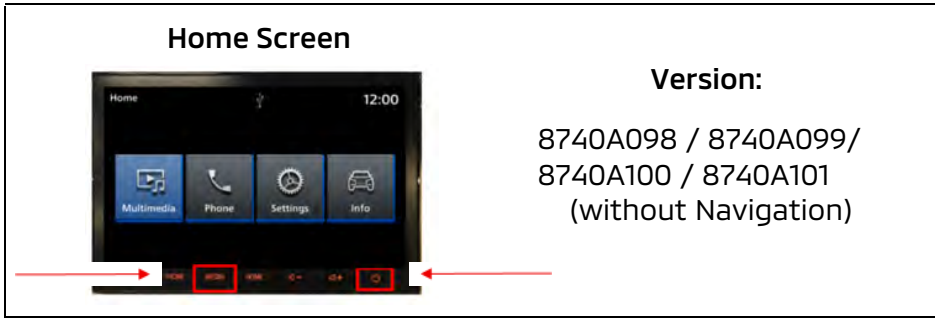
i. When "Update result: Pass!" appears, the update is complete and the USB flash drive may be removed. The home screen will then return.

Note: The Head Unit will be rebooted automatically when the update is completed.

*If "Update result: Exception!" is displayed, execute ACC off and retry beginning at step 1.

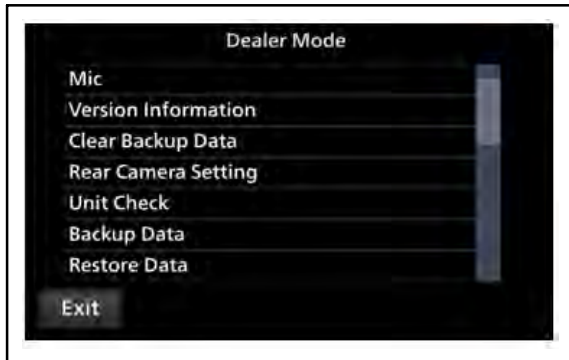
1. Push both [MEDIA] + [Power] at the same time and hold for 3 seconds.

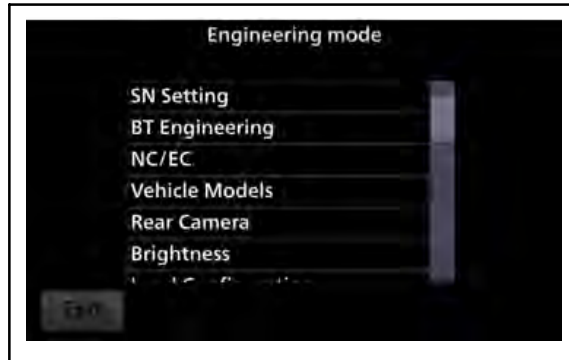
2. The Dealer Mode screen will appear.

3. At this screen, push and hold [MEDIA] + [Power] for 5 more seconds.

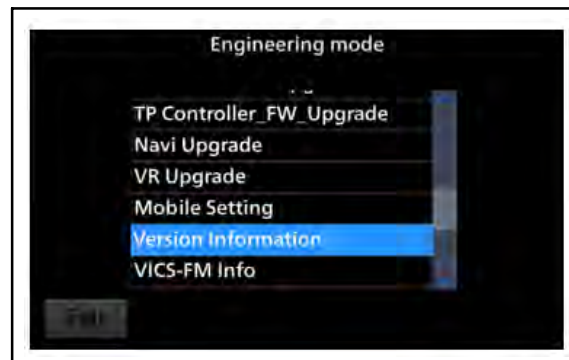
4. The Engineering Mode screen will appear.

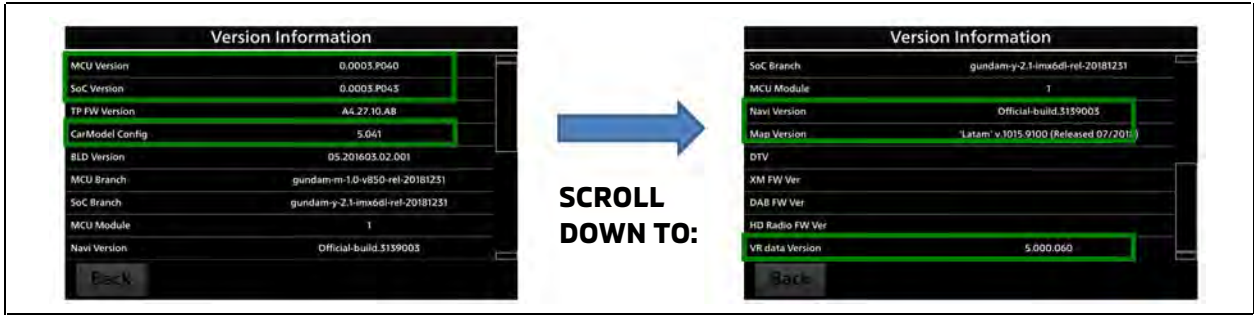
5. Scroll down to "Version Information" and push "next page".

MCU Version	: 0.0085.P002
SoC Version	: 0.0085.P003
CarModel Config	: 5.500
Navi Version	: Blank
Map Version	: Blank
VR data Version	: 5.000.200

6. Confirm the version is **0.0085.P003**: This version is for vehicles **without Navigation**. Refer to the Display Audio Software Version Chart on page 2, if necessary.
7. Verify that the issues described on page 1 of this TSB are no longer present.
8. Reset all of the customer's audio presets and settings from the chart on page 9.
