# HYUNDAI

## Technical Service Bulletin

| GROUP<br><b>EV SYSTEMS</b> | NUMBER<br><b>24-EV-005H</b> |

**SUBJECT:** IONIQ EV DTC INSPECTION AND BSA REPLACEMENT

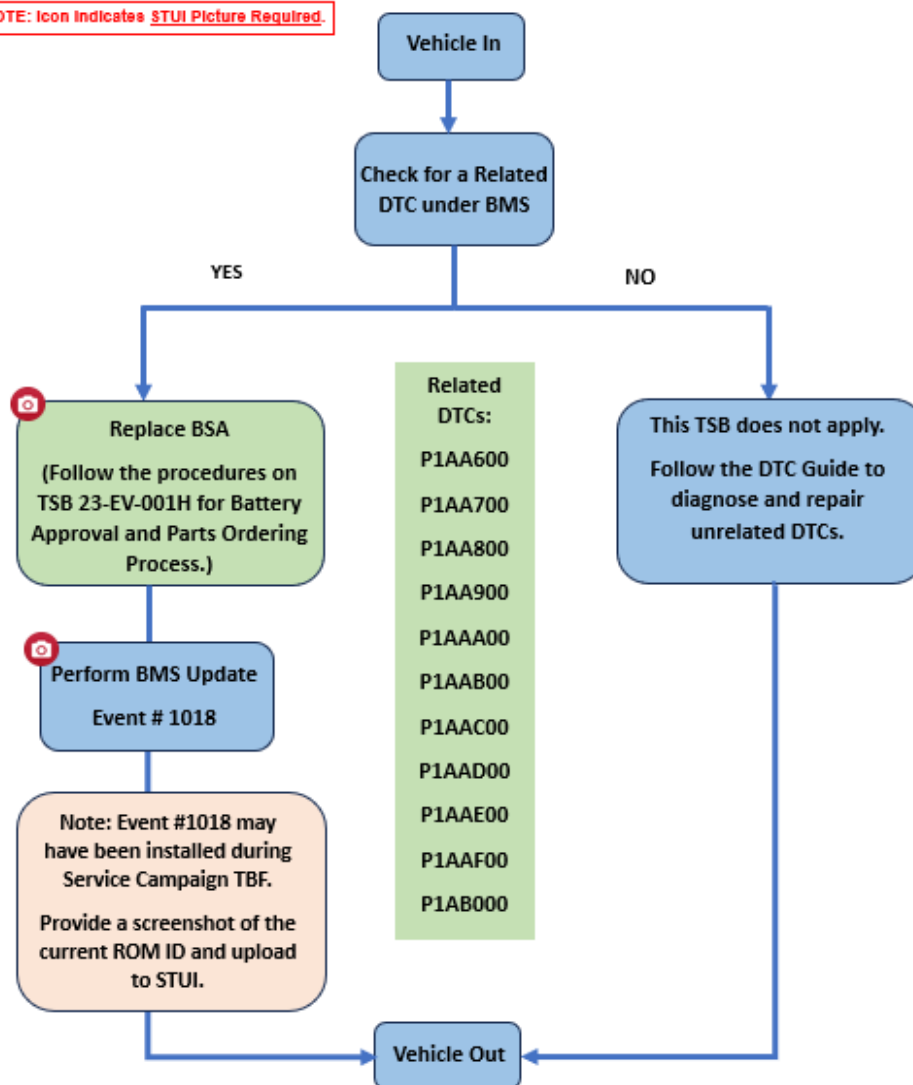
## Inspection Procedure Overview:

NOTE: Icon Indicates STUI Picture Required.

- If the related DTC(s) exists, replace the BSA following the procedures on TSB 23-EV-001H (or latest version) and perform BMS Event #1018 software update (if applicable).
- If any other DTC(s) exists, this TSB does not apply. Follow the DTC Guide to appropriately diagnose and repair the vehicle.

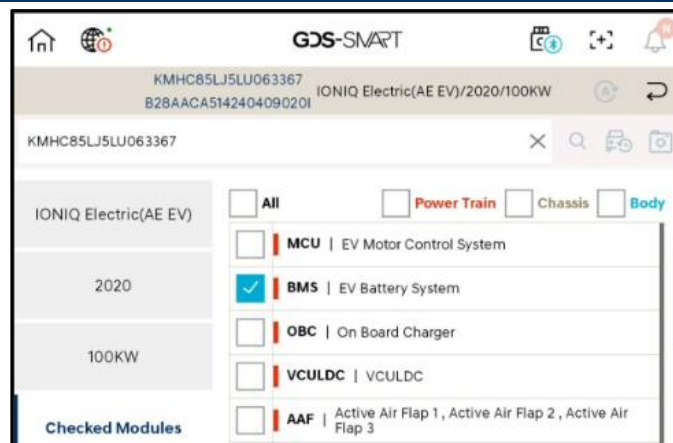
- Using the GDS, perform a Fault Code Search under the BMS System.

- Check for any of the related DTCs to the right.

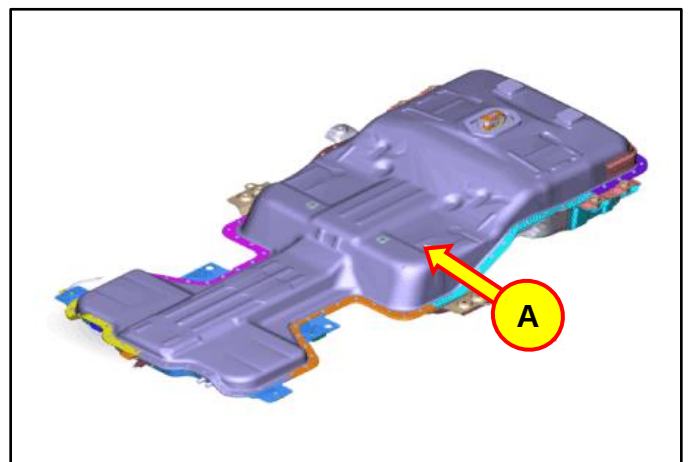
2. Replace the Battery System Assembly (BSA).

Refer to Shop Manual:

**Battery Control System > High Voltage  
Battery System > Repair Procedures**

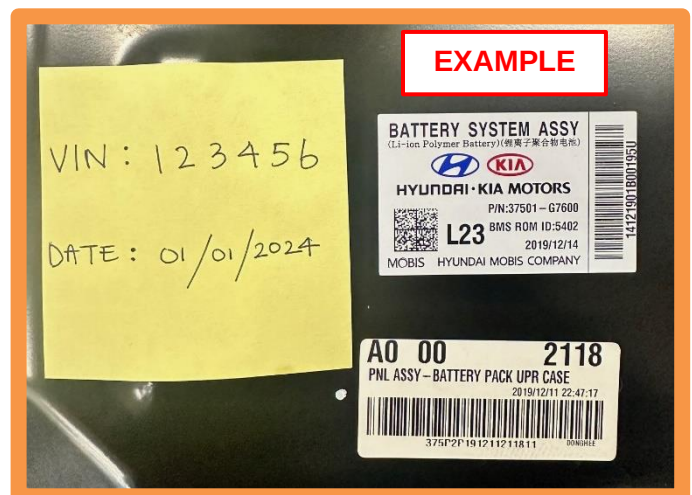
Using STUI, take a photo of the **NEW Battery System Assembly (BSA) label** with the last 6 digits of the VIN and the date of repair on a piece of paper.

Upload the photo to STUI.

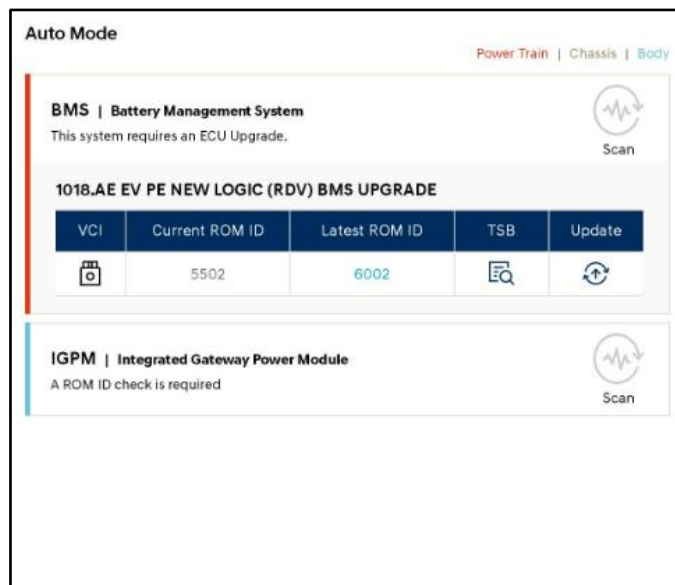
BMS Upgrade Event # 1018 may have been installed during Service Campaign TBF, reference the current ROM ID to the ROM ID information table on Page 8 to determine if the update is necessary.

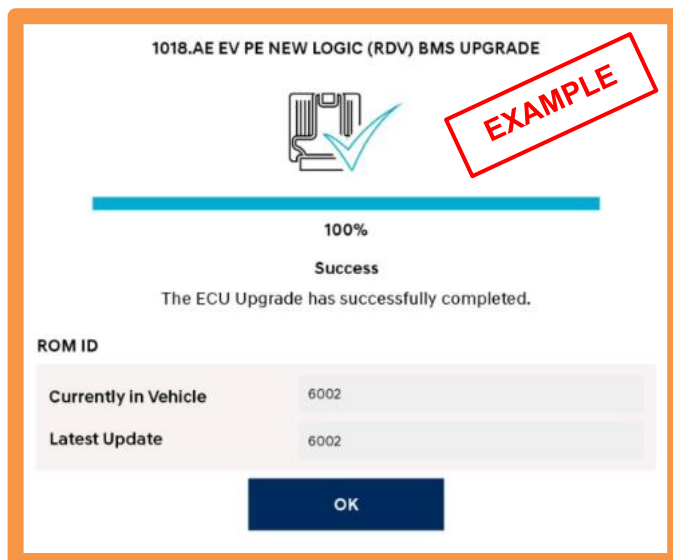
Take a screenshot of the BMS Update Complete screen using your particular tablet's screenshot save method and upload to STUI.

If there is not a BMS Upgrade available, please verify Event # 1018 has been installed, and provide a screenshot of the current ROM ID and upload to STUI.
