<b>REFERENCE:</b>	<b>TSB:</b> 08-178-24 <b>GROUP:</b> 08 - Electrical	<b>Date:</b>	August 7, 2024	<b>REVISION:</b>	-						
<b>VEHICLES AFFECTED:</b>	<p><b>2022 - 2023 (WS) Grand Wagoneer/Wagoneer</b>  <b>2022 - 2023 (WL) Grand Cherokee/Grand Cherokee L</b>  <b>This bulletin applies to vehicles equipped with a Global Telematics Box Module (TBM) (Sales Code RDG) and one of the following radios:</b></p> <ul style="list-style-type: none"> <li>● Uconnect 5 NAV W 8.4" Display (Sales Codes UBL or UEL).</li> <li>● Uconnect 5 NAV W 10.1" Display (Sales Codes UBN or UEN).</li> <li>● Uconnect 5 NAV W 12.1" Display (Sales Codes UBQ or UEQ).</li> </ul>			<p><b>MARKET APPLICABILITY:</b></p>

This bulletin provides information regarding the latest Firmware Over The Air (FOTA) update and provides the service technician an overview of the steps a customer will need to take to complete the update. The radio software will be updated from T25.50 to U29.42.

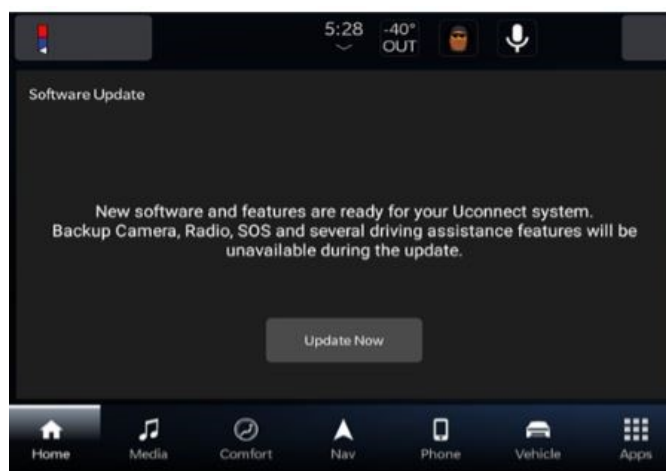
**Fig. 1**

Software Acceptance Screen

1. The vehicle needs to be in 'Park'. The ignition needs to be in the off position.
2. If the customer selects “Update Now” [Fig.1](#) they can shut off the vehicle and leave. The update will be completed automatically.

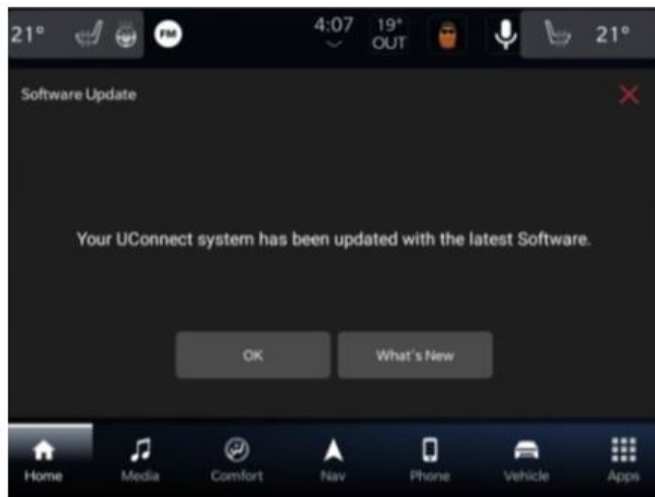
3. Upon completion of update, the radio will display a confirmation message [Fig. 2](#).

**Fig. 2**  
Software Update Confirmation Screen
