## STELLANTIS Technical Service Bulletin (TSB) Radio Over The Air Update from PARTS & SERVICES U29.28 and U33.9 to U33.43 Software Version August 10, 2024 TSB: 08-181-24 **REVISION:** REFERENCE: Date: **GROUP:** 08 - Electrical 2022 - 2024 (RU) Chrysler Pacifica / Voyager **VEHICLES MARKET APPLICABILITY:** This bulletin applies to vehicles equipped with one of the following: AFFECTED: $\times$ NA **MEA** • Uconnect 5 NAV W 8.4" Display (Sales Codes UBL or UEL) with a SA IAP Global Telematics Box Module (Sales Code RDG). Uconnect 5 NAV W 10.1" Display (Sales Codes UBN or UEN) with a EE CH Global Telematics Box Module (Sales Code RDG). **CUSTOMER** Customers may also experience one or more of the following: SYMPTOM: • Unable to select the Turn by Turn Navigation. Blank Performance Pages (Rearview Camera (RVC) Functions Normally). Android Auto Voice Recognition inoperative. Media Tuner delayed. Charge Schedule HMI (RVC Functions Normally). Ambient Light inoperative. Map in Cluster inoperative. Media Widget blank. Navigation Map black. Off road pages inoperative (RVC Functions Normally). VR inoperative. Incorrect song title displayed (Carplay® only). HU switches from Media Page to Home

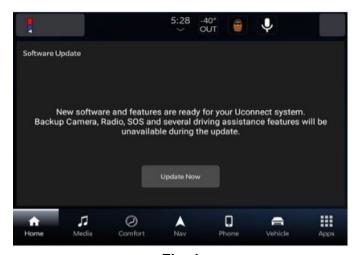
**Fig. 1**Software Acceptance Screen

- 1. The vehicle needs to be in 'Park'. The ignition needs to be in the off position.
- If the customer selects "Update Now" Fig. 1 they can shut off the vehicle and leave. The update will be completed automatically.

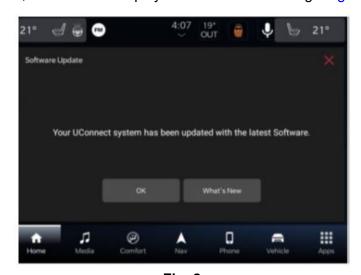
Fig. 2
Software Update Confirmation Screen

3. Upon completion of update, the radio will display a confirmation message Fig. 2.
