# Service Bulletin

Bulletin No.: 24-NA-050

**Subject: Silverado and Sierra Setting DTC P0606 and either DTC P0562 or P0563**

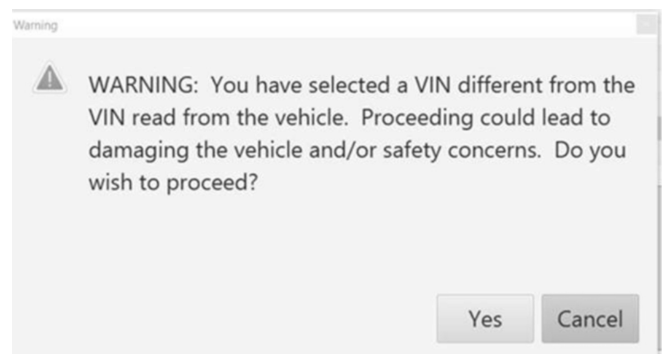
**Important:** If the vehicle VIN DOES NOT match, the message below will be shown

**Important:** Techline Connect screens shown above.  
**Important:** If the same calibration/software warning is noted on the TLC Summary screen, select OK and follow screen instructions. After a successful programming event, the WCC is located in the Service Programming System dialogue box of the SPS
