Service Bulletin

Bulletin No.: 24-NA-146

Subject: Improved NVH and Knock Detection Diagnostics Available through ECM Software Download

Brand:	Model:	Model Year:		VIN:		Engine:	Transmission:
		from	to	from	to		
Cadillac	CT5	2022	2024	-	-	6.2L (RPO LT4)	All

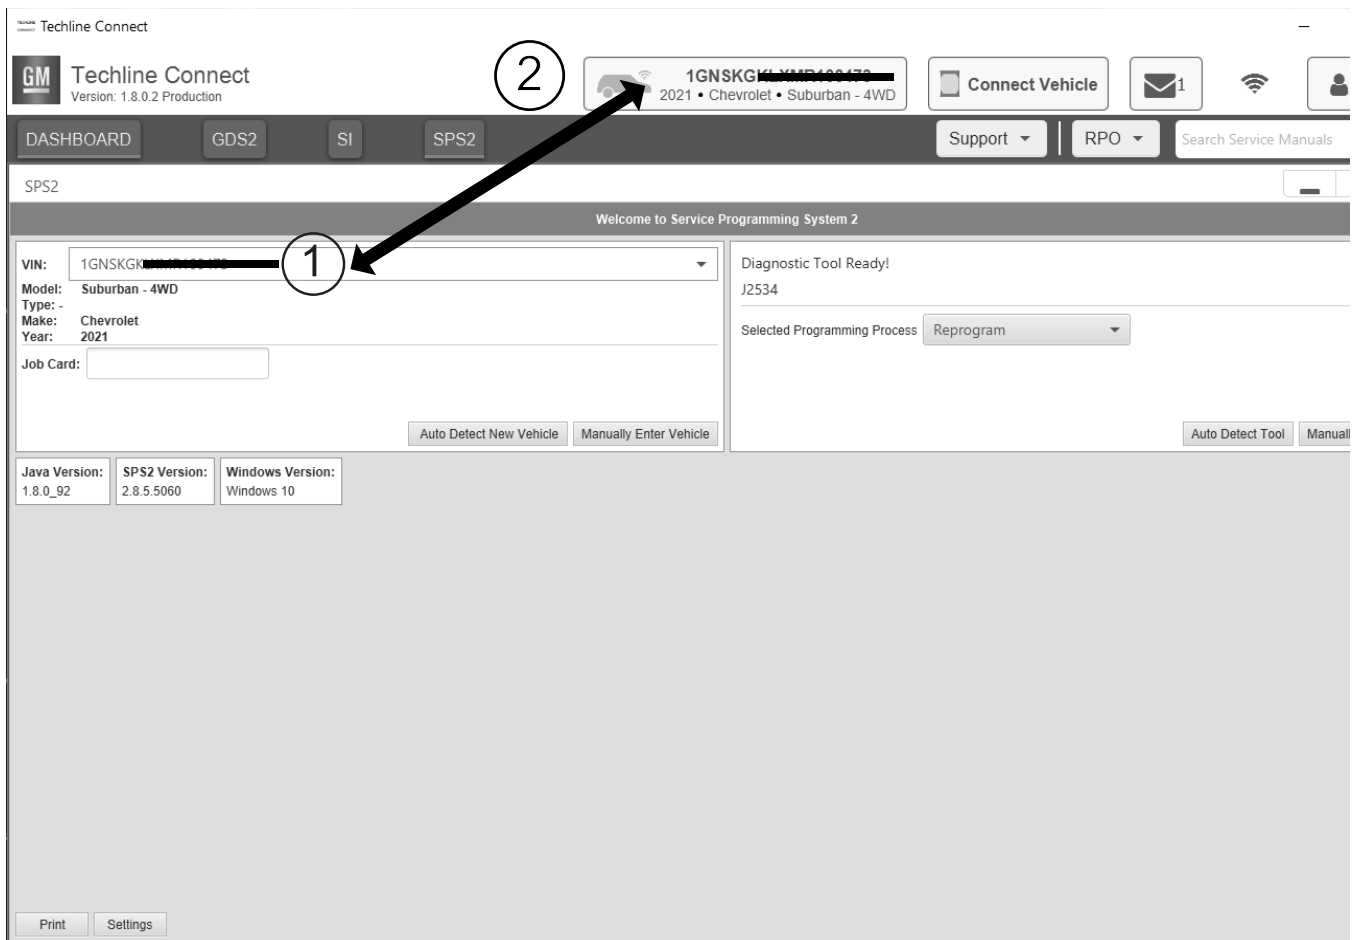
5743643

Caution: Be sure the VIN selected in the drop down menu (1) is the same as the vehicle connected (2) before beginning programming.

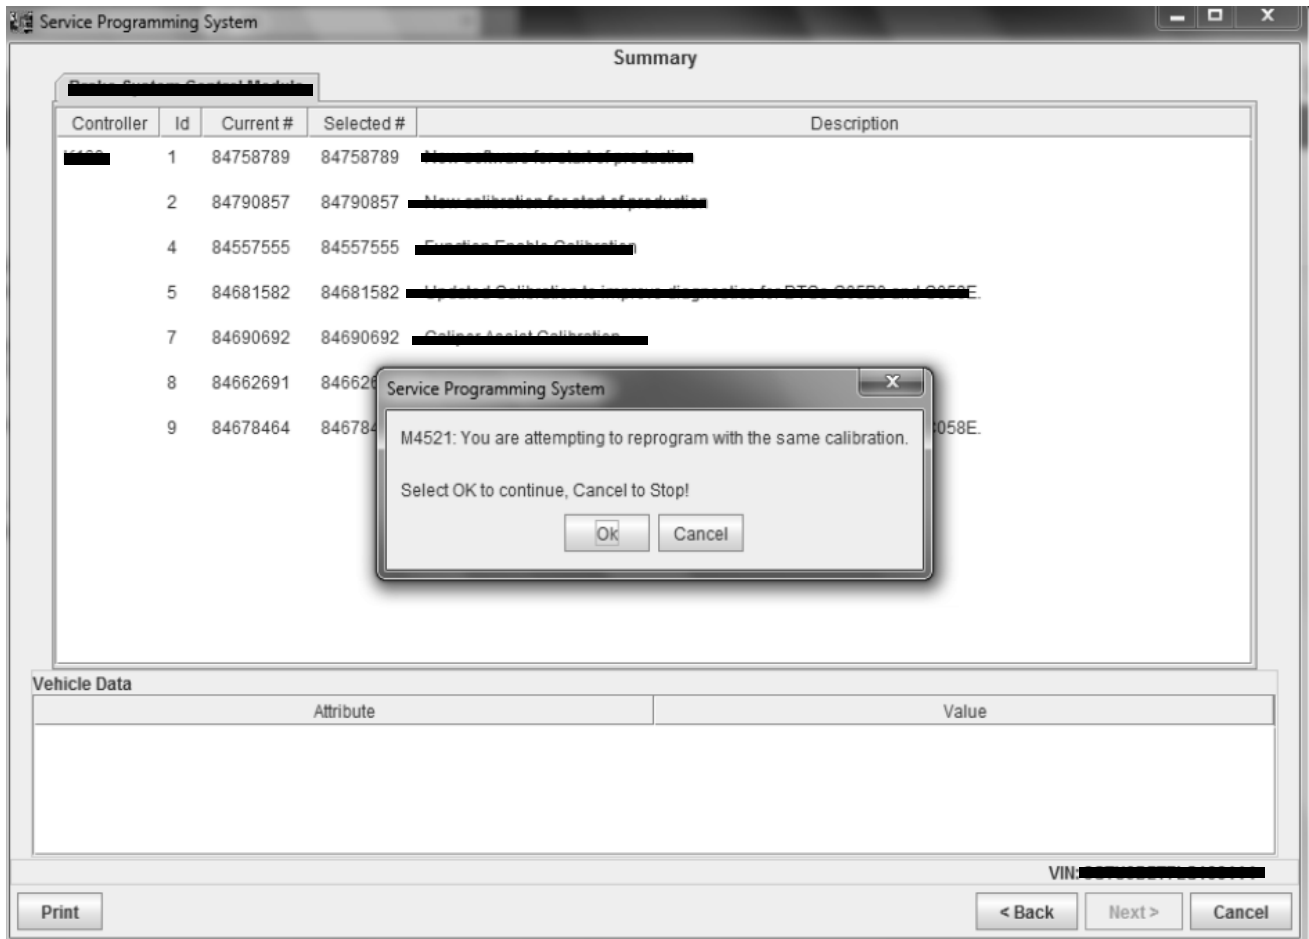
5431207

M4521: You are attempting to reprogram with the same calibration.
Select OK to continue, Cancel to Stop!

Important: Techline Connect and TIS2WEB screens shown above.

Important: If the same calibration/software warning is noted on the TLC or SPS Summary screen, select OK and follow screen instructions. After a successful programming event, the WCC is located in the Service Programming System dialogue box of the SPS

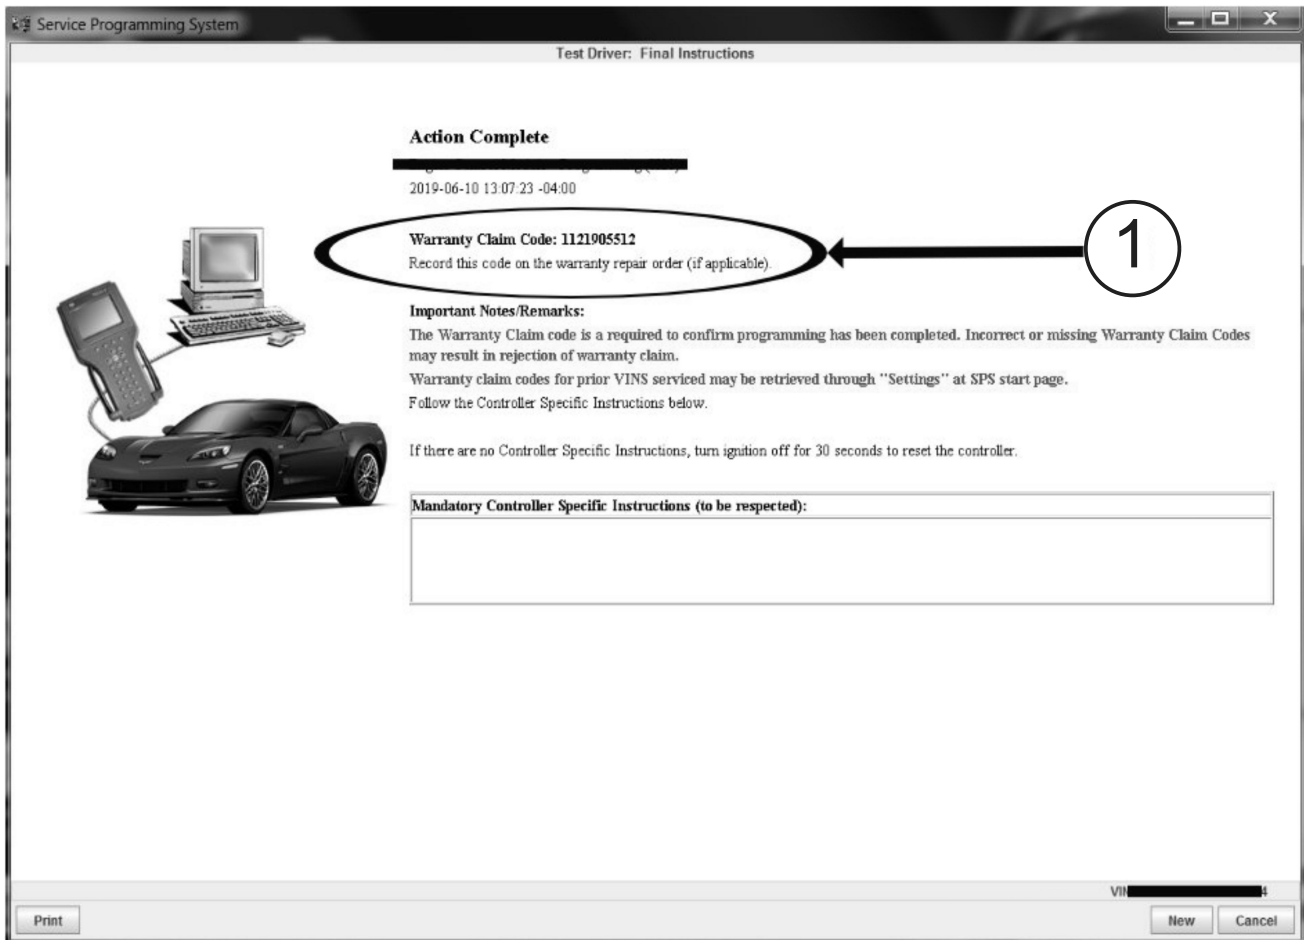
5431209

Warranty Claim Code

Programming Complete.
VIN: [REDACTED]
2020-08-19 12:23:43 PM

Card: 1
Warranty Claim Code: 28YN46808556

Note: The screenshots above are an example of module programming and may not be indicative of the specific module that is being programmed. Module selection and VIN information have been blacked out.
