GROUP	MODEL
TRA	2021-2023 MY Sorento (MQ4a), K5 (DL3a) w/2.5L T-GDI w/DCT
NUMBER	DATE
111 (Rev 1, 08/22/2024)	July 2024

TECHNICAL SERVICE BULLETIN

8-SPEED DUAL CLUTCH TRANSMISSION EOP SENSORLESS LOGIC IMPROVEMENT

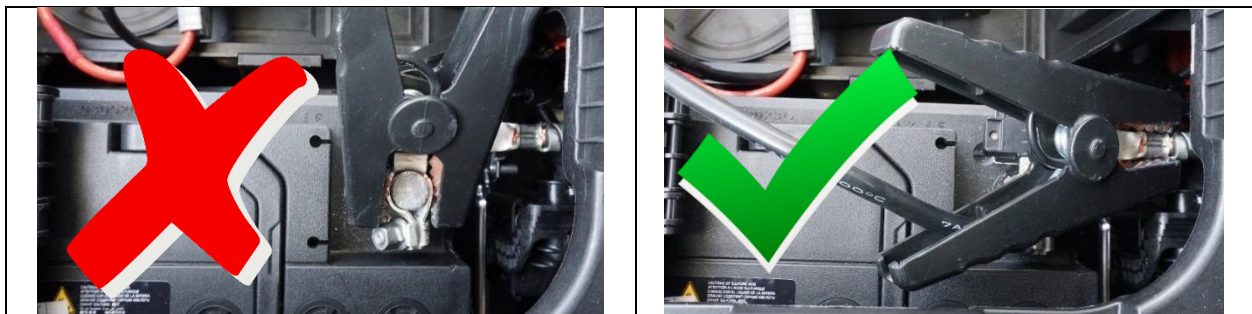
Connect the negative (-) terminal to the battery as shown below.

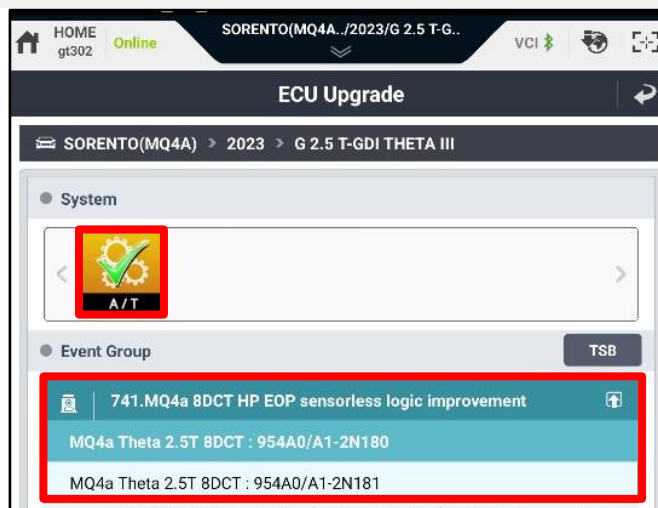
1. **UPGRADE EVENT:**

741.MQ4a 8DCT HP EOP Sensorless Logic Improvement

or

742.DL3a 8DCT HP EOP Sensorless Logic Improvement

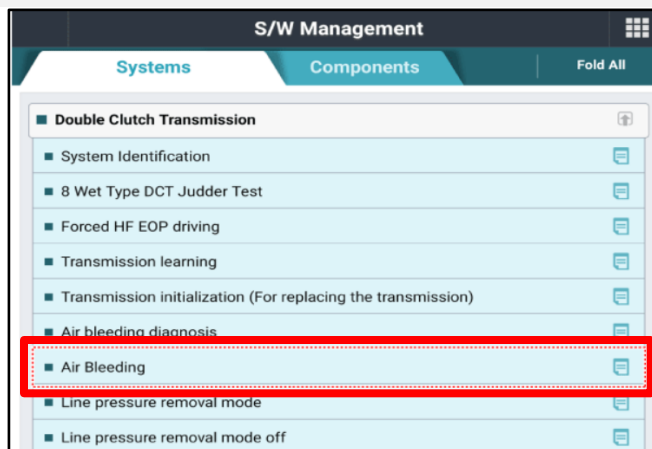
Air Bleeding Procedure:

1. Using KDS, select S/W Management → A/T → Systems → Double Clutch Transmission (or Automatic transmission) → Air Bleeding.
