TGW3 Non-Communication

Service Category Service Department

Mack

Model Years	Models
2023, 2024	AN, GR, PI, TE, LR

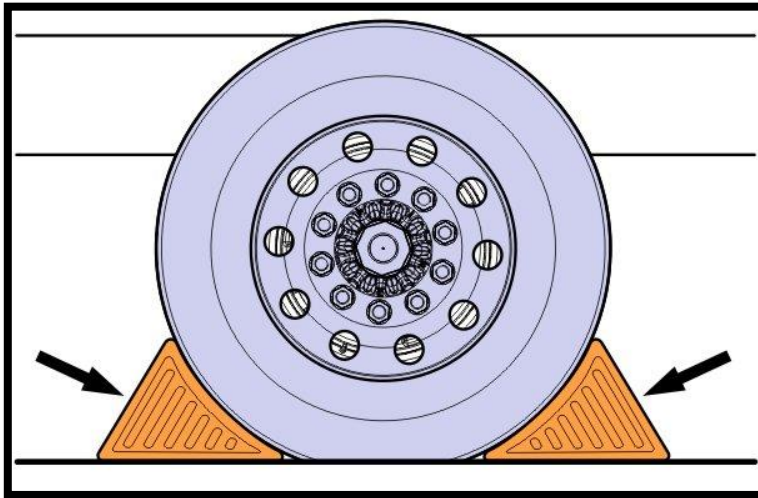
1. Secure the vehicle for service.
2. Apply the parking brake.
3. Place the gear lever in neutral.
4. Install wheel chocks.

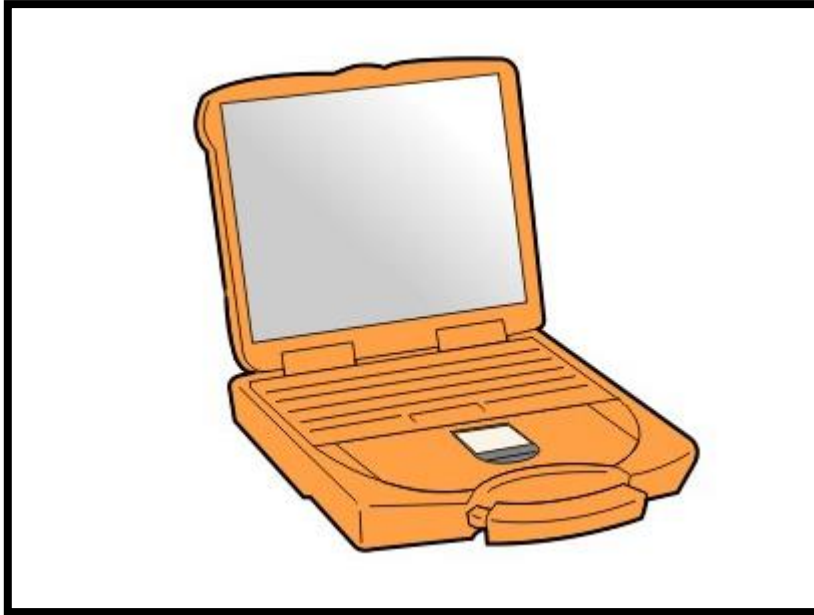
5. Connect the vehicle to Premium Tech Tool.

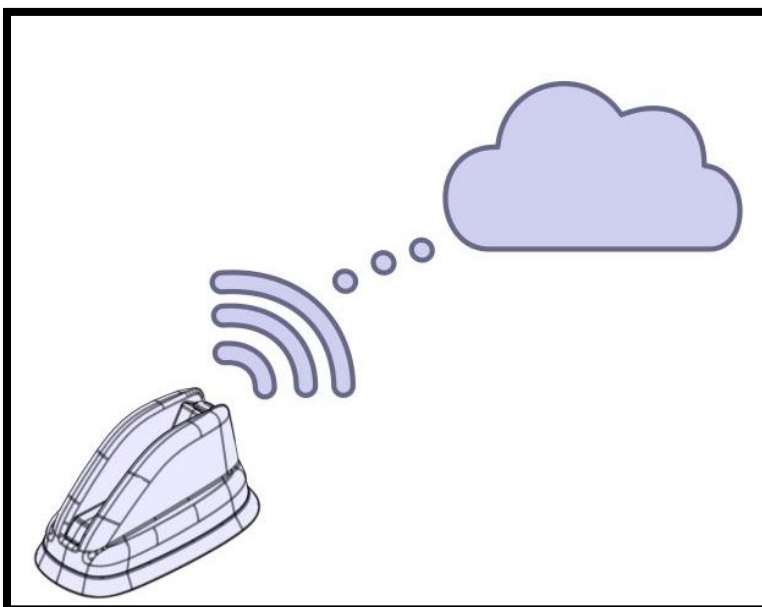
6. Perform PTT operation **1700-08-03-39, Program Electronic Control Unit – Telematic Gateway TGW.**
7. Perform PTT Operation **3979-07-03-02, Telematics system SIM ID, Calibration.**
8. Let the vehicle wait for 30 minutes with the power turned on.

NOTE: Ensure that there is adequate cellular reception in the area where the vehicle is waiting.

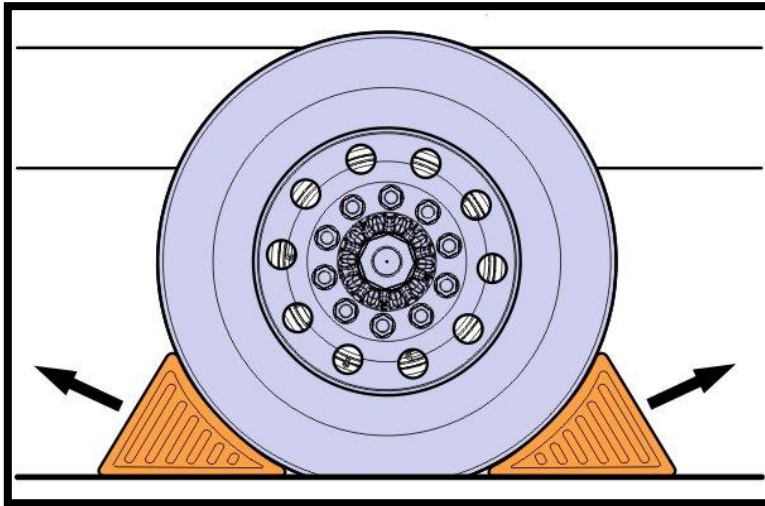
11. Disconnect the vehicle from Premium Tech Tool.
12. Remove the wheel chocks.
