SERVICE BULLETIN

NUMBER: 15-256-19R

SUBJECT: FOTA (Firmware Over-The-Air) Reprogramming
 Procedure to Optimize Harman Gen 3.1 Audio / Navigation Units

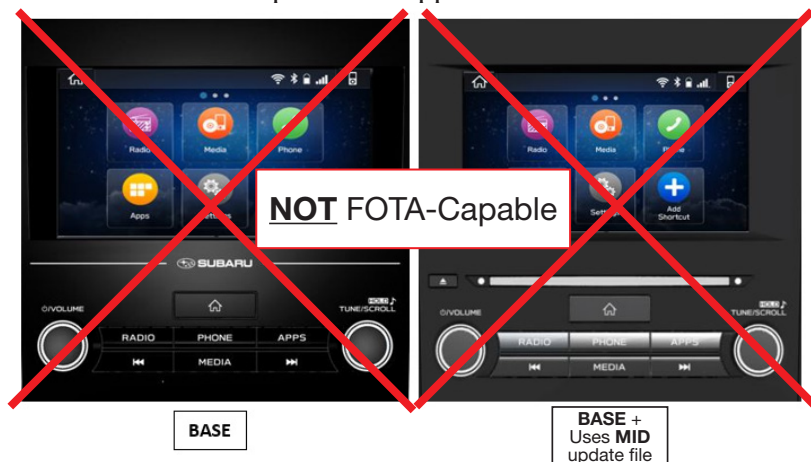
Multimedia System Type	Descriptive Features
6.5 Inch Display Audio System (Base)	No CD slot / Eject Button
6.5 Inch Display Audio System (Base +)	Equipped with CD Player and Eject Button
8.0 Inch Display Audio System (Mid)	Phone Button
8.0 Inch Audio / Navigation System (High)	Map Button but no Phone Button

Reference photos of each head unit faceplate are supplied below:

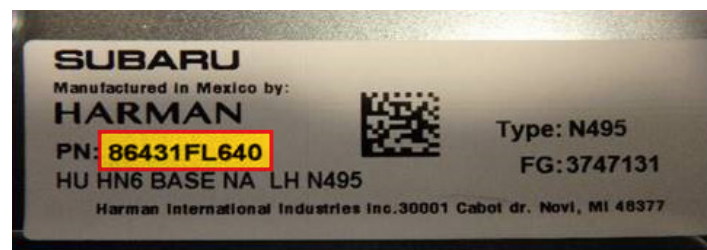
IMPORTANT NOTE: If the H/U needs to be removed for any reason, always confirm the part number shown on the unit matches the part number in the Electronic Parts Catalog (EPC) for the specific VIN being repaired. Example photos are provided below for reference.

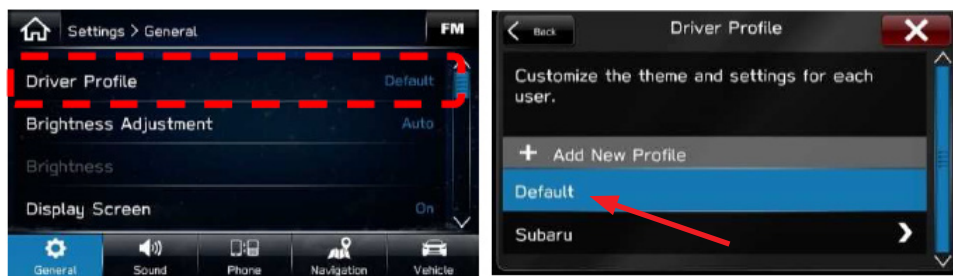
2-1-1) Confirm the driver profile (example shows “Default” as driver profile).

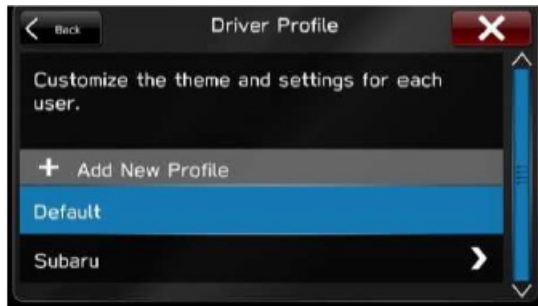
NOTE: Make sure to check the next screen by scrolling (pressing the right arrow > button).
2-1-4) Change to next driver profile and repeat the actions above as necessary. (Example photo below shows other driver profiles. Be sure to note all the preset stations for each driver profile.)

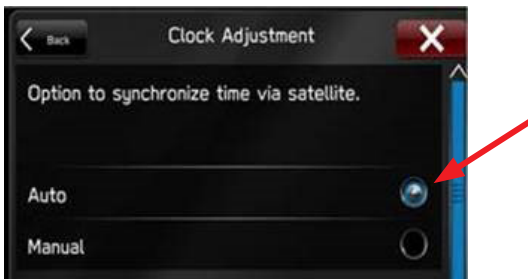
NOTE: The H/U clock **must** be set correctly in order to check for any available FOTA updates. Always confirm the Clock Adjustment mode is set to Auto.

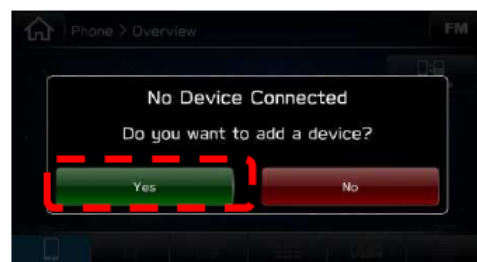
1.2.2) Select Yes on “No Device Connected” pop-up.

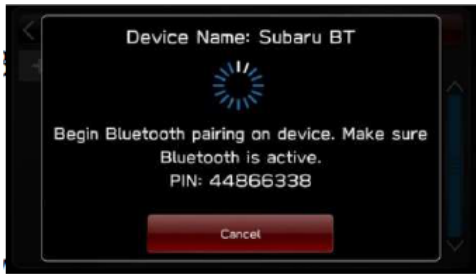
1.2.3) While the H/U displays the “waiting” screen shown below, operate the smartphone screens and select “Subaru BT” from the discoverable device list.

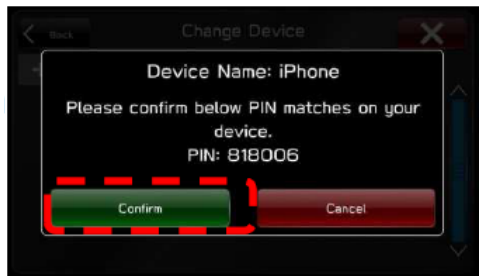
1.2.4) Confirm the same PIN code is shown on the smartphone then select “Confirm”.

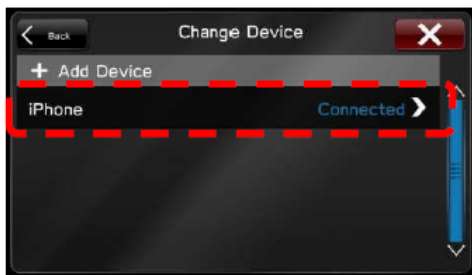
1.3.1) On the “Change Device” screen, identify the most recently paired device (iPhone is shown here).

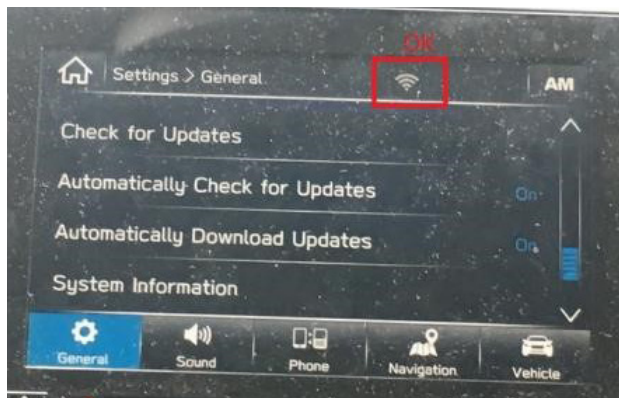
NOTE: Initially, it may appear that no action is occurring.

THIS IS NORMAL. Wait at least 2 minutes for progress percentage to appear in the upper right of the H/U screen before attempting to restart the process.

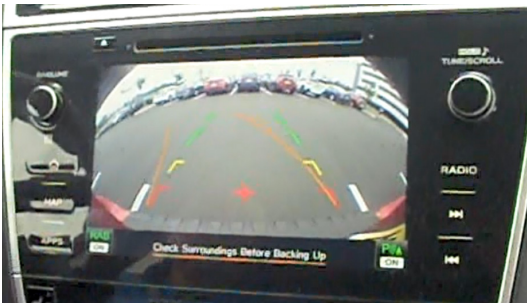
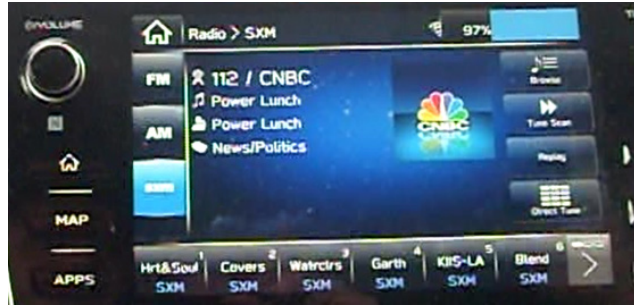
1.6.1) Wait until the download progress reaches 100%. During the software download, the H/U is fully functional. **NOTE:** It is normal for the progress to hang at some points for 1-2 minutes. This does not indicate a concern. **BE PATIENT.**

NOTE: When downloading via Wi-Fi, it may take anywhere from 5 to 20 minutes for the update to complete depending on the provider transfer rate signal strength.
