TGW3 Non-Communication

Introduction

Volvo trucks has determined that certain VN and VHD model trucks built with TGW3 have stopped communicating after production. Follow the instructions below to update the TGW software and perform the SIM card calibration procedure to re-establish TGW connection.

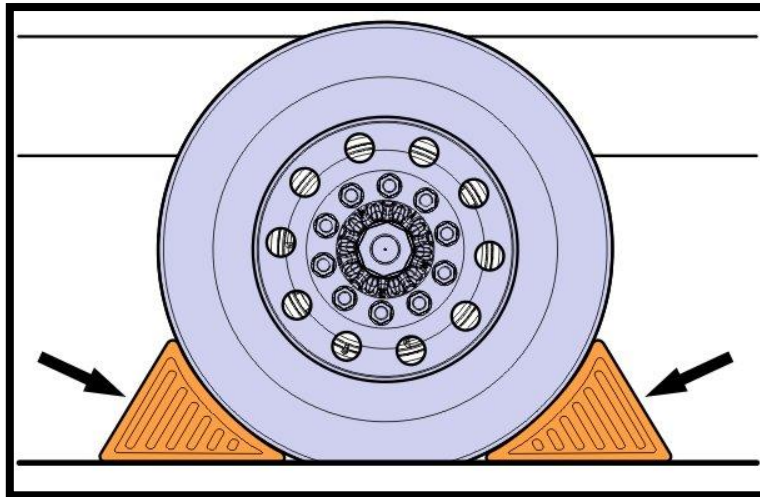
1. Secure the vehicle for service.
2. Apply the parking brake.
3. Place the gear lever in neutral.
4. Install wheel chocks.

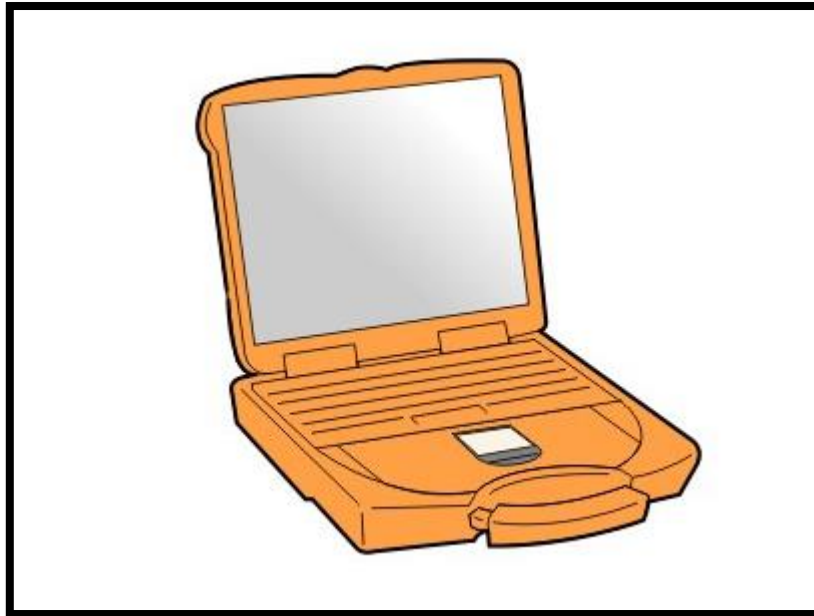
5. Connect the vehicle to Premium Tech Tool.

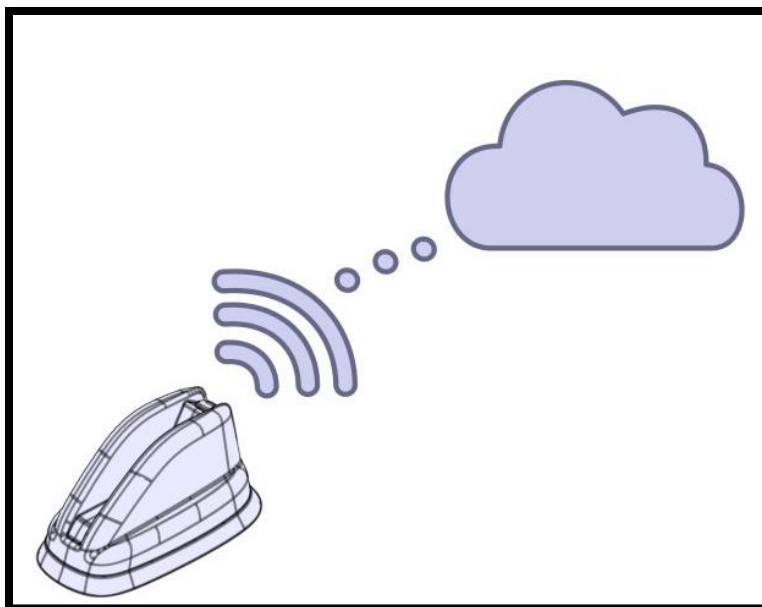
6. Perform PTT operation **1700-08-03-39, Program Electronic Control Unit – Telematic Gateway TGW.**
7. Perform PTT Operation **3979-07-03-02, Telematics system SIM ID, Calibration.**
8. Let the vehicle wait for 30 minutes with the power turned on.

NOTE: Ensure that there is adequate cellular reception in the area where the vehicle is waiting.

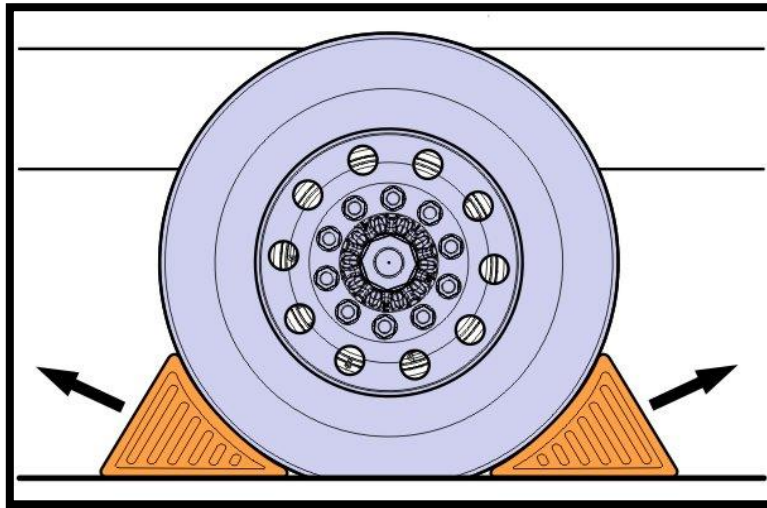
11. Disconnect the vehicle from Premium Tech Tool.
12. Remove the wheel chocks.
