TECHNICAL SERVICE BULLETIN

TELEMATICS CONTROL UNIT RESET AFTER AUTOMATIC COLLISION NOTIFICATION

APPLIED VEHICLES: 2021-2024 Armada (Y62)
2022-2023 Frontier (D41)
2021, 2023 Rogue (T33)
2020-2024 Titan/Titan XD (A61)
2023-2024 Z (Z34)

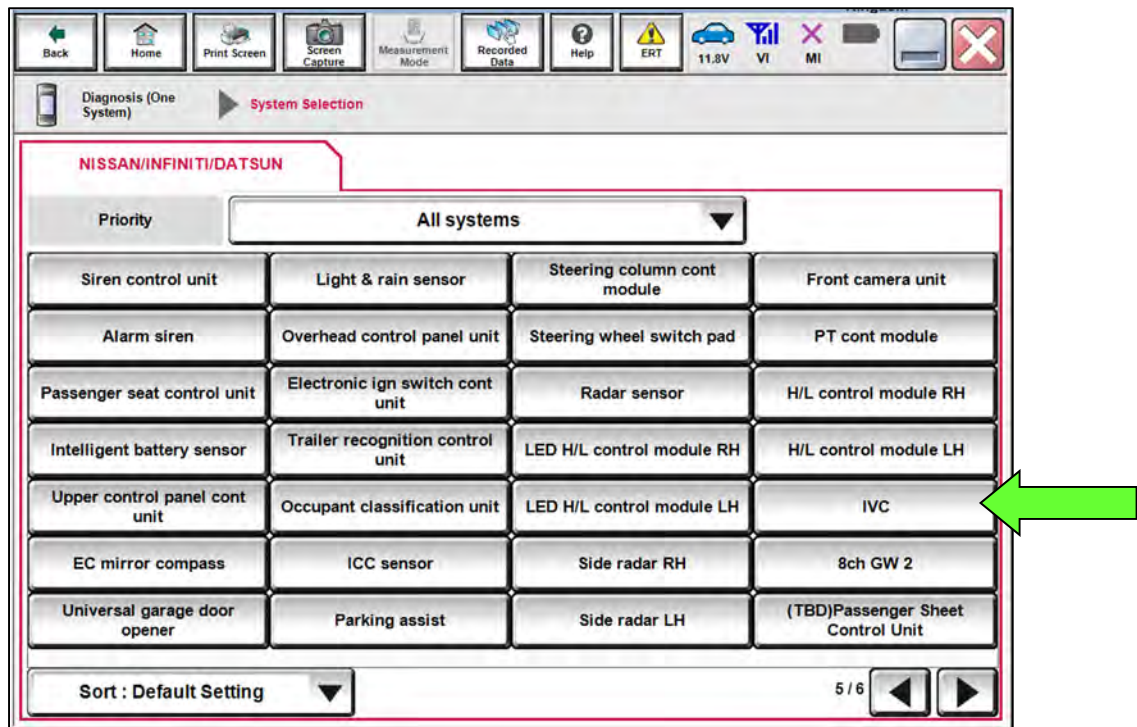
Figure 2

8. Select **IVC**.
