Service Bulletin

Bulletin No.: 24-NA-010

Subject: Service Brake System Message and DTC C2A17 Set or Stored

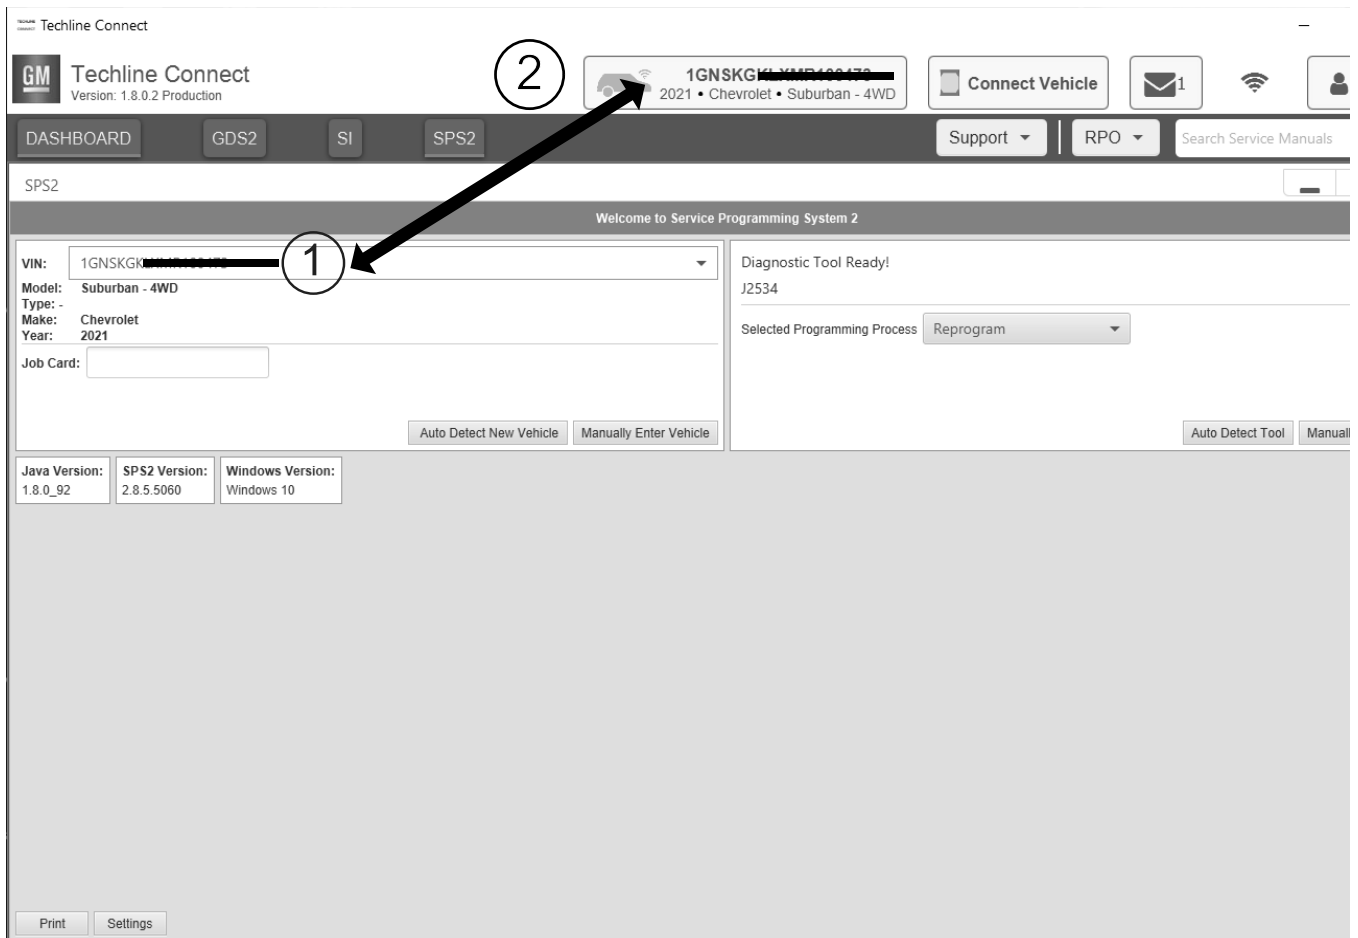
5743643

Caution: Be sure the VIN selected in the drop down menu (1) is the same as the vehicle connected (2) before beginning programming.

Important: Techline Connect screens shown above.
Important: If the same calibration/software warning is noted on the TLC Summary screen, select OK and follow screen instructions. After a successful programming event, the WCC is located in the Service Programming System dialogue box of the SPS
