# Service Action

## Code: 91FN

#### Software Update for High Voltage Battery Control Module - Version 3.2.1

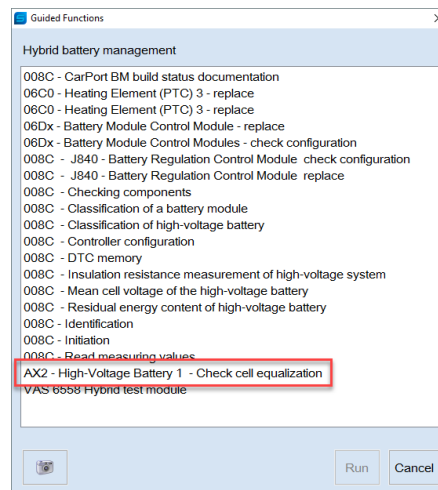
## Step 1 - Perform “Check Cell Equalization” Test Plan

- Use operating mode, **DIAGNOSIS**.
- Select the Guided Functions test plan list for address 008C.
- Perform test plan, “AX2 – High-Voltage Battery 1 – Check cell equalization” and follow the on-screen prompts.
- If the test plan results indicate the HV battery is OK:
  - Proceed to Step 2
- If the test plan results indicate a cell module requires replacement:
  - **The cell module(s) must be replaced before performing any additional software updates.**
  - Proceed to Section C.
  - After the cell module(s) have been replaced, proceed to Step 2 of the SVM instructions to begin the software update process.

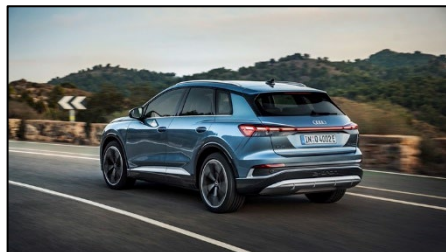
## Step 5 – Road Test + Clear Fault Memory + Perform Calibration Drive

- Perform a road test/calibration drive at a speed above 25 mph (40 km/h).
- Erase the entire event memory.
- Send the diagnostic log to GFF Paperless.
- Perform a calibration drive at a speed above 25 mph (40 km/h).

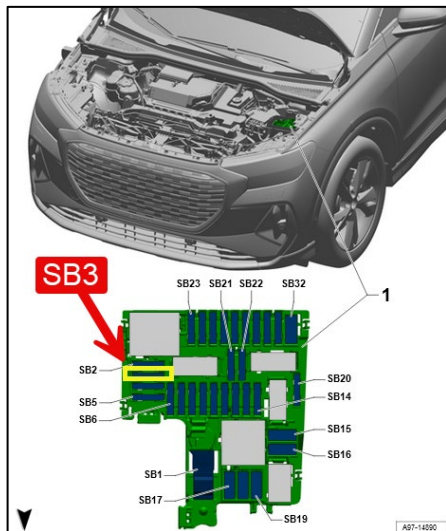
## Step 6 – Reset AX4

- To prevent charging complaints after the software update is complete, the high-voltage battery charger control module (J1050/AX4) must be reset.
- Remove fuse SB3 from the under-hood SB fuse panel for one minute and then insert it again.
- Reference ELSA Wiring Diagrams for fuse location, if necessary:
  - *ELSA Wiring Diagram > Component locations > Component Locations: Fuses > Page 3: Fuse Panel B SB, from January 2021*
- Proceed to Section D once the reset is complete.

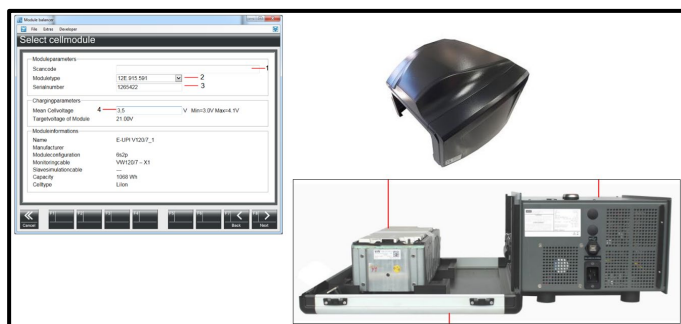
### Perform cell balancing on new cell module:

- Check Measured Value Block (MVB) "maximum voltage for battery cells, IDE08217.
- The voltage reading listed will be entered in the DSS Manager program when balancing the new cell module.
- Follow the VAS6910 operating instructions in conjunction with the DSS Manager program to perform the cell balancing on the new cell module.

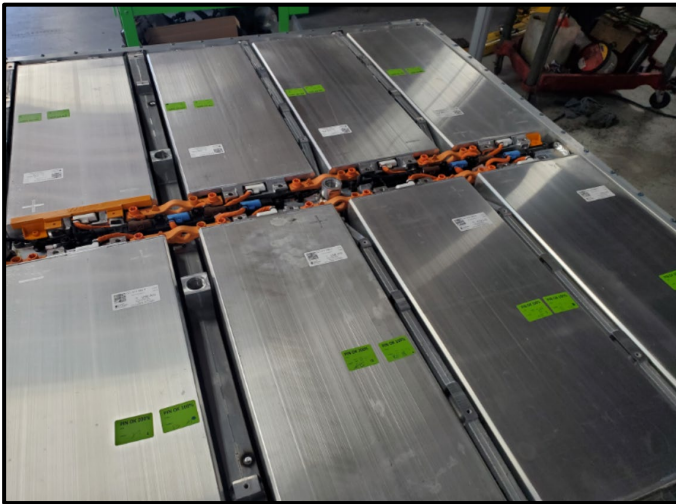
Remove high-voltage battery cover:

Using power tools to remove the bolts can damage the threads in the lower housing. Damaged threads for the hollow bolts <4> cannot be repaired and will require replacement of the lower housing.

The upper part of battery housing can be reused under certain circumstances and does not have to be replaced.

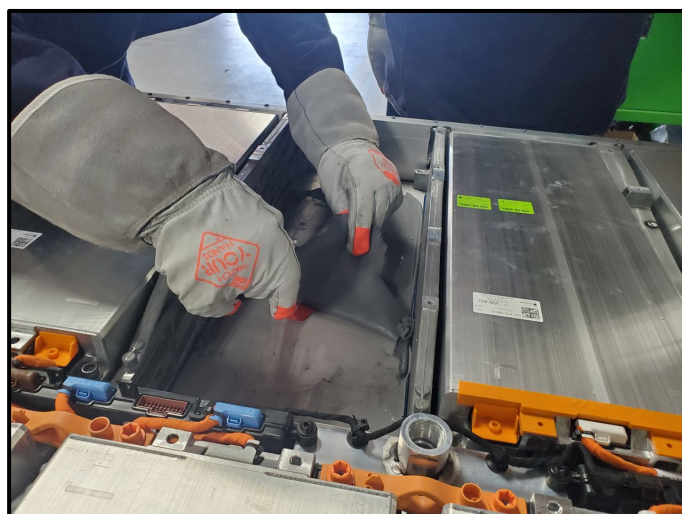
### Remove the cell module:

- See ELSA Repair manual: *Repair Manual > Motor > Electric Drive Motor 0EH, 0EJ > 93 Electric drive > High-Voltage Battery Components > Battery Module, Removing*
- Ensure the shock protection is installed on ALL open high-voltage connections.

Pay close attention to the wiring harnesses, so they are not damaged or pinched during removal.

The cell module can be freed from the adhesive bond from either end of the cell module.

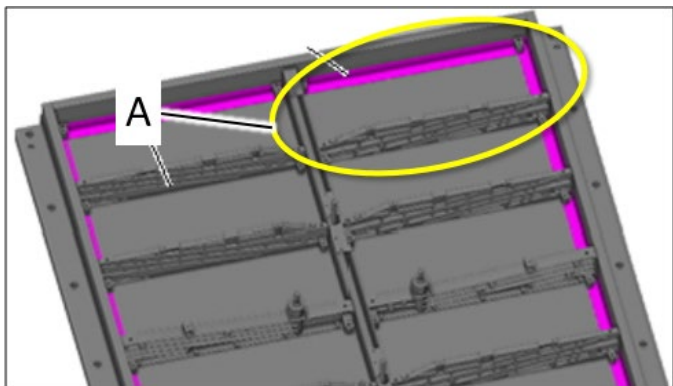
### Clean the mounting area for the new cell module:

- When cleaning the cell module mounting area, use extreme care so the sealant for the high-voltage battery splines and lower housing is not damaged and that no cleaners come into contact with the sealant.
- Vacuum any loose debris from the mounting area of the cell module.
- Clean cell module mounting area with Cleaner D -009-401-04 or isopropyl alcohol and allow it to completely dry.
- Do not allow the cleaner to come in contact with any of the lower housing frame sealant.

- Reference ELSA Repair manual: *Repair Manual > Motor > Electric Drive Motor 0EH, 0EJ > 93 Electric drive > High-Voltage Battery Components > Battery Module, installing*
- Note the following when installing the new cell module(s):
- Peel off the protective backing and apply the separating foil <arrow> as needed along the outer frame edges, in the area where the cell module is mounted.

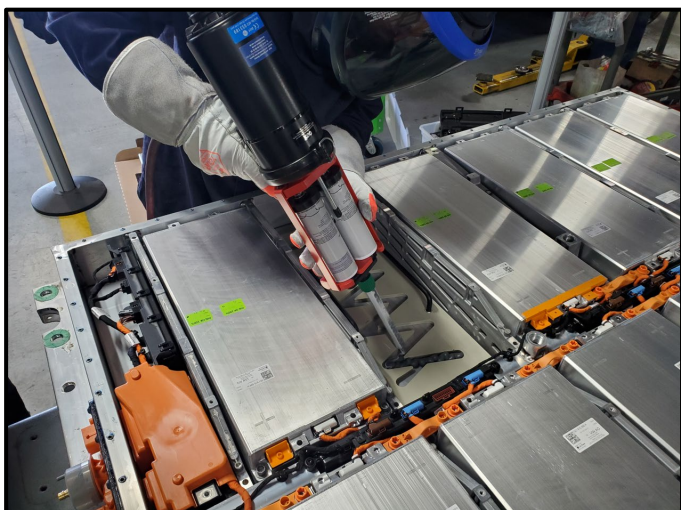
- Double check the expiration date of the paste before applying.
- Use Double Cartridge Adhesive Gun -VAS5237- to apply the heat paste.

- Before applying the heat paste, release a small amount through the applicator to ensure the paste is mixing properly.

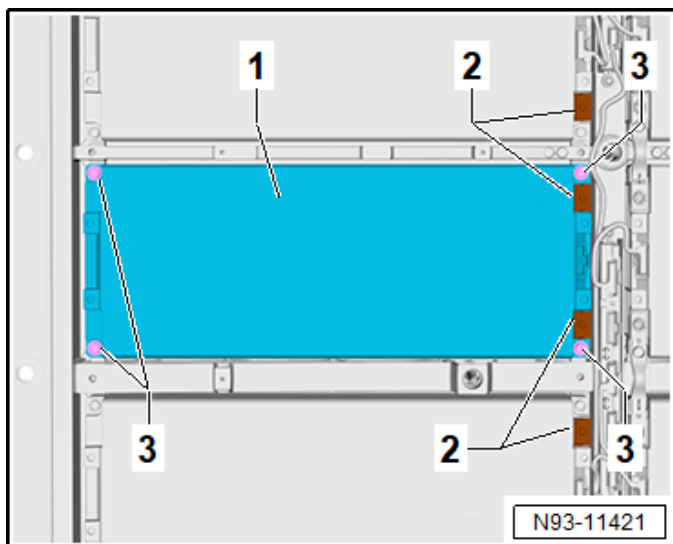
- When filling Template -T10606-, ALL of the heat paste must be used.

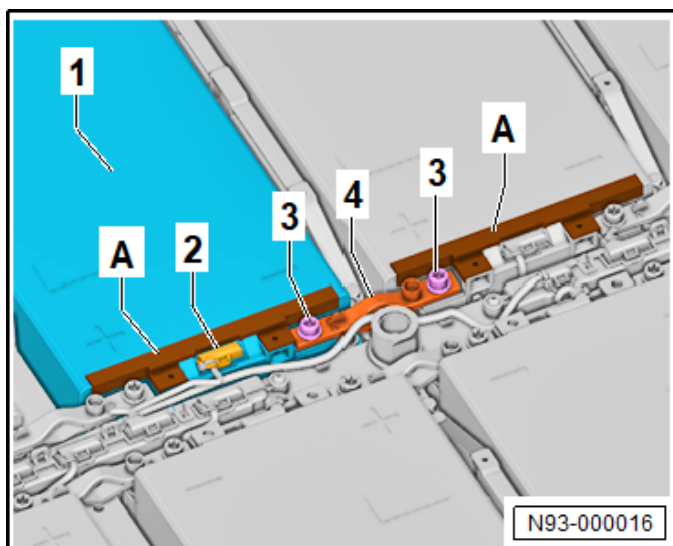
- Pay close attention to the wiring harnesses when installing the cell module.
- Torque new bolts <3> in a cross pattern to 16 Nm + 180°.

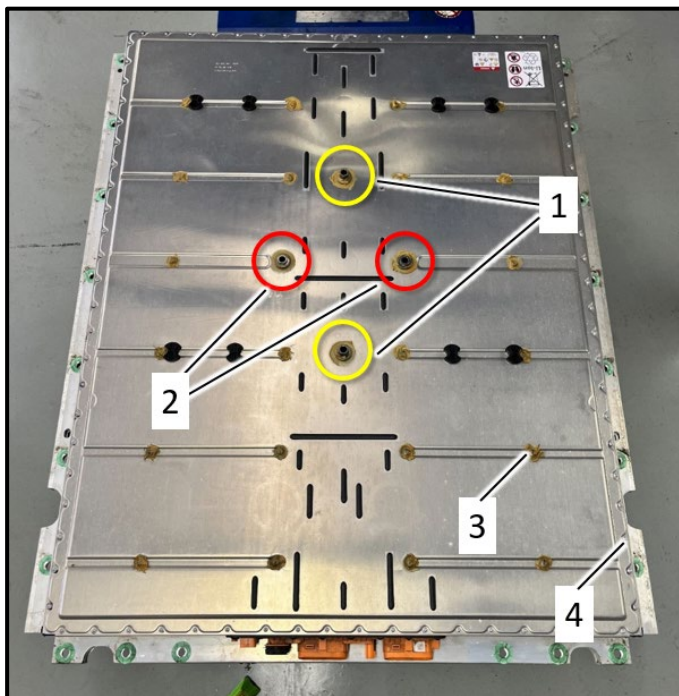
### Check for high-voltage battery faults:

- Using -VAS671007- or -VAS5581A-, in conjunction with the Diagnostic Tester, verify there are no faults stored for any high-voltage battery component before installing the high-voltage battery cover.

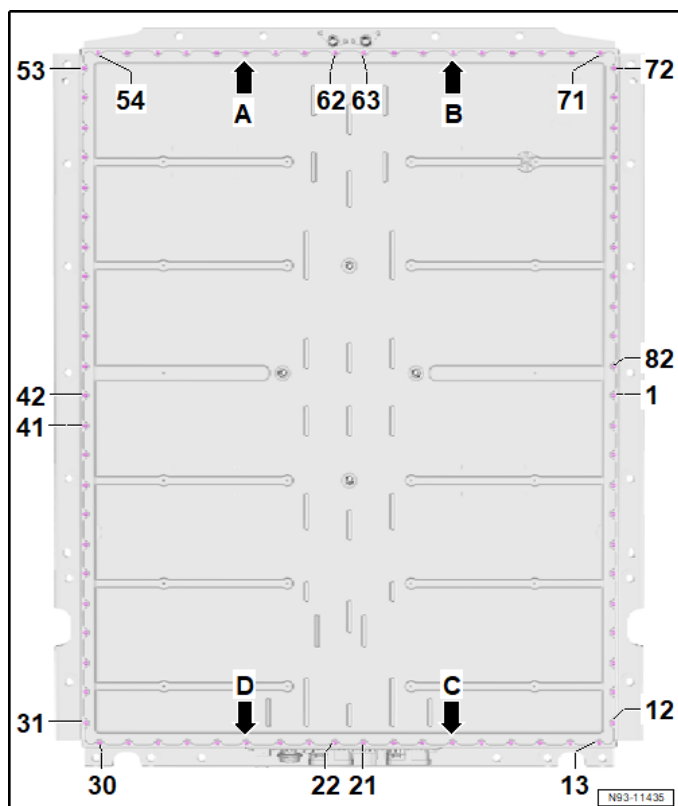
- Torque the new fasteners in the following order:
1. Connection element bolts <1 through 4> to 100 Nm.
  2. Middle bolts <5 through 26> to 5.5 Nm + 90°.

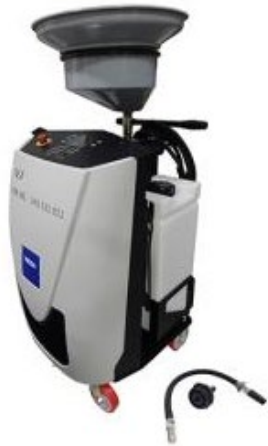
## Fill cooling system

- Top off coolant.
- See ELSA Repair Manual: *Repair manual > Motor > Electric Drive Motor 0EH, 0EJ > 19 Cooling System > Cooling System/Coolant > Cooling System, Filling*
- Perform these steps in conjunction with Guided Function test plan, “0001 – Filling cooling circuit.”

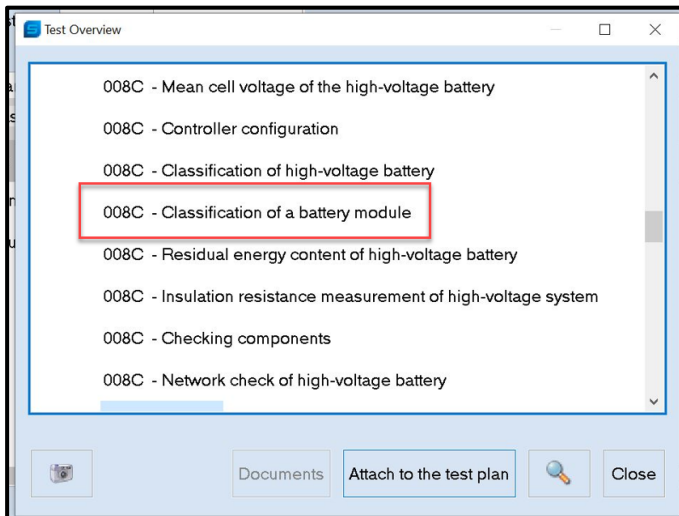
#### Perform classification of removed cell module(s):

- Select "Self Test" and populate the "008C – Classification of a battery module" test plan.
- Perform the test plan and follow all on-screen prompts.
