Technical Service Bulletin

SUBJECT:		No: TSB-22-54-002REV	
SOFTWARE UPDATE FOR SMARTPHONE LINK DISPLAY AUDIO - REVISED		DATE: August 2024	
		MODEL: See below	
CIRCULATE TO:	<input type="checkbox"/> GENERAL MANAGER	<input checked="" type="checkbox"/> PARTS MANAGER	<input checked="" type="checkbox"/> TECHNICIAN
<input checked="" type="checkbox"/> SERVICE ADVISOR	<input checked="" type="checkbox"/> SERVICE MANAGER	<input checked="" type="checkbox"/> WARRANTY PROCESSOR	<input type="checkbox"/> SALES MANAGER

A software update is now available for the Smartphone Link Display Audio (SDA). This update resolves several issues that may occur in various models equipped with SDA, as listed below.

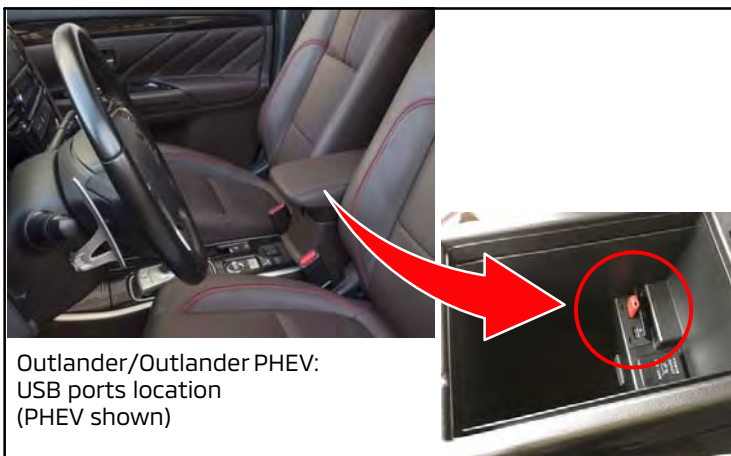
1. **For Outlander and Outlander Sport / RVR vehicles:** Turn vehicle ON, and keep the engine idling for the entire update procedure.
For Outlander PHEV: Put vehicle in READY mode for the entire update procedure.
2. Plug in the USB flash drive containing the ***CORRECT software update file* for that vehicle*** into the vehicle's USB port (either port may be used for the update).
***Refer to step 4 of "B. Transfer Files to USB Flash Drive" in this TSB for correct file identification.**
 - For Outlander and Outlander PHEV, two USB ports are located inside the center console.
 - For Outlander Sport / RVR, two USB ports are located in the front lower dash.

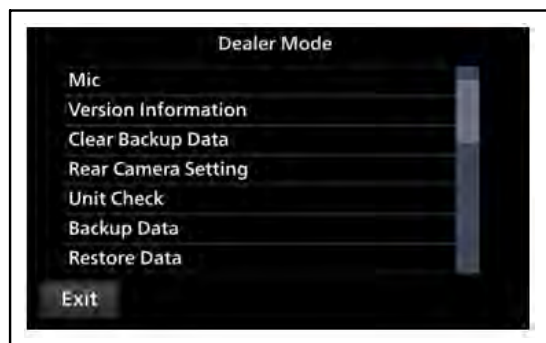
3. Before starting the update process, confirm the current software version.
 - a. Push both [MEDIA] + [

] at the same time and hold for 5 seconds.

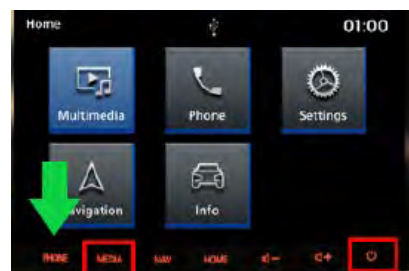
- b. The Dealer Mode screen will appear. At this screen, push and hold the **HOME** button for 5 seconds (shown below).

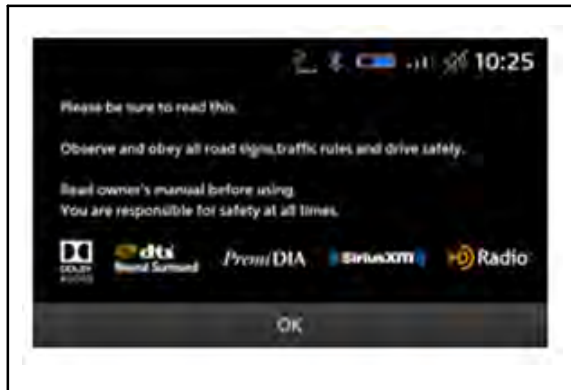
- a. ACC on.
- b. Press "OK" and wait for the Home Screen to appear.

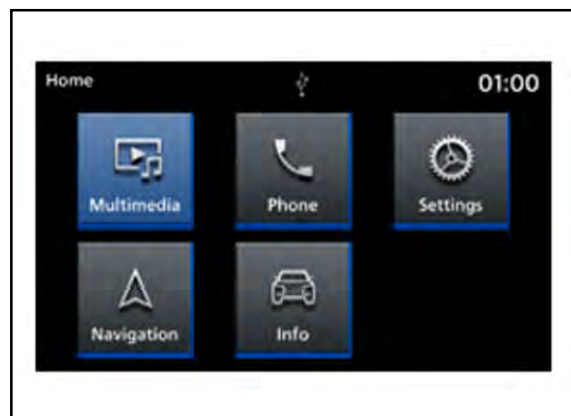
- c. Insert USB flash drive into the vehicle USB port.
- d. The software auto update will begin. If the software update doesn't start automatically, please push "OK" on the disclaimer screen.

Note: The update may take approximately 46 minutes to complete.

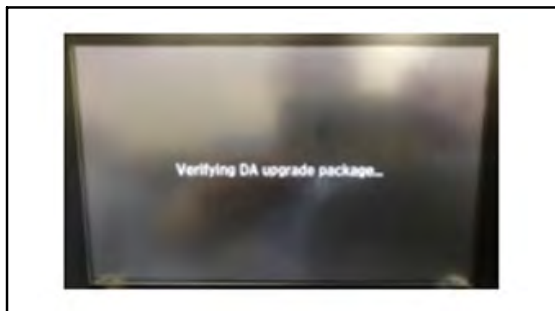
- e. This screen will be displayed for approximately 5 minutes.

NOTE: Do NOT turn the power OFF, remove the flash drive or add another flash drive during the update.

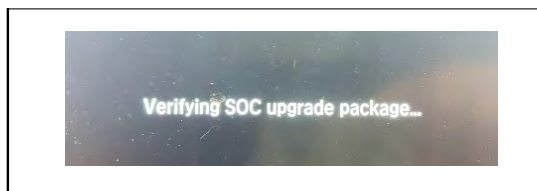
- f. This screen will be displayed for approximately 7 minutes.

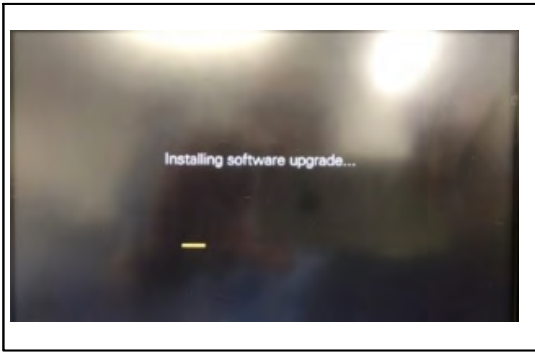
g. This screen will be displayed for about 13 minutes.

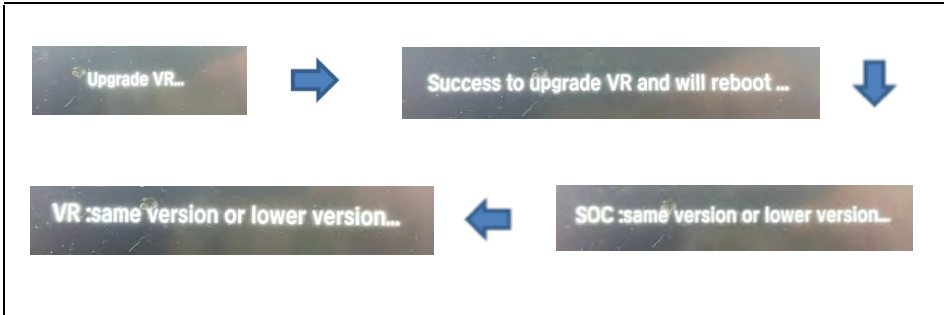
h. These screens may or may not appear. If they appear, it will be for approximately 22 seconds, total.

i. When "Update result: Pass!" appears, the update is complete the USB flash drive may be removed. The home screen will then return.

Note: The Head Unit will be rebooted automatically when the update is completed.

*If "Update result: Exception!" is displayed, execute ACC off and retry beginning at step 1.

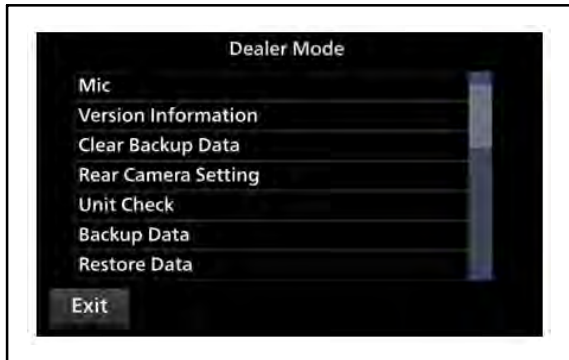
2. The Dealer Mode screen will appear.
3. At this screen, push and hold the HOME button for 5 seconds.

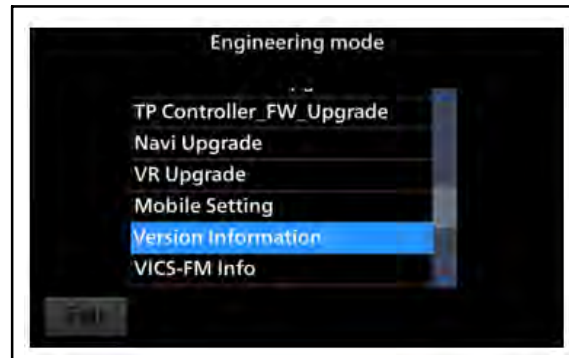
5. Scroll down to "Version Information" and push "Version Information".

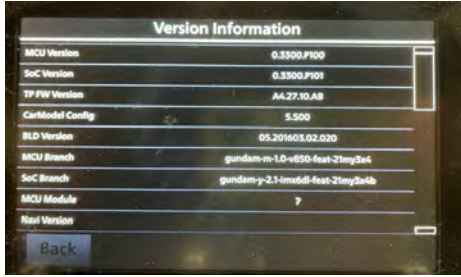
6. Confirm the Version Information matches the chart on page 2 of this bulletin.
7. Verify that the issues described on page 1 of this TSB are no longer present.
8. Reset all of the customer's audio presets and settings according to the chart on page 9.
