August 2024
SF685 A

Subject: Common Telematics Platform Cummins Engine

Models Affected: Specific model years 2022-2023 Freightliner Cascadia; and Western Star 47X and 49X vehicles manufactured September 4, 2021, through September 15, 2022.

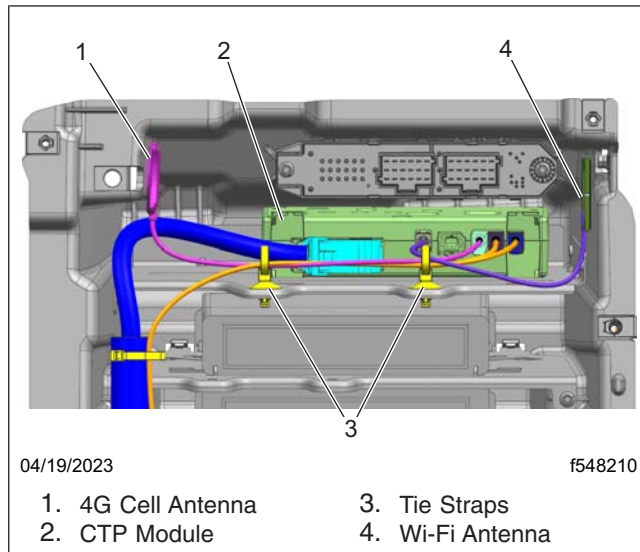
Fig. 1, Electronics Bay

4. Remove the four VPDM mounting fasteners, then gently lower the VPDM on to the cab floor. For instructions, see **Group 54** of the applicable workshop manual.
5. Position the new CTP2 ECU in the top shelf of the electronics bay, then press the ECU firmly towards the back of the shelf. See **Fig. 1**. Lower the front of the CTP2 onto the surface of the shelf, and adjust its position horizontally until the tabs on the CTP2 are fully seated in the mounting slots.

- Connect the CTP2 electrical harness connector and antenna connectors to CTP2. See **Fig. 1** for connector and antenna connection locations.

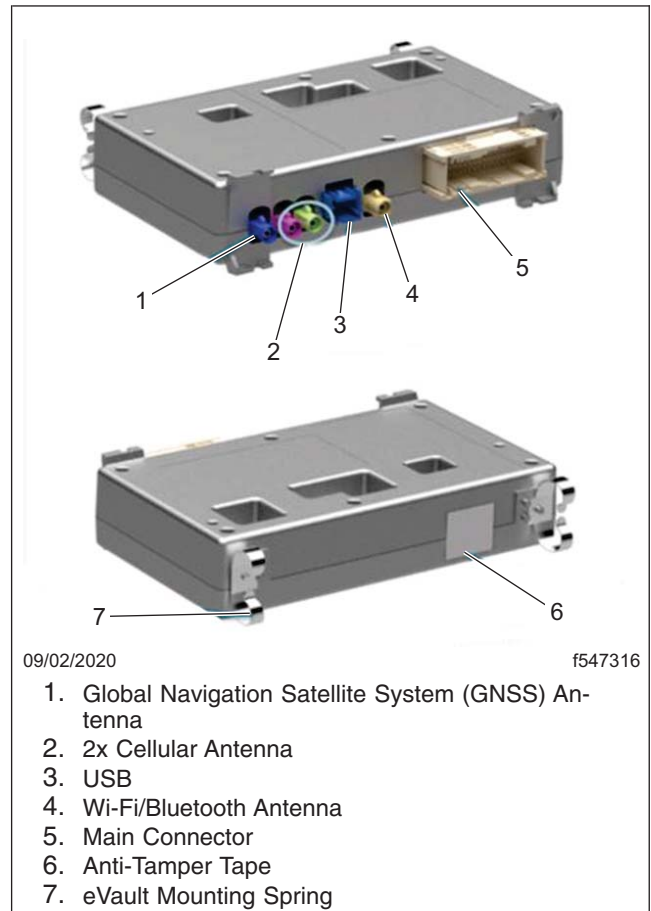
Fig. 2, CTP2 Connection Locations

NOTE: Some vehicles may not have a harness to connect to the large blue CTP USB connector, shown in **Fig. 2**. In such cases, the CTP USB connector remains empty.

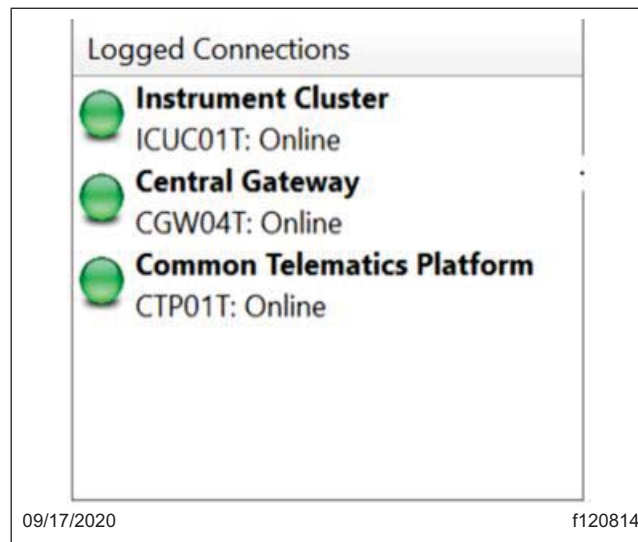
Fig. 3, DiagnosticLink Logged Connections Panel

- Wait until all the three devices are fully connected and the connection indicators turn green. See [Fig. 3](#).

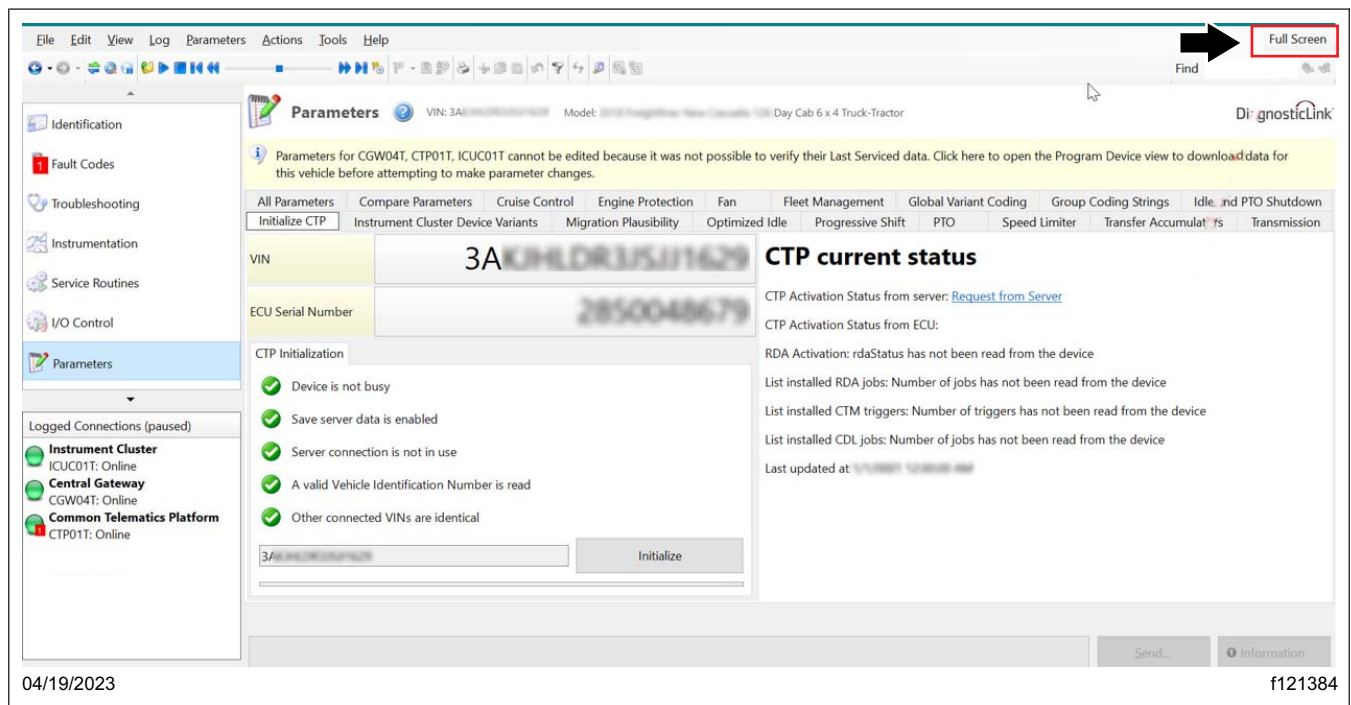
Fig. 5, Switching to Full Screen Display

16. With the 'Initialize CTP' tab still selected, select the 'Full Screen' button on the upper-right corner of the window. See Fig. 5.

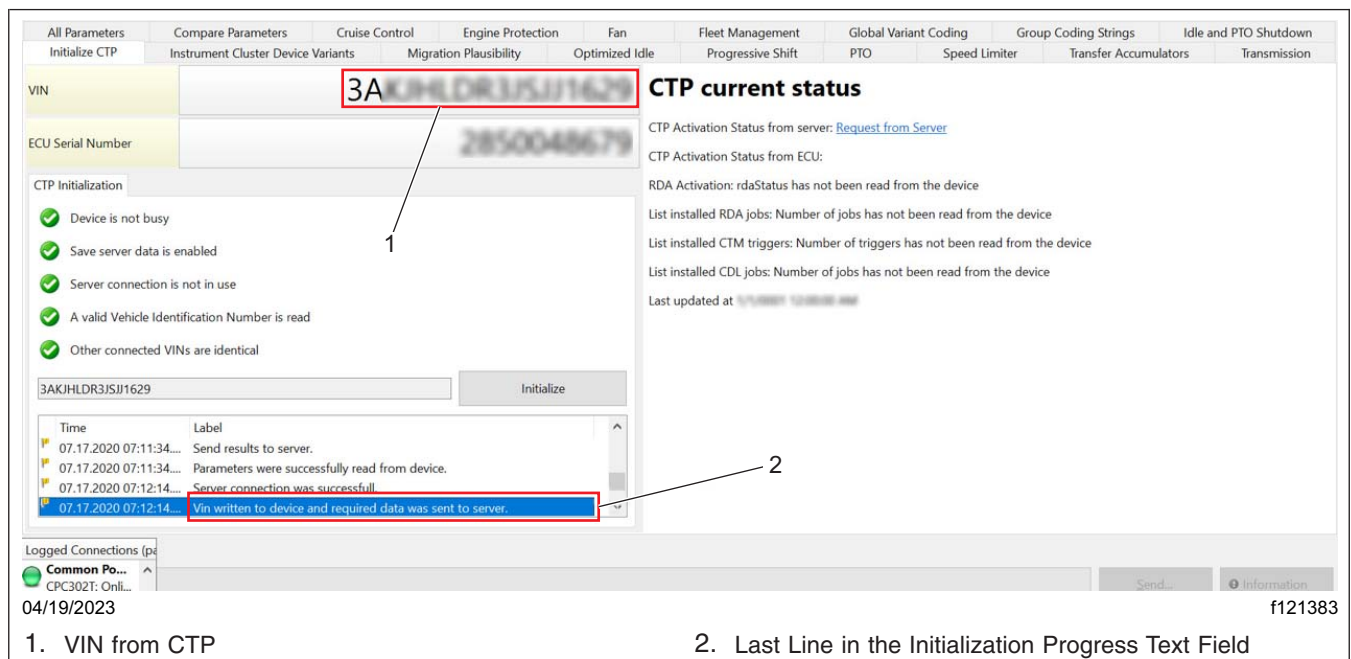
Fig. 6, Screenshot of DiagnosticLink

17. Take a screenshot of the DiagnosticLink window while making sure the VIN and the last line in the initialization progress text field are visible, as shown in Fig. 6.

1. VIN from CTP

2. Last Line in the Initialization Progress Text Field
