D24M2

**Subject: Field Service Campaign D24M2
DETROIT® ePowertrain™ eCPC Reprogramming**

PROBLEM: The new eCPC software improvement was developed to allow vehicles to continue moving in a limp home mode during certain hardware failures and to improve the speed of the eAxle oil pump.

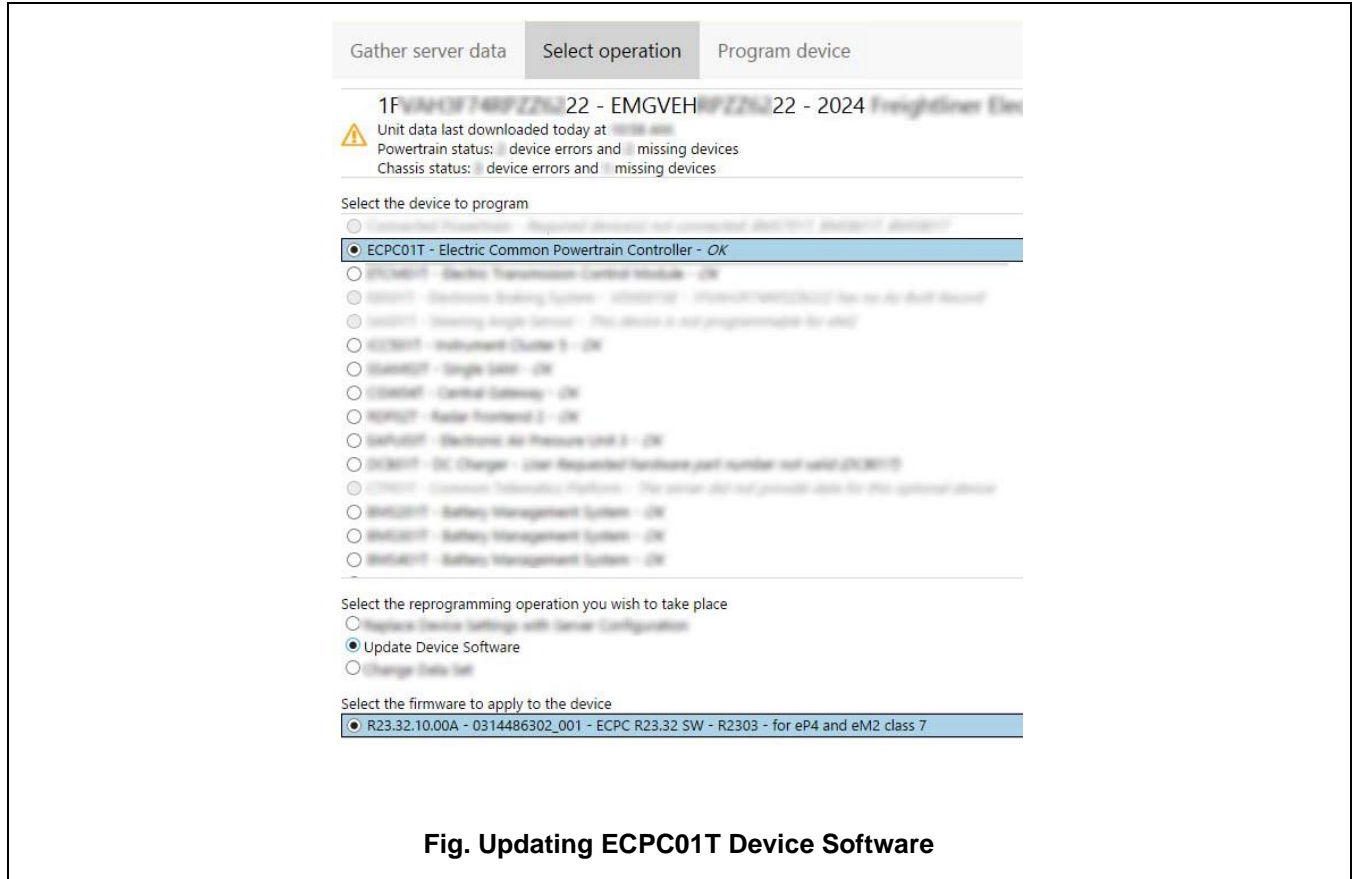
Fig. Updating ECPC01T Device Software

16. Select 'Update Device Software' as the reprogramming operation. See Figure 'Updating ECPC01T Device Software'.

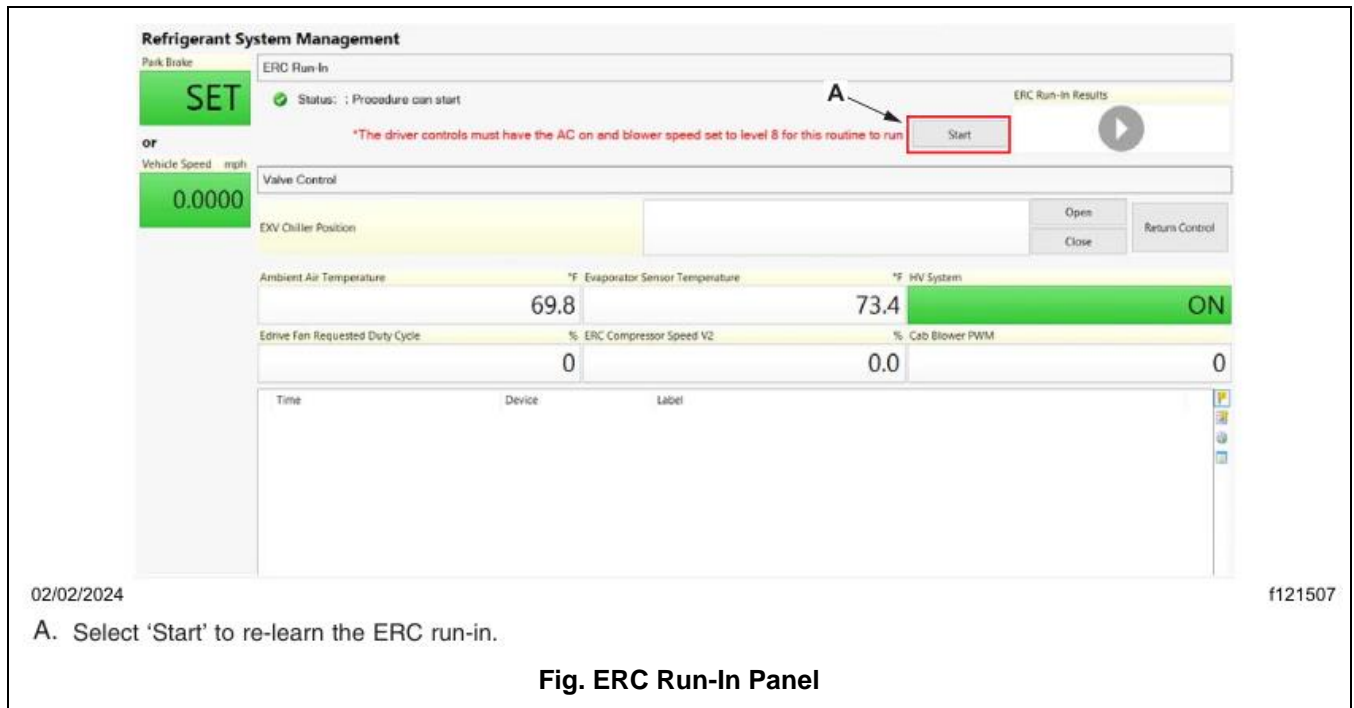
21. To enable the high voltage system, turn the keyswitch key to OFF position, release the ESTOP button on the dash panel, then turn the keyswitch to the ON position.
22. Perform the ERC run-in procedure by opening the 'Refrigerant System Management' panel. This panel is located on the 'Service Routines' tab in DL version 8.19 SP1 and later. In DL versions 8.19 and earlier, it is under the 'I/O Controls' tab.
23. Set the blower fan speed to a minimum of level 8.
24. Select 'Start' to re-learn the ERC run-in. See Figure 'ERC Run-In Panel'.
