GENERAL MOTORS
DCS7012
URGENT - DISTRIBUTE IMMEDIATELY

Subject: N242442070 - Customer Satisfaction Program
Multiple Module Reprogramming

Models: 2022 GMC HUMMER EV Pickup

N242442070 Multiple Module Reprogramming

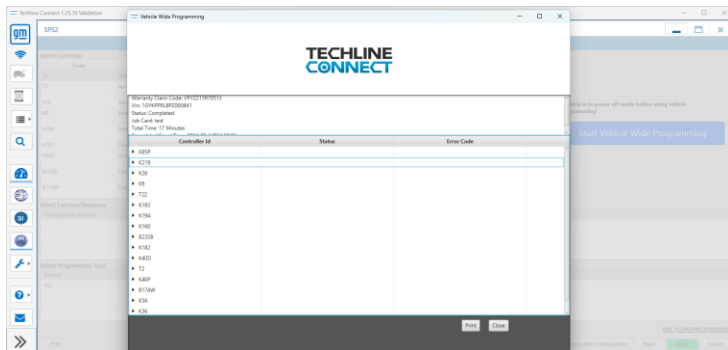
6693875

- If any applicable module does NOT display “SUCCESS” or “SKIPPED”:
 - 4.1 Attempt Vehicle Wide Programming a second time.
 - 4.2 If any applicable module fails the second attempt, attempt to program the module individually through SPS. If the failure continues, contact Techline Customer Service Center.

Note: The screenshot above is an example of Vehicle Wide Programming and may not be indicative of the specific modules that are being programmed. VIN information has been blacked out.
