HYUNDAI Technical Service Bulletin	GROUP CAMPAIGN	NUMBER 24-01-051H-1
	DATE SEPTEMBER 2024	MODEL(S) IONIQ 5 (NE1) IONIQ 6 (CE1) KONA ELECTRIC (SX2 EV)
SUBJECT: VCMS SOFTWARE UPDATE – CHARGING LOGIC (SERVICE CAMPAIGN 9B5)

SUBJECT:VCMS SOFTWARE UPDATE – CHARGING LOGIC
(SERVICE CAMPAIGN 9B5)**GDS Information:**

System Selection: VCMS (Vehicle Charging Management System)

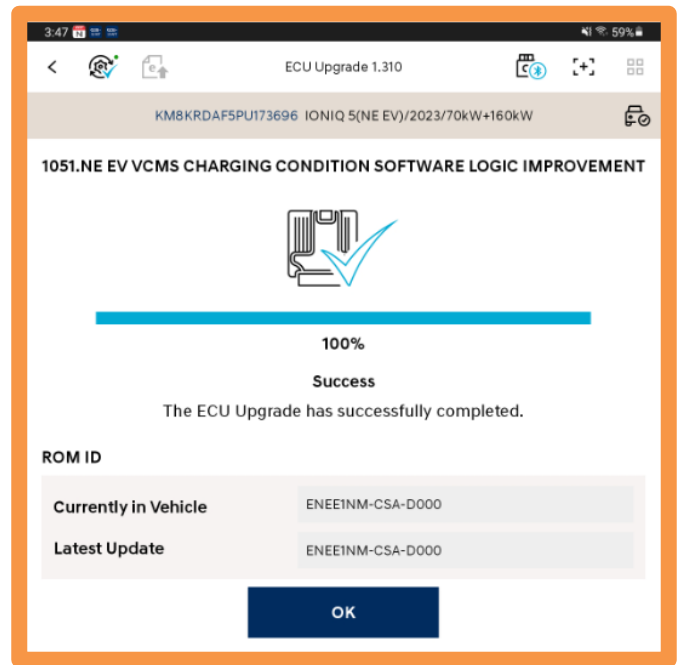
- Perform an **All Systems Fault Code** search and erase DTC history that had incidentally occurred from the ECU update.
- Start the vehicle in **Ready** mode to confirm proper operation.
