Service Bulletin

Bulletin No.: 24-NA-176

Subject: Turn Signal Over Cancelling

Brand:	Model:	Model Year:		VIN:		Engine:	Transmission:
		from	to	from	to		
Chevrolet	Colorado	2023	2024				
GMC	Canyon	2023	2024

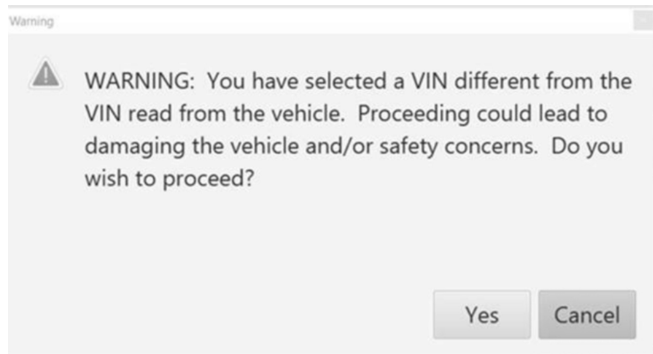
5877000

Important: If the vehicle VIN DOES NOT match, the message below will be shown

Important: Techline Connect screens shown above.
