SERVICE BULLETIN

APPLICABILITY: 2016-18MY Legacy & Outback
 2016-18MY Impreza
 2016-18MY Crosstrek
 2016-18MY Forester
 2017-18MY WRX/STI

NUMBER: 15-316-24R
DATE: 02/27/24
REVISED 09/10/24

SUBJECT: Gen1 Telematics DCM Reprogramming for 3G Sunset

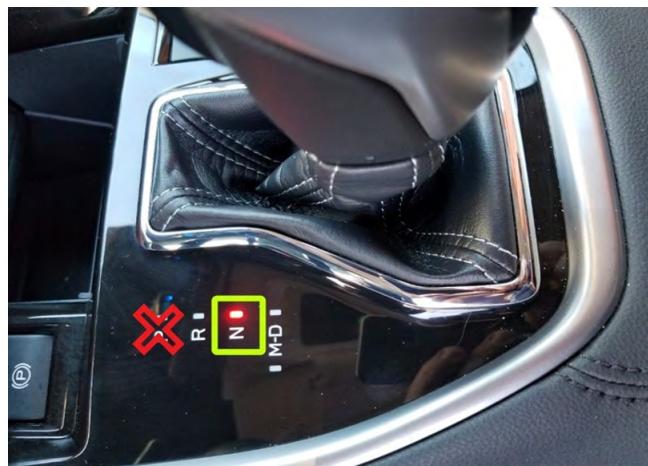
CAUTION: Ensure the Midtronics GR8 / Midtronics DCA-8000 set to Power Supply Mode is connected to the vehicle, the parking brake is engaged, ignition is in the “ON” position, the engine is OFF, the shift selector in NEUTRAL and the wheels are blocked. This must be done to ensure the power supplied to the DCM is not turned off. If this step is not performed, the CAN will power down the DCM during the reflash, and the reprogramming will fail, resulting in irreparable damage.

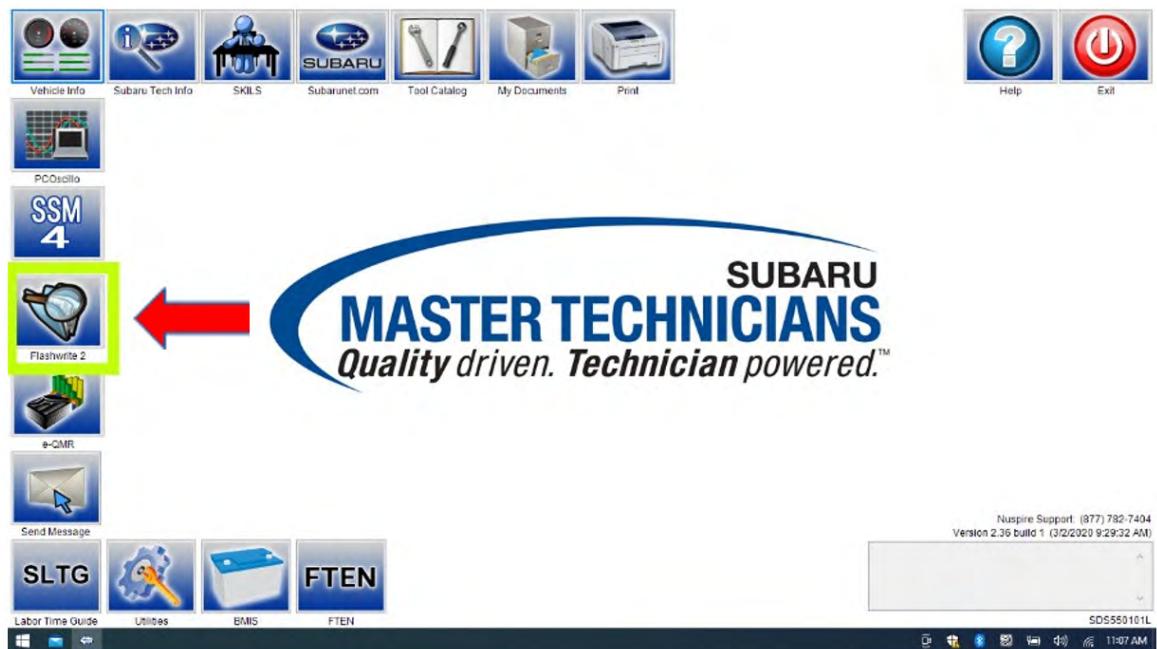
1. Connect the SDS Notebook and DSTi. Select **FlashWrite2** from the SDS Notebook GUI screen.

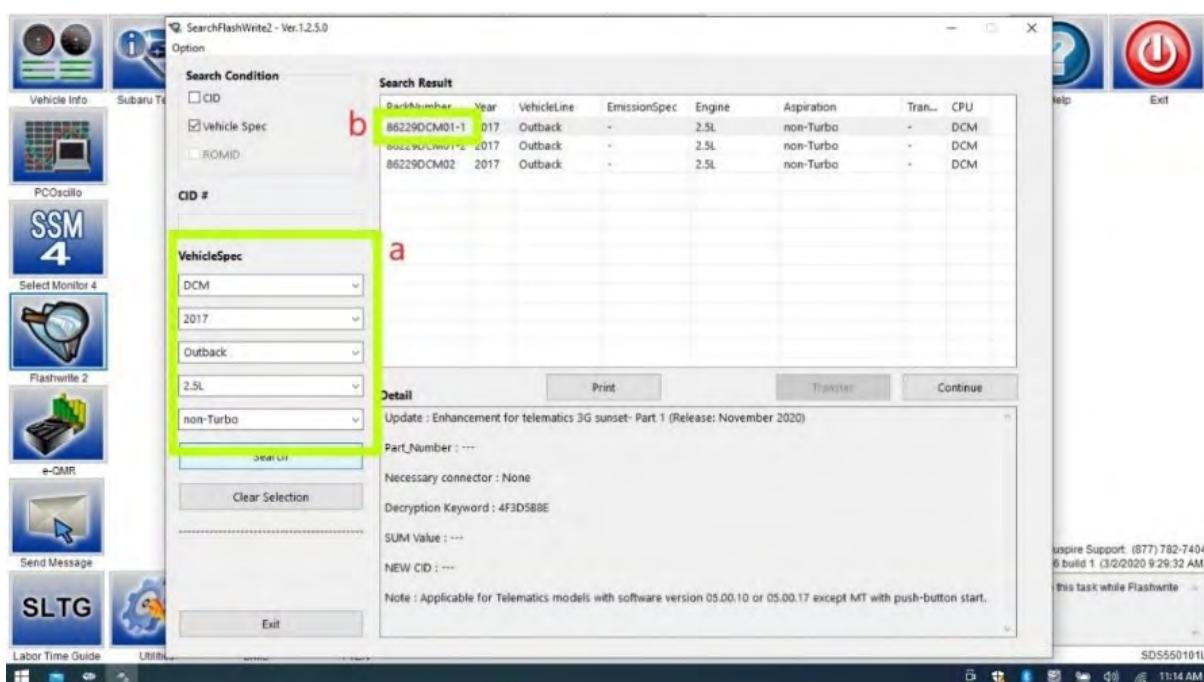
2. Once FlashWrite 2 opens, select DCM from the Vehicle Spec drop-down.
 - Complete entering the Vehicle Spec information.
 - Click and select the Pak file **86229DCM01-1.pak** intermediate image in FlashWrite.

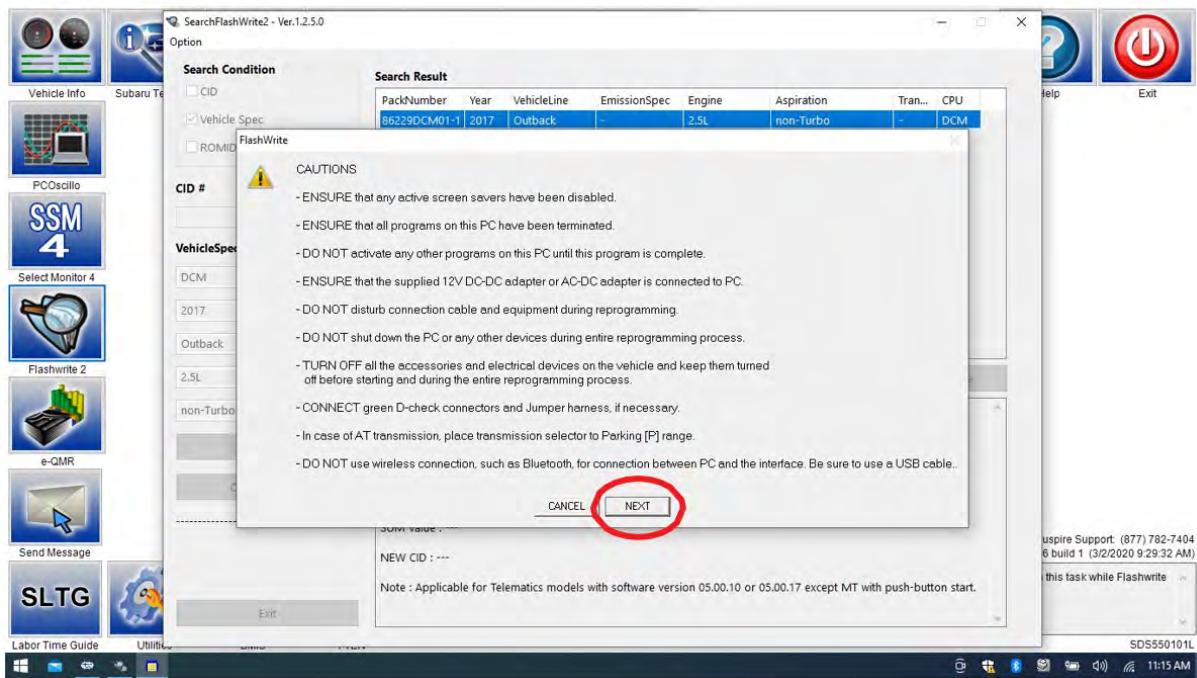
3. CAUTIONS will be displayed. Check the notices and click on “NEXT.”

CAUTION: In the screenshot above, the on-screen directions indicate leaving the vehicle in PARK; doing this will cause the reflash procedure to FAIL. The vehicle **MUST BE LEFT IN NEUTRAL** for the entire reflash procedure. Reference page #3 above for all the vehicle conditions required for reprogramming.

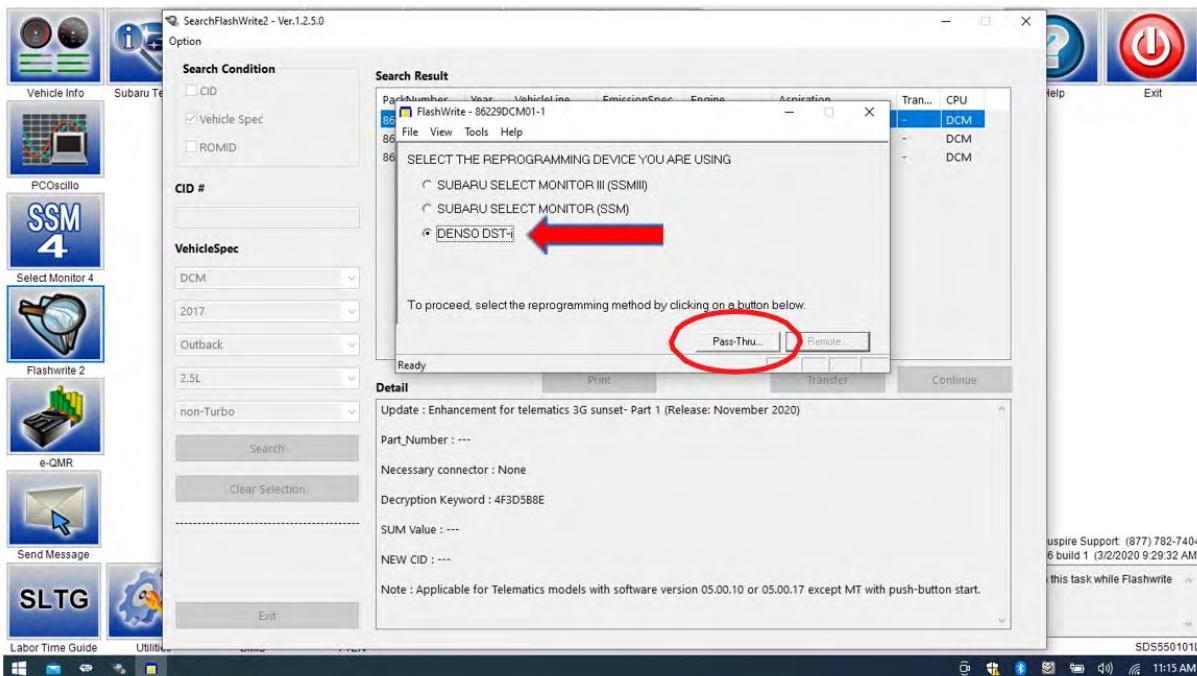
4. Select the reprogramming device and click “OK.”

5. Click on “Pass Thru.”

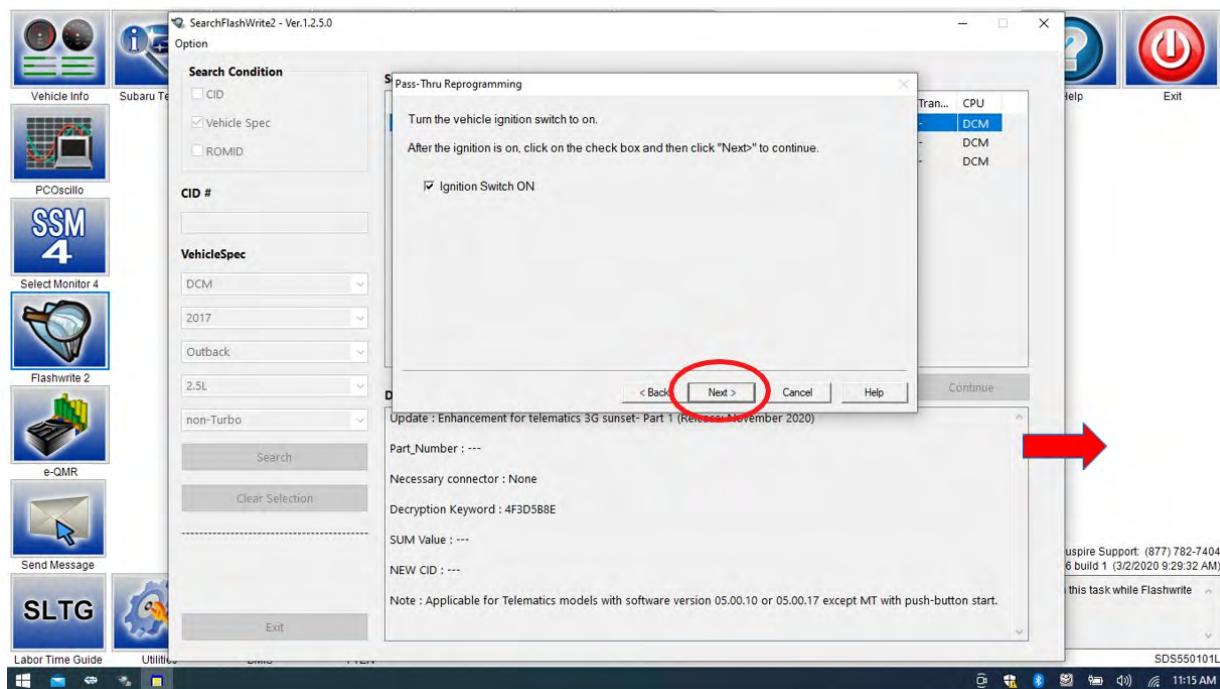
6. Confirm the ignition is “ON” and the shift selector is **NEUTRAL**.

a) Turn on the ignition switch and click on ‘Next.’

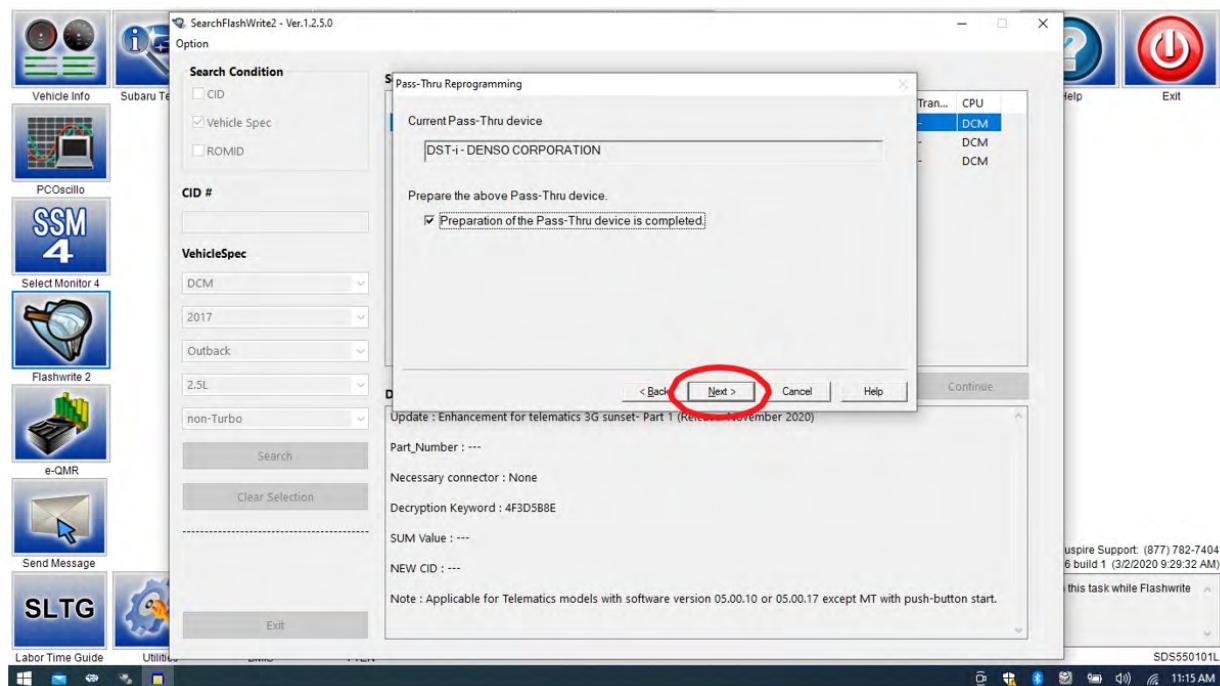
b) Pass-through preparation is completed; click on Next to continue.

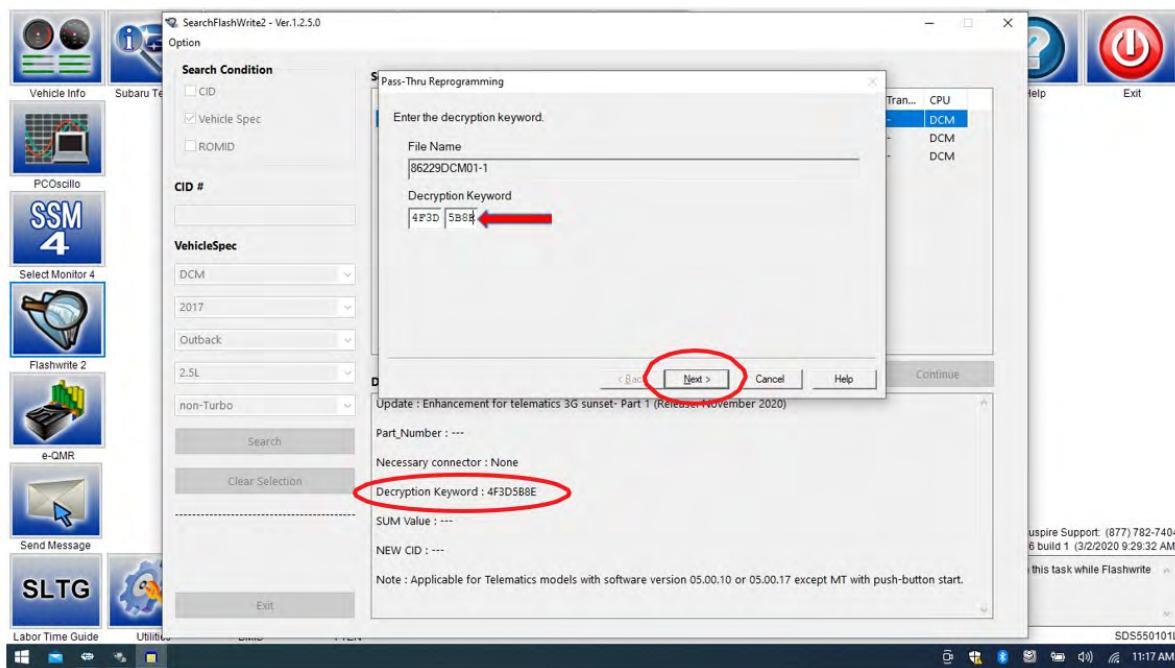
7. Enter the Decryption Keyword from the table above (4F3D5B8E) and click “Next.”

| Starting DCM Software Version | File Description | Decryption Keyword |
|---|---|---|
| DCM_05.00.10 or 05.00.17 | 86229DCM01-1.pak | 4F3D5B8E |

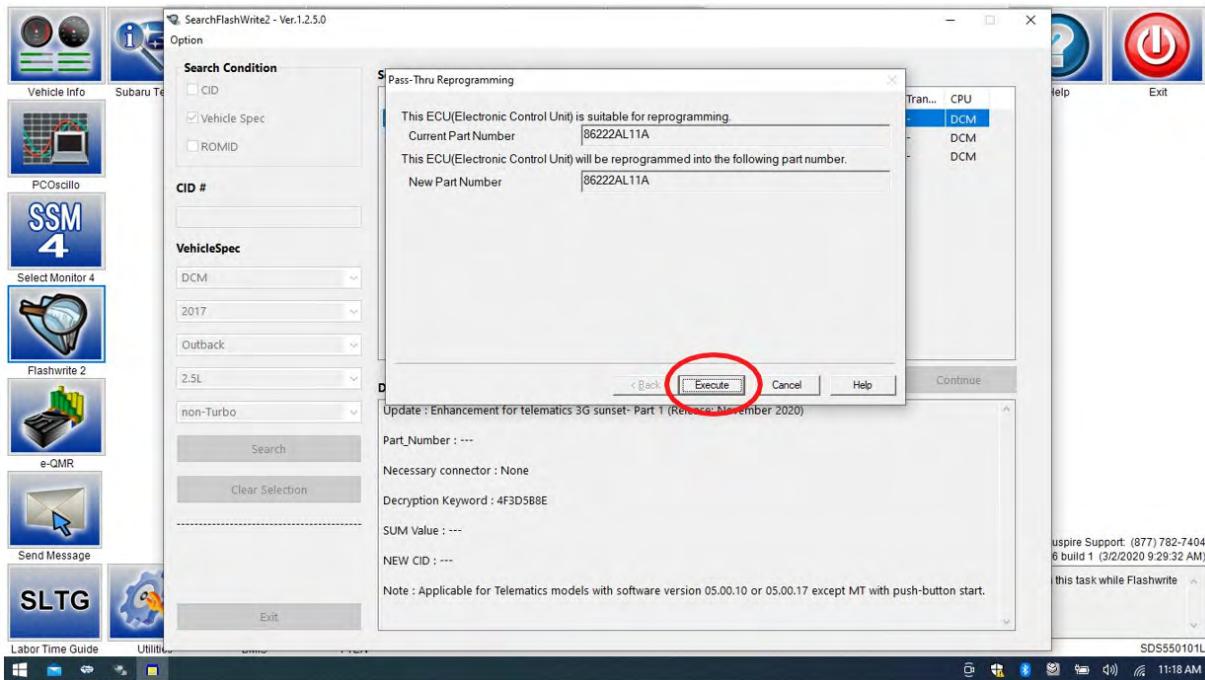
8. Click on “Execute.”

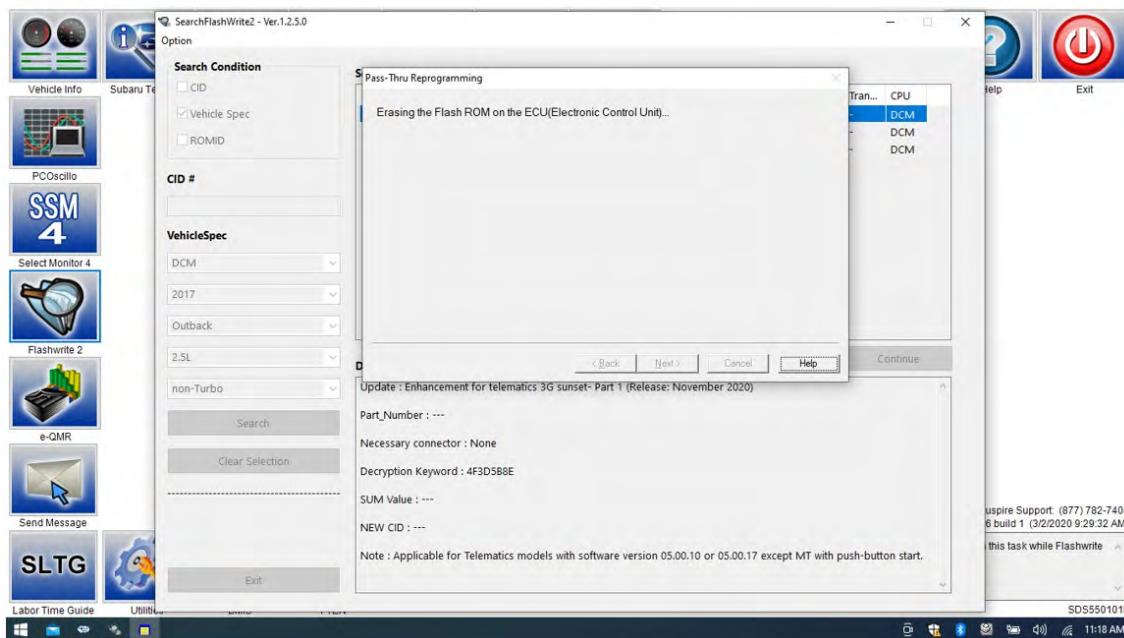
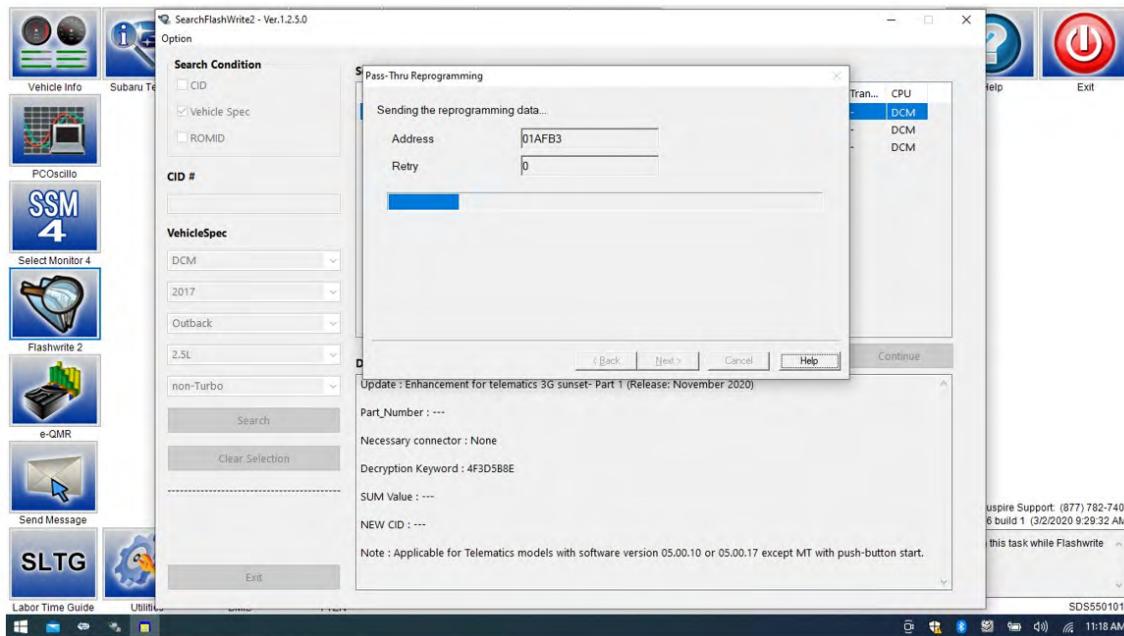
9. Reprogramming will begin. Please wait.

NOTE: Pay close attention to the start of the status bar progression. Failures may occur at the beginning of the procedure. Once progress is at 5%, reprogramming should continue trouble-free until 100% complete. The update may take up to 60 minutes to complete.

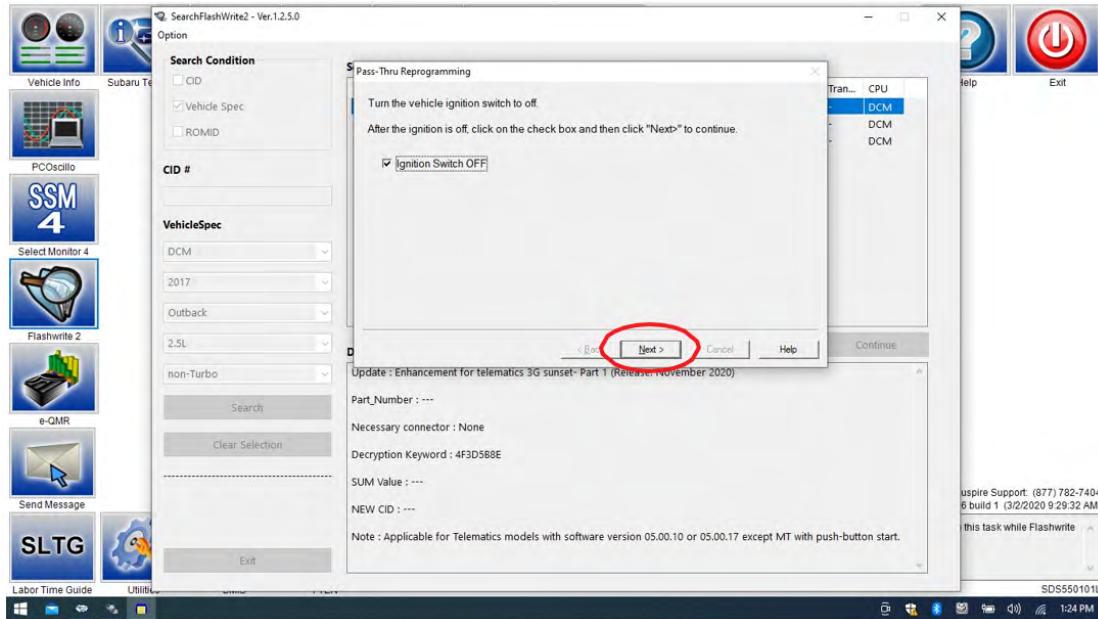
10. CRITICAL STEP: After reprogramming, always put a CVT-equipped vehicle in PARK and ensure the ignition is turned OFF. A prompt to switch the ignition OFF will be displayed. **DO NOT CLICK OK UNTIL THE VEHICLE IS IN PARK AND THE IGNITION IS SWITCHED OFF.**

NOTE: For CVT-equipped vehicles with push-button start:

- WITHOUT TOUCHING THE BRAKE PEDAL, push the start button (once).
- Move the selector into Park.
- Push the start button again to switch the vehicle OFF.
- WAIT 30 SECONDS and click OK.

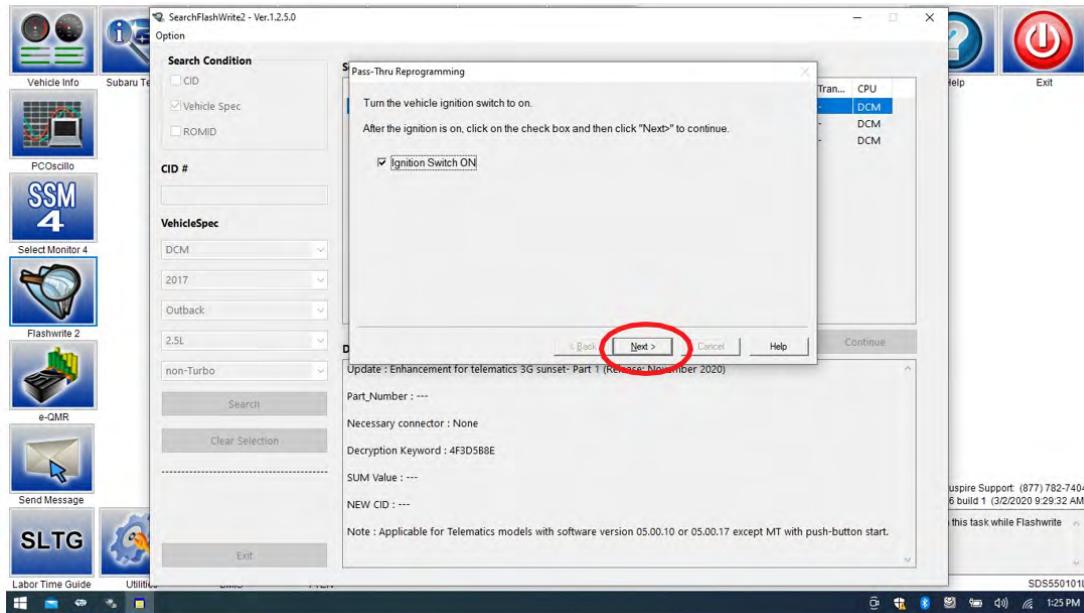
11. CRITICAL STEP: WAIT 30 seconds, cycle the ignition key or push-button start from OFF to ON, then click "Next."

CRITICAL: Wait at least a full 5 minutes before proceeding from this point. During this waiting period, "repartitioning" is taking place in the DCM and cannot be interrupted. Do not attempt any other functions during this time (e.g., switching the ignition off, starting another update, using the SSM to check DCM status, Opening the door(s), etc.).

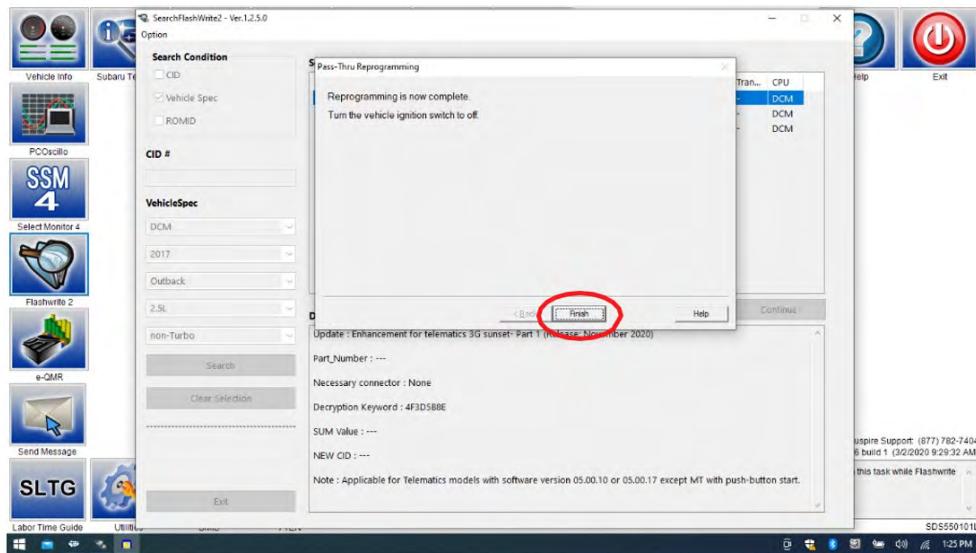
12. “Reprogramming is now complete” is displayed. Click on “Finish.”

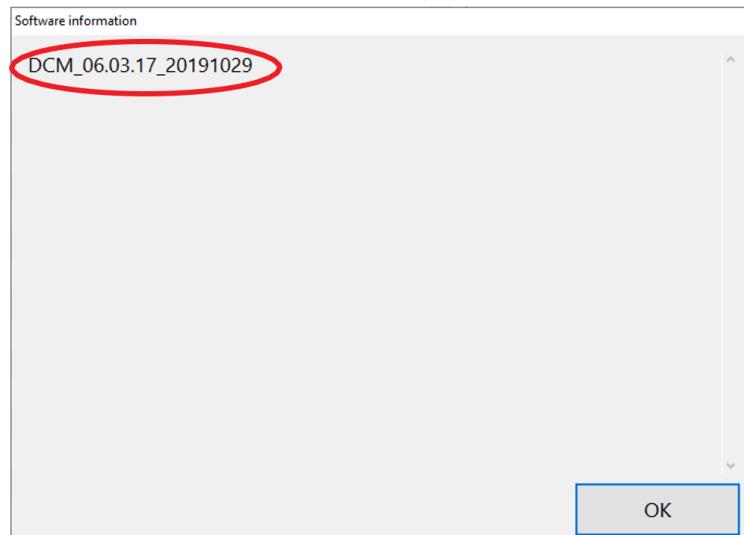
13. With the vehicle in Park and the ignition on:

- a) Confirm SSM and DCM communication by retrieving the current software version.
- b) Click “Each System” on the left-hand menu.
- c) Select “Telematics” from the Systems List.
- d) Click “Work Support” on the left-hand menu.
- e) Select “Software Information” from the Work Support Items List.
- f) Record the current version of the software on R.O. for reference.

NOTE: If SSM cannot communicate with DCM, DCM DTCs are current, or the DCM software version cannot be retrieved, contact Techline for assistance before proceeding.

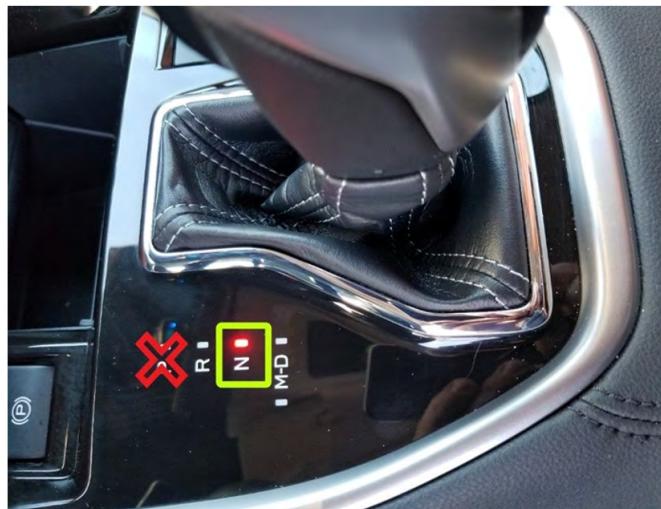
CAUTION: Ensure the Midtronics GR8 / Midtronics DCA-8000 set to Power Supply Mode is connected to the vehicle, the parking brake is engaged, ignition is in the “ON” position, the engine is OFF, the shift selector in NEUTRAL and the wheels are blocked. This must be done to ensure the power supplied to the DCM is not turned off. If this step is not performed, the CAN will power down the DCM during the reflash, and the reprogramming will fail, resulting in irreparable damage.

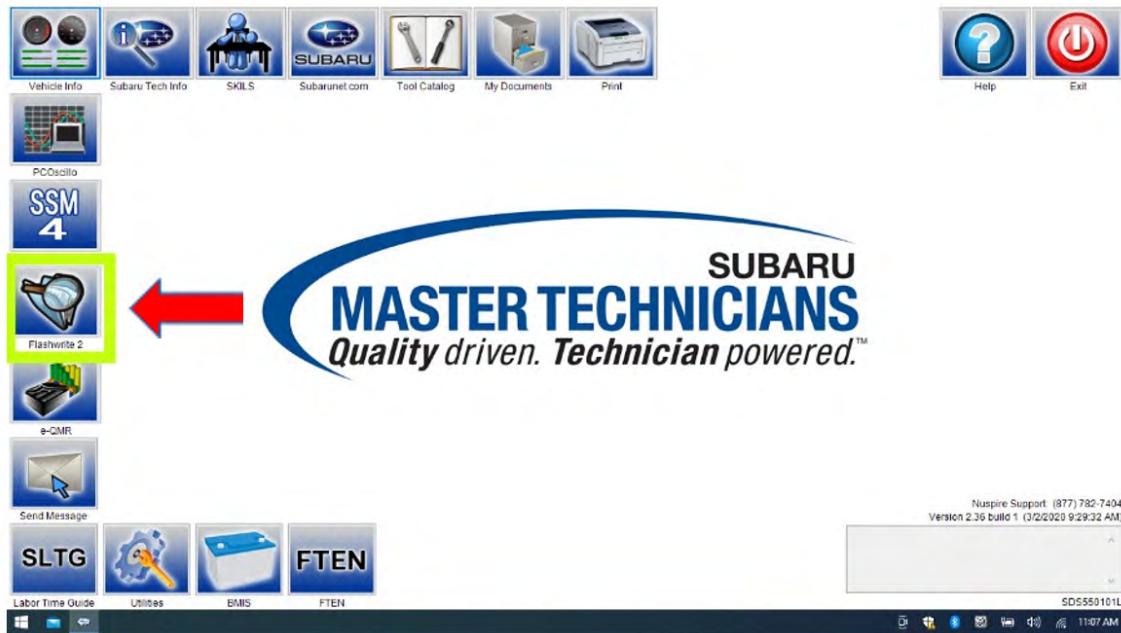
1. Connect the SDS Notebook and DSTi. Select **FlashWrite2** from the SDS Notebook GUI screen.

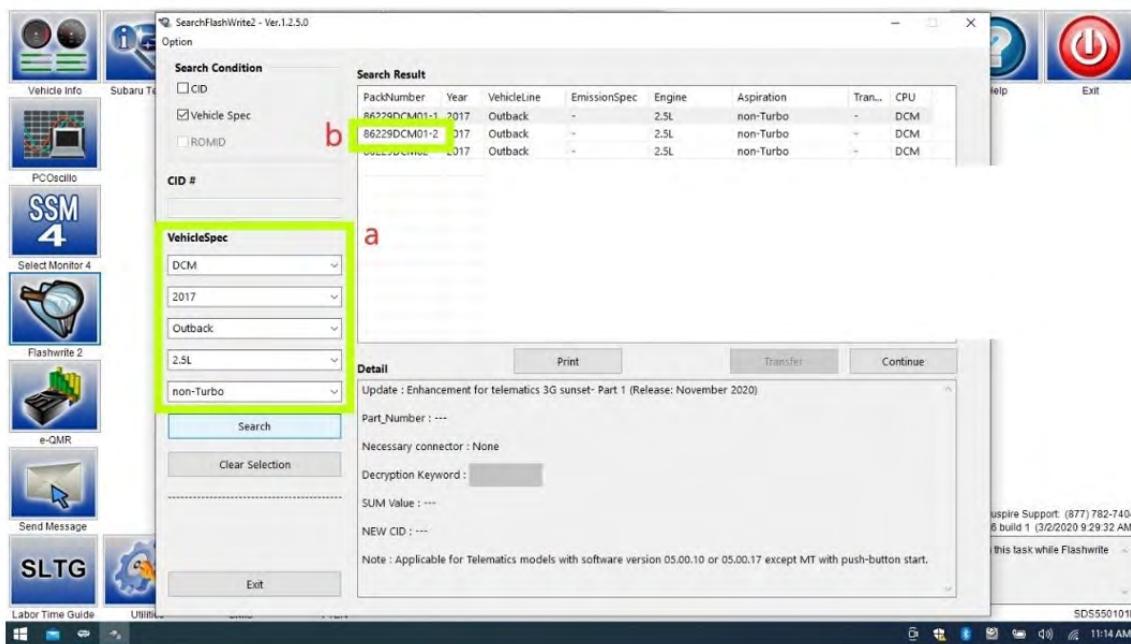
2. Once FlashWrite 2 opens, select DCM from the Vehicle Spec drop-down.
 - Complete entering the Vehicle Spec information.
 - Click and select the PK2 file **86229DCM01-2.pk2** intermediate image in FlashWrite.

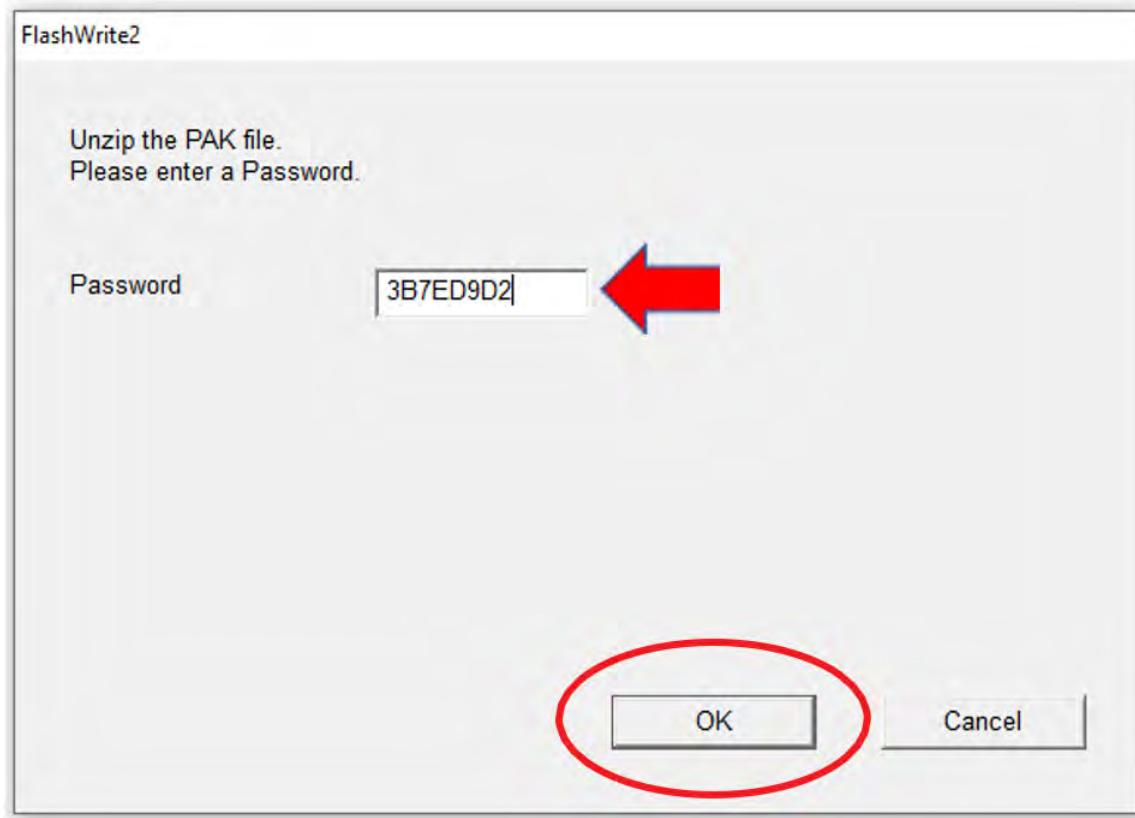
3. Enter the Decryption Keyword from the table above (3B7ED9D2) and click “OK.”

| Starting DCM Software Version | File Description | Decryption Keyword |
|---|---|---|
| DCM_05.00.22 or 05.00.30 | 86229DCM01-2.pk2 | 3B7ED9D2 |

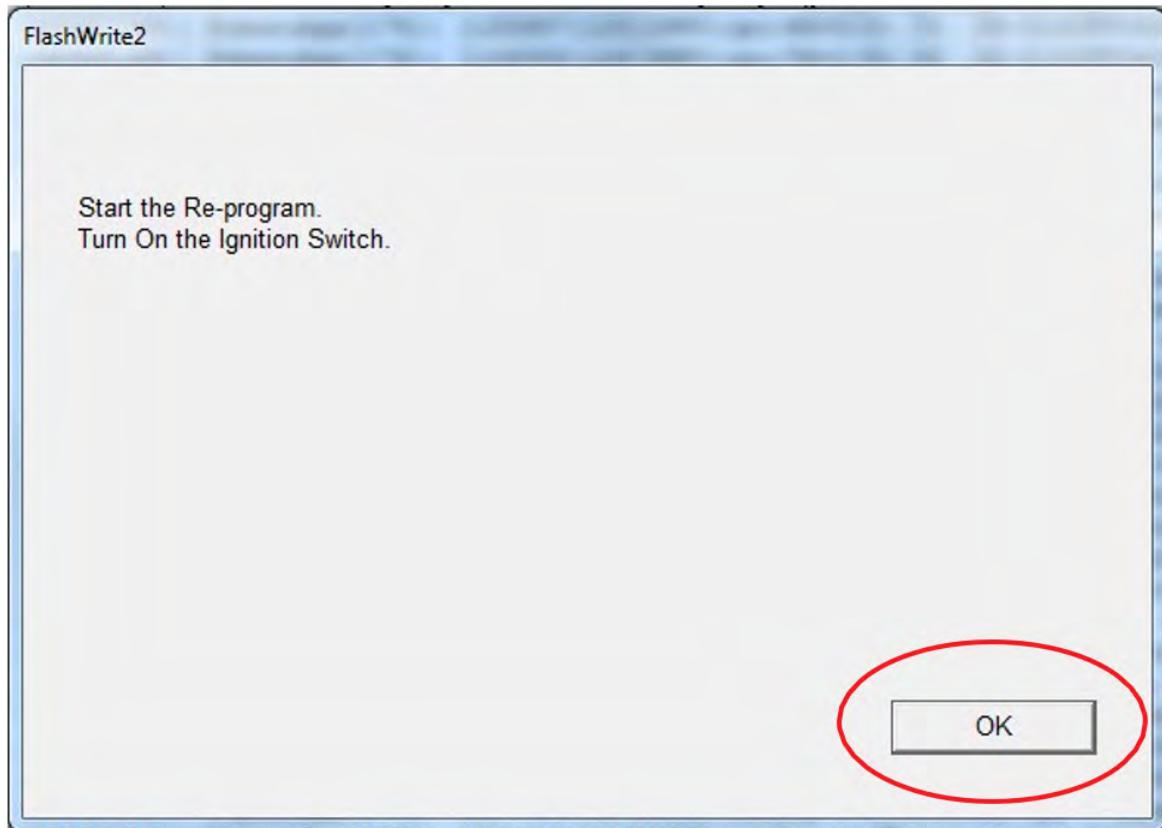
4. Turn the ignition ON and Click ‘OK’ to start the reprogram.

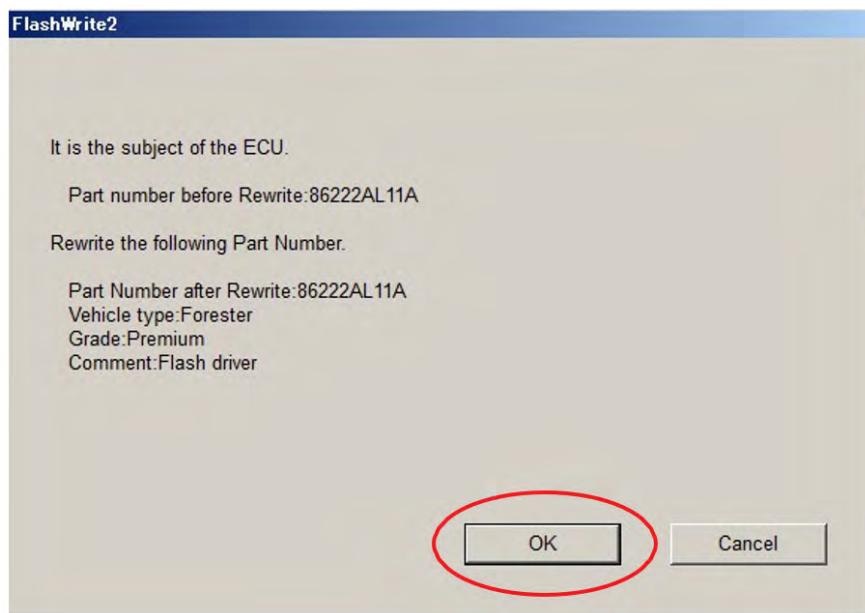
c) The part numbers before and after reprogramming will be displayed. Click ‘OK.’

NOTE: This screen image is an EXAMPLE and may not represent the installed part number. These values will be the same before and after any reprogramming. The Screen will always indicate “Forester” no matter what model or model year is being reprogrammed.

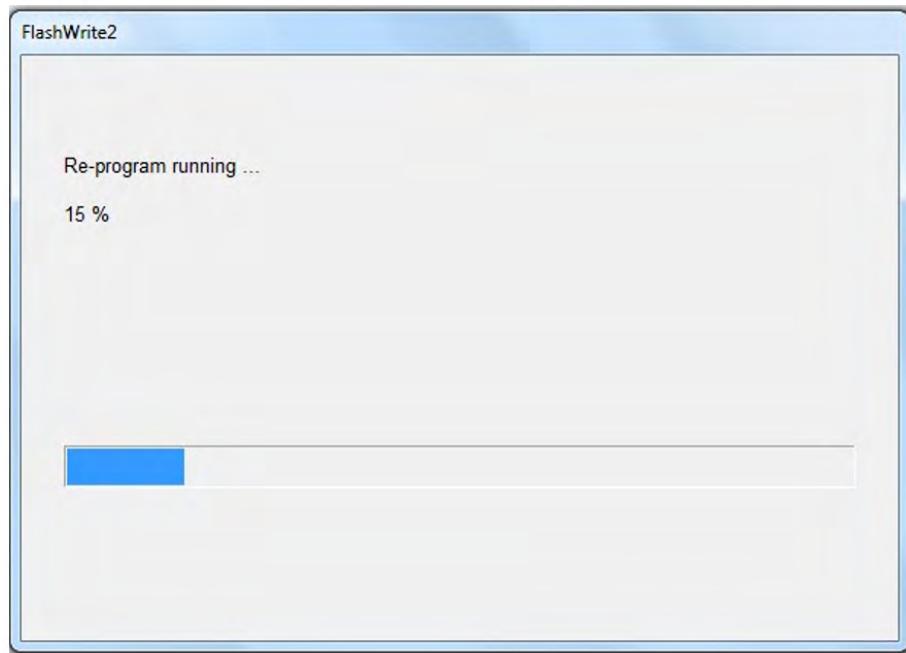
d) A CAN reprogramming progression bar will appear and start incrementing toward 100%. The update may take up to 60 minutes to complete.

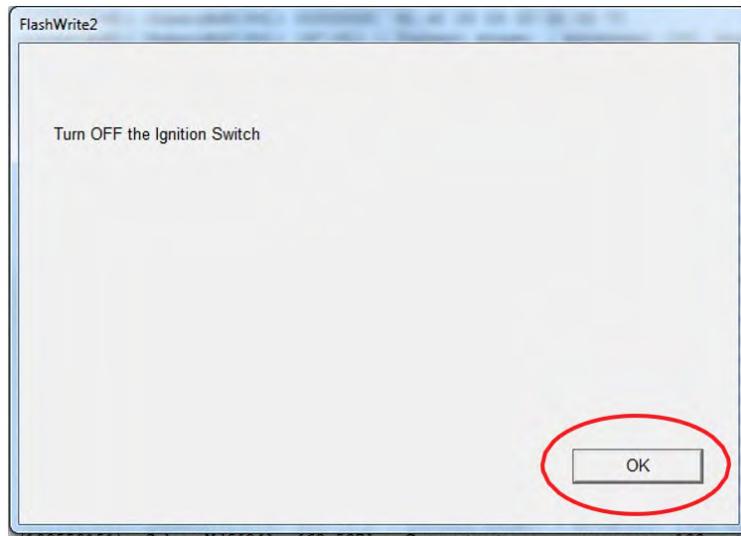
e) **CRITICAL STEP:** After reprogramming, always put a CVT-equipped vehicle in PARK and ensure the ignition is turned OFF. A prompt to switch the ignition OFF will be displayed. **DO NOT CLICK OK UNTIL THE VEHICLE IS IN PARK AND THE IGNITION IS SWITCHED OFF.**

- WITHOUT TOUCHING THE BRAKE PEDAL, push the start button (once).
- Move the selector into Park.
- Push the start button again to switch the vehicle OFF.
- WAIT 30 SECONDS and click OK.

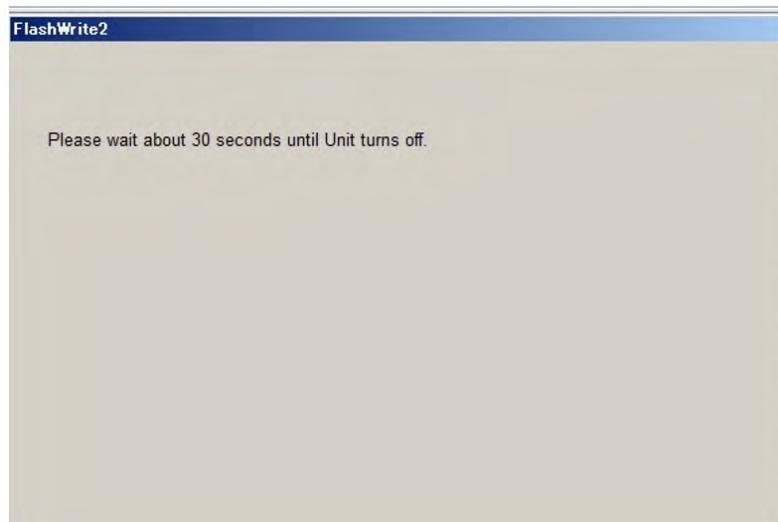
f) **CRITICAL STEP:** FlashWrite will display the banner message "Please wait about 30 seconds until Unit turns off". This banner page has a built-in timer and will NOT continue until 30 seconds have passed and the DCM has safely shut down. There is no way to verify the DCM has shut down except to wait to ensure the full 30 seconds have passed. The next screen, e) shown below, will display automatically.

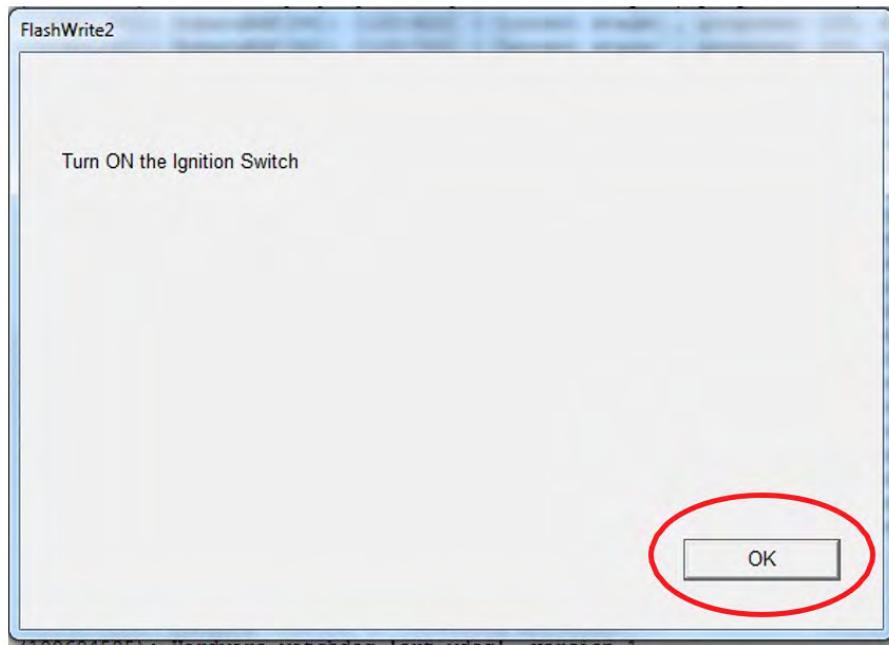
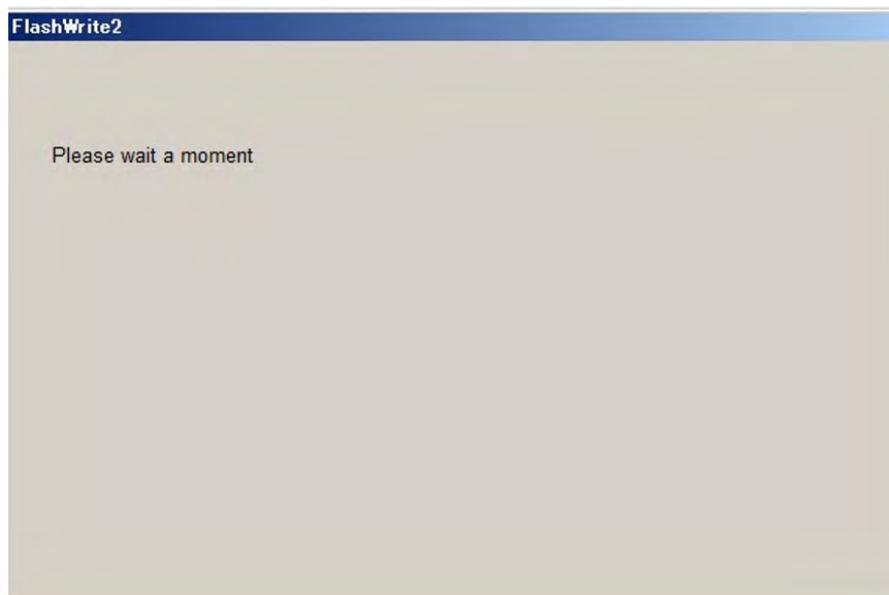
g) A prompt for toggling the ignition to ON will be displayed. Click on ‘OK’

h) FlashWrite will display the banner message “Please wait a moment.”

CRITICAL: Wait at least a full 5 minutes before proceeding from this point. During this waiting period, “repartitioning” is taking place in the DCM and cannot be interrupted. Do not attempt any other functions during this time (e.g., switching the ignition off, starting another update, using the SSM to check DCM status, Opening the door(s), etc.).

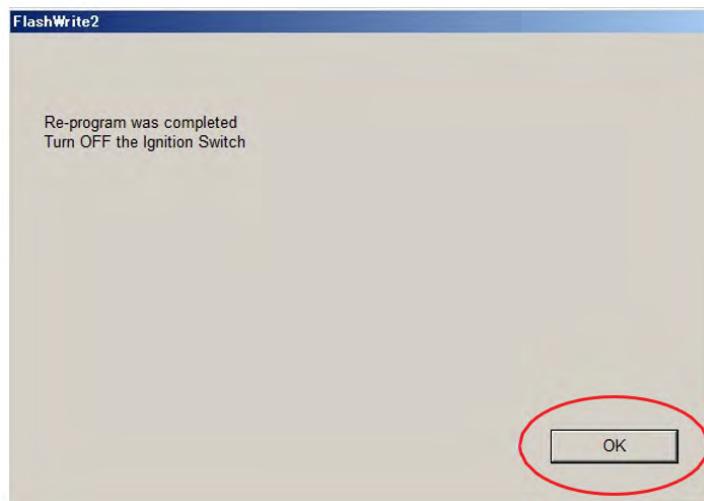
i) FlashWrite will display the banner message “Re-program was completed. Turn OFF the Ignition Switch.”

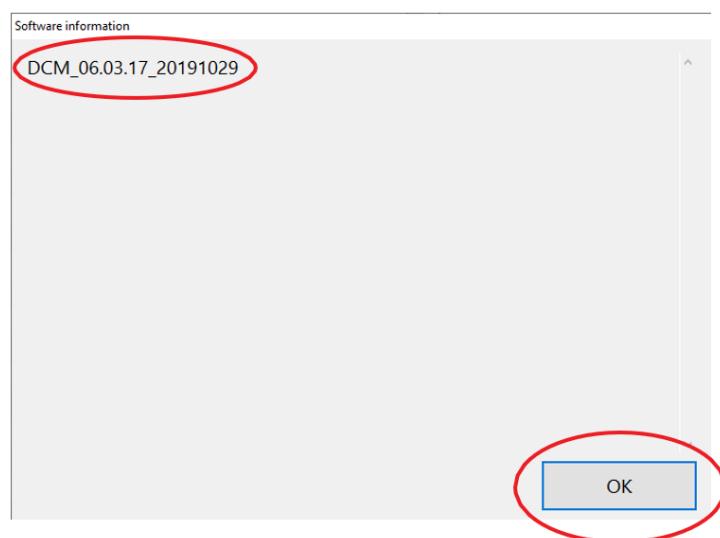
5. Verify the new DCM software version:

- j) Confirm SSM and DCM communication by retrieving the current software version.
- k) Click “Each System” on the left-hand menu.
- l) Select “Telematics” from the Systems List.
- m) Click “Work Support” on the left-hand menu.
- n) Select “Software Information” from the Work Support Items List.
- o) Record the current version of the software on the RO for reference.
 - i. Successful retrieval of DCM software version? Proceed to **Step 6 below**.
 - ii. If SSM cannot communicate with DCM, DCM has current DTC(s), or the DCM software version cannot be retrieved, contact Techline for assistance before proceeding.

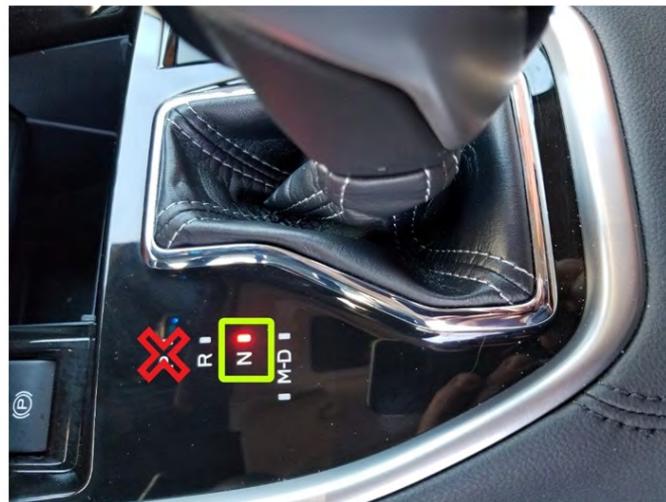
CAUTION: Ensure the Midtronics GR8 / Midtronics DCA-8000 in Power Supply Mode is connected to the vehicle, the parking brake is engaged, the ignition is in the “ON” position, the engine is OFF, the shift selector is in NEUTRAL, and the wheels are blocked. This must be done to ensure the power supplied to the DCM is not turned off. If this step is not performed, the CAN will power down the DCM during the reflash; the update will fail and result in irreparable damage to the DCM.

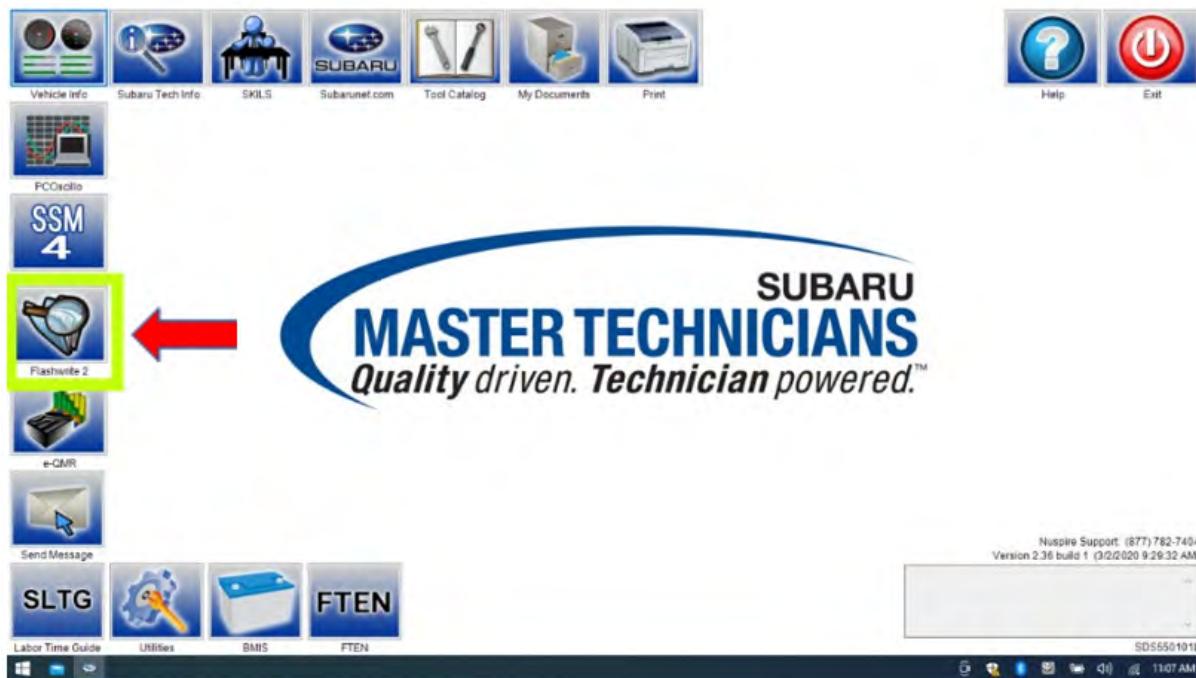
1. Connect SDS Notebook and DSTi. Select **FlashWrite2** from the SDS Notebook GUI screen.

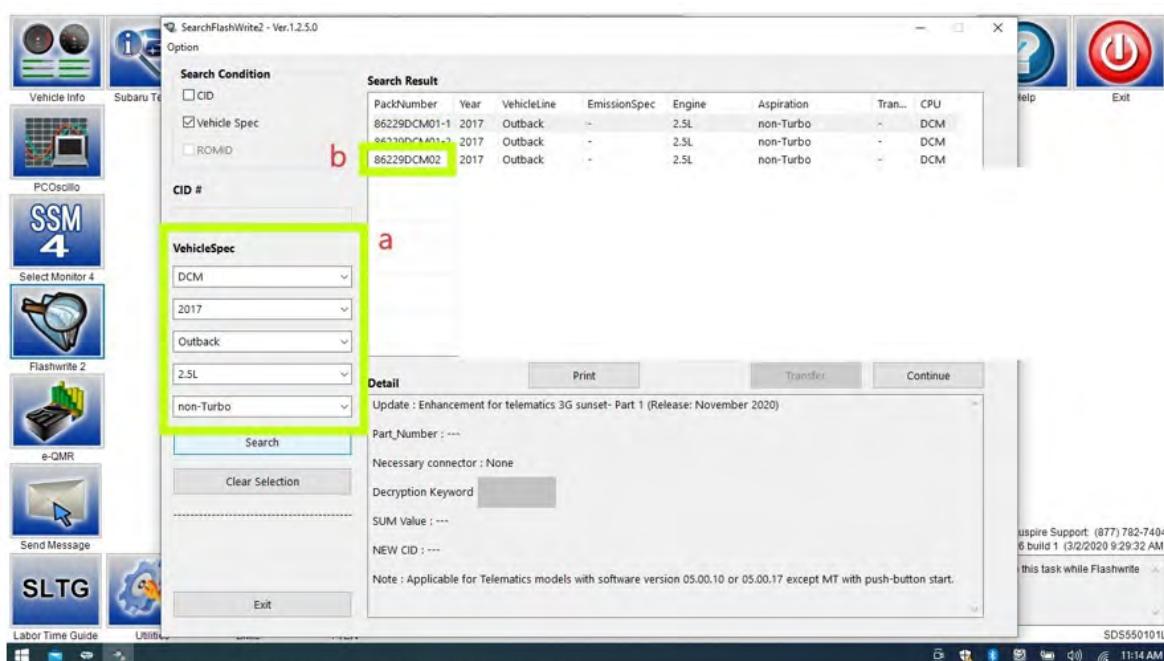
2. Once FlashWrite 2 opens, select DCM from the Vehicle Spec drop-down.
 - Complete entering the Vehicle Spec information.
 - Click and select the PK2 file **86229DCM02.pk2** intermediate image in FlashWrite.

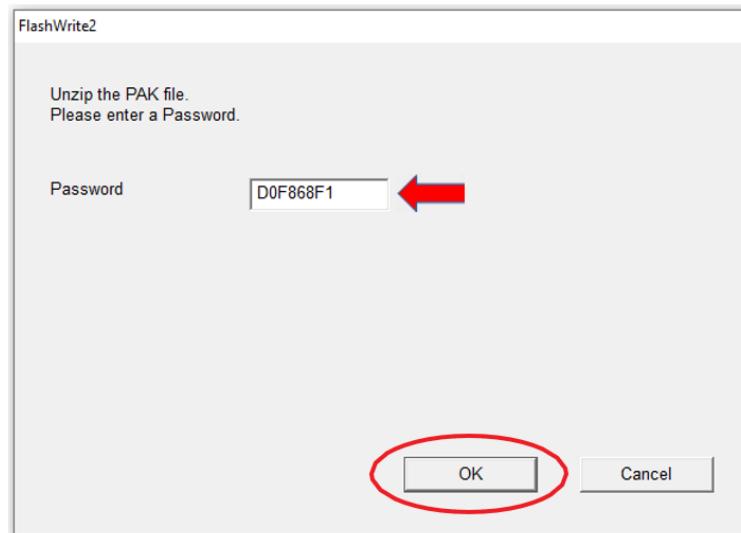
3. Enter the Decryption Keyword from the table above (D0F868F1) and click “OK.”

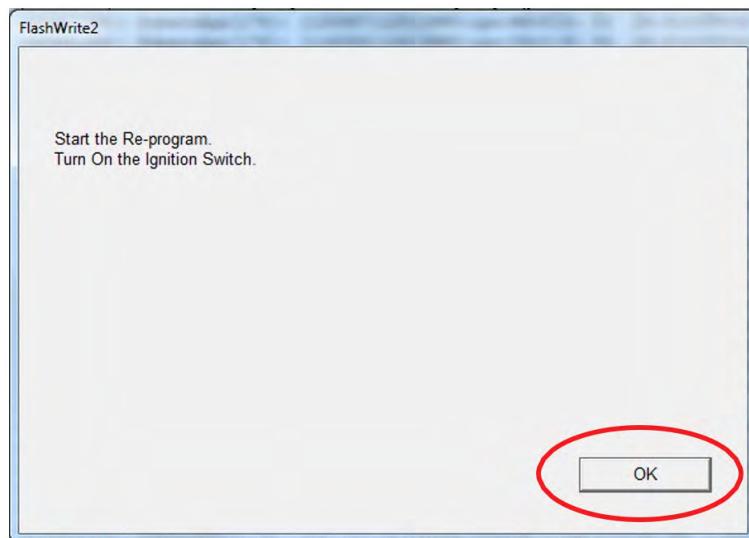
a) Turn the ignition switch ON and Click ‘OK’ to start the reprogram.
