SERVICE BULLETIN

APPLICABILITY: 2016-18MY Legacy & Outback
 2016-18MY Impreza
 2016-18MY Crosstrek
 2016-18MY Forester
 2017-18MY WRX/STI

NUMBER: 15-316-24R
DATE: 02/27/24
REVISED 09/10/24

SUBJECT: Gen1 Telematics DCM Reprogramming for 3G Sunset

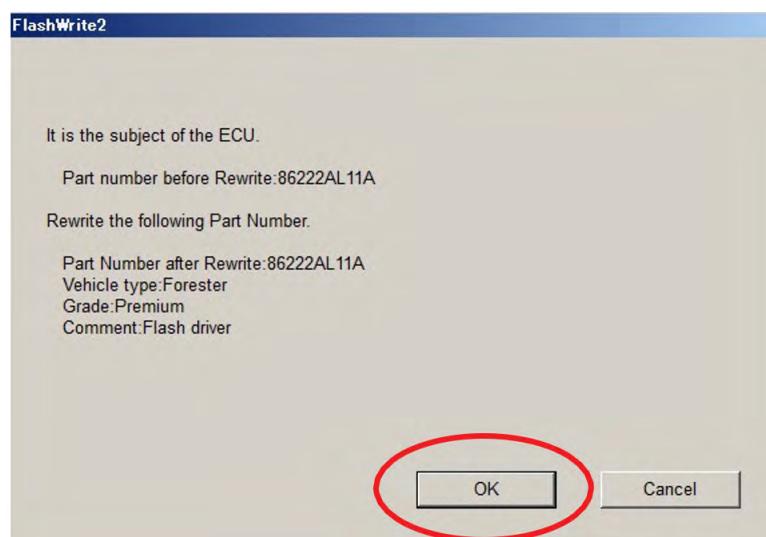
b) Part numbers before and after reflash will be displayed. Click ‘OK.’

NOTE: This screen image is an EXAMPLE and may not represent the installed part number. These values will be the same before and after any reprogramming. The Screen will always indicate "Forester" no matter what model or model year is being reprogrammed.

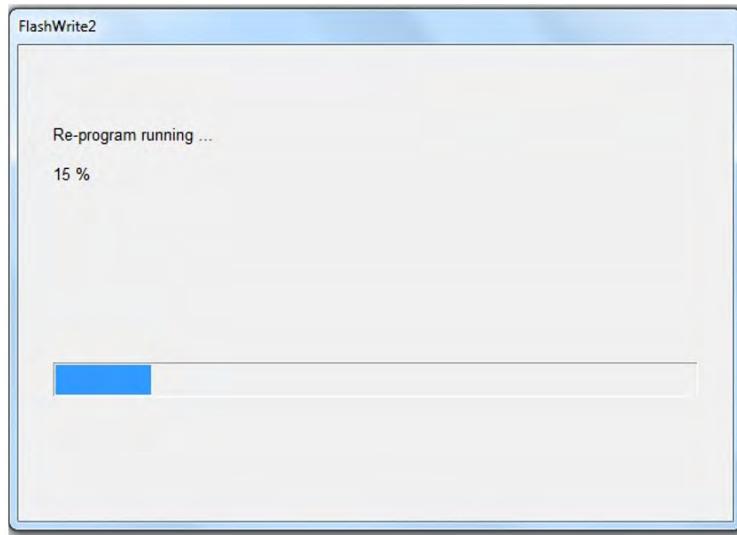
A CAN reprogramming progression bar will appear and start incrementing toward 100%. The update may take up to 60 minutes to complete.

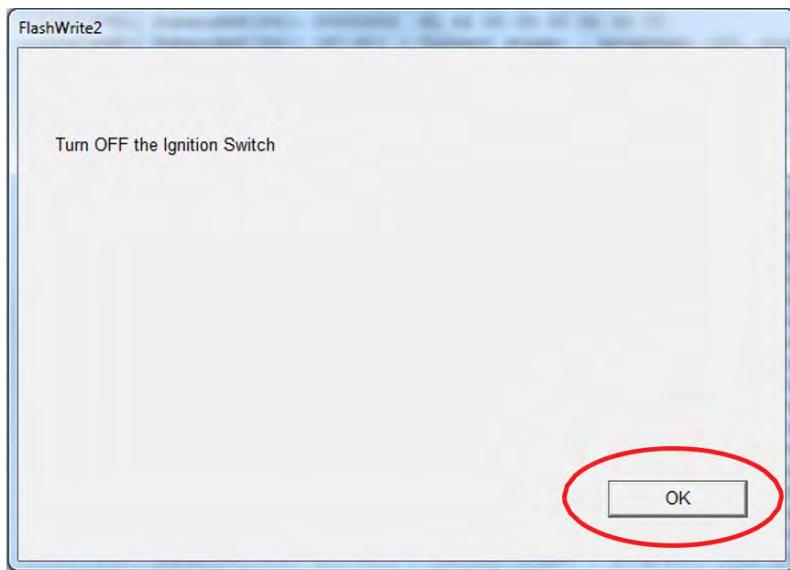
- 1. CRITICAL STEP:** After reprogramming, always put a CVT-equipped vehicle in PARK and ensure the ignition is *turned OFF*. *A prompt to switch the ignition OFF will be displayed. DO NOT CLICK OK UNTIL THE VEHICLE IS IN PARK AND THE IGNITION IS SWITCHED OFF.*

- WITHOUT TOUCHING THE BRAKE PEDAL, push the start button (once).
- Move the selector into Park.
- Push the start button again to switch the vehicle OFF.
- WAIT 30 SECONDS and click OK.

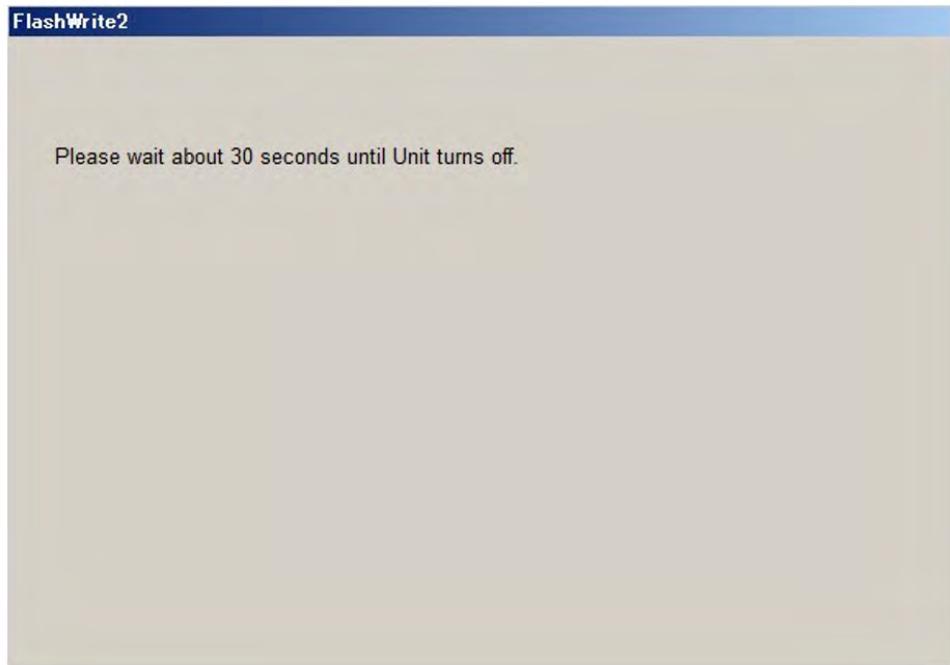
b) CRITICAL STEP: FlashWrite will display the banner message “Please wait about 30 seconds until the Unit turns off”. This banner page has a built-in timer and will NOT continue until 30 seconds have passed and the DCM has safely shut down. There is no way to verify that the DCM has shut down except **to wait to ensure the full 30 seconds have passed**. The next screen, **e)** shown below, will display automatically.

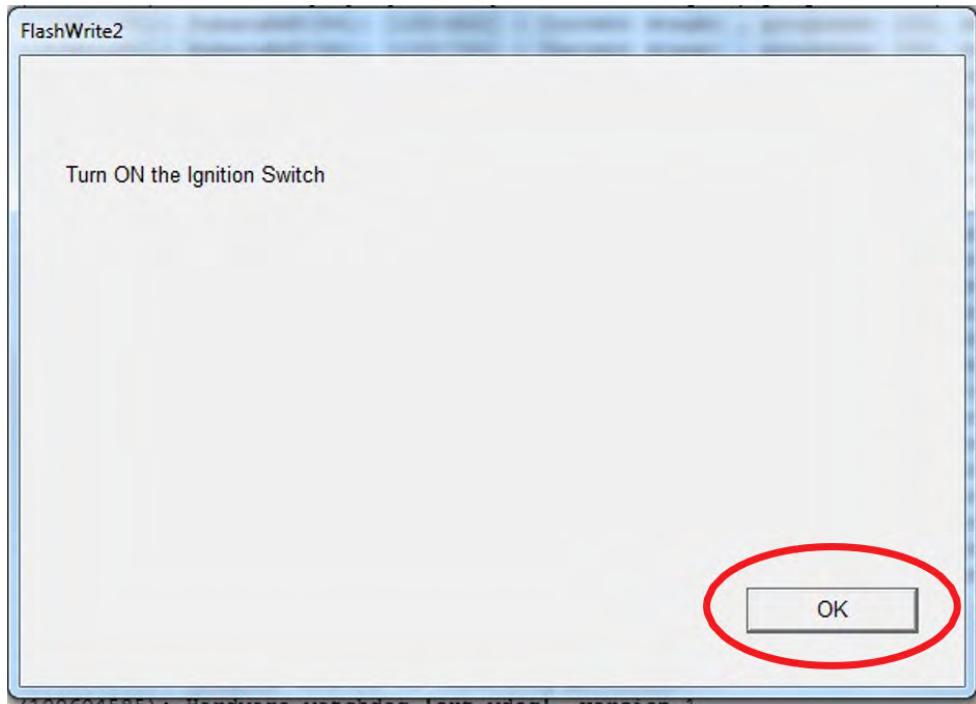
c) The prompt for switching the ignition to ON will be displayed. Click on ‘OK.’

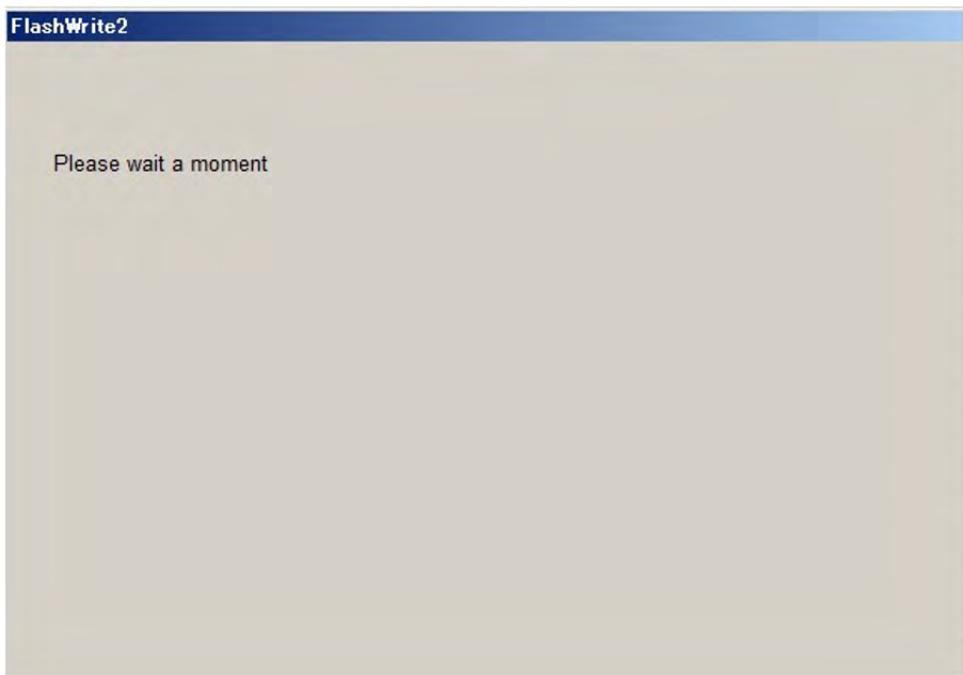
d) FlashWrite will display the banner message “Please wait a moment.”

CRITICAL: Wait at least a full 5 minutes before proceeding from this point. During this waiting period, “repartitioning” is taking place in the DCM and cannot be interrupted. Do not attempt any other functions during this time (e.g., switching the ignition off, starting another update, using the SSM to check DCM status, Opening the door(s), etc.).

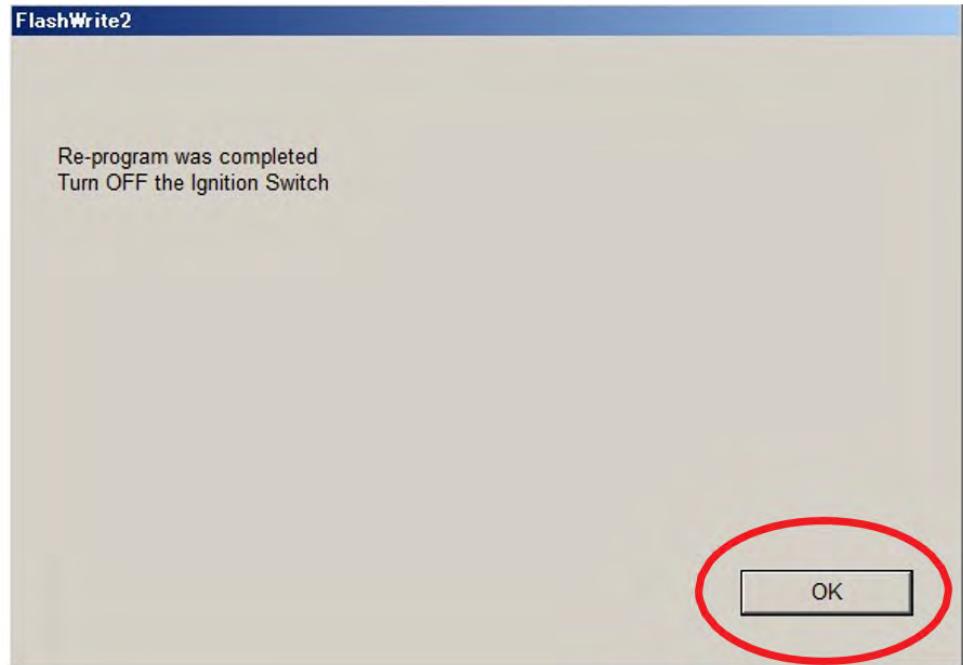
e) FlashWrite will display the banner message “Re-program was completed. Turn OFF the Ignition Switch.”

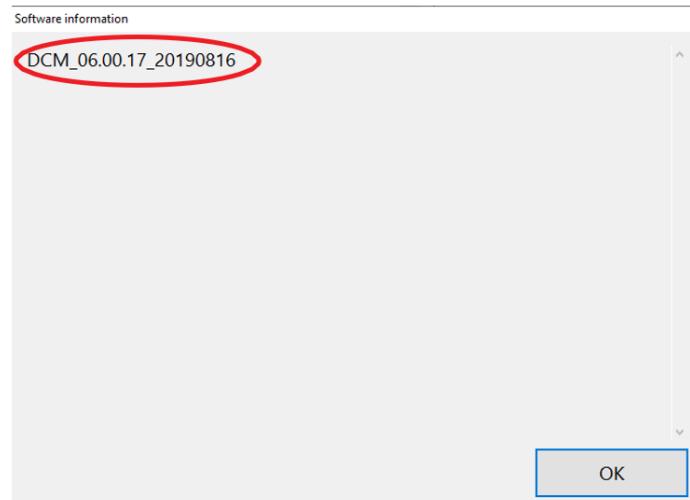
- a) Click “Each System” on the left-hand menu.
- b) Select “Telematics” from the Systems List.
- c) Click “Work Support” on the left-hand menu.
- d) Select “Software Information” from the Work Support Items List.
- e) Record the current version of the software on the RO for reference.
 - i. The final version of DCM software should be **DCM_06.00.17_20190816**.
 1. If the final version is correct, proceed to Step 5 below.
 2. If the final version is incorrect, record the DCM software version and contact Techline.
