## TGW3 Non-Communication

**Service Category** Service Department

**Section** Function Group 397

### Introduction

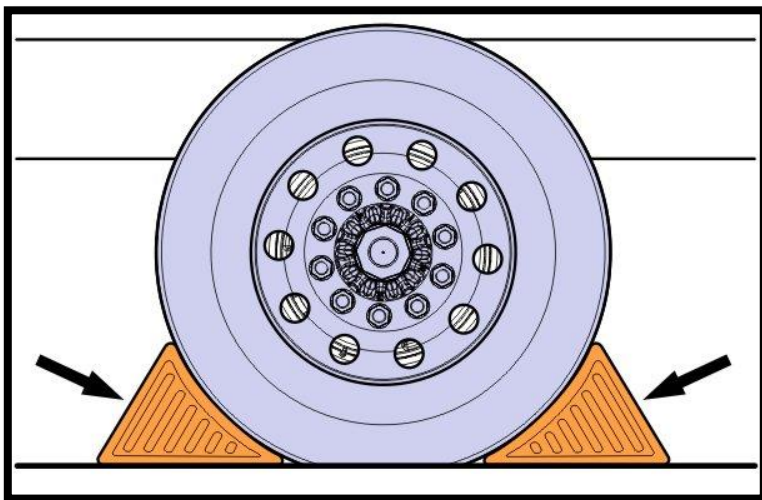
1. Secure the vehicle for service.
2. Apply the parking brake.
3. Place the gear lever in neutral.
4. Install wheel chocks.

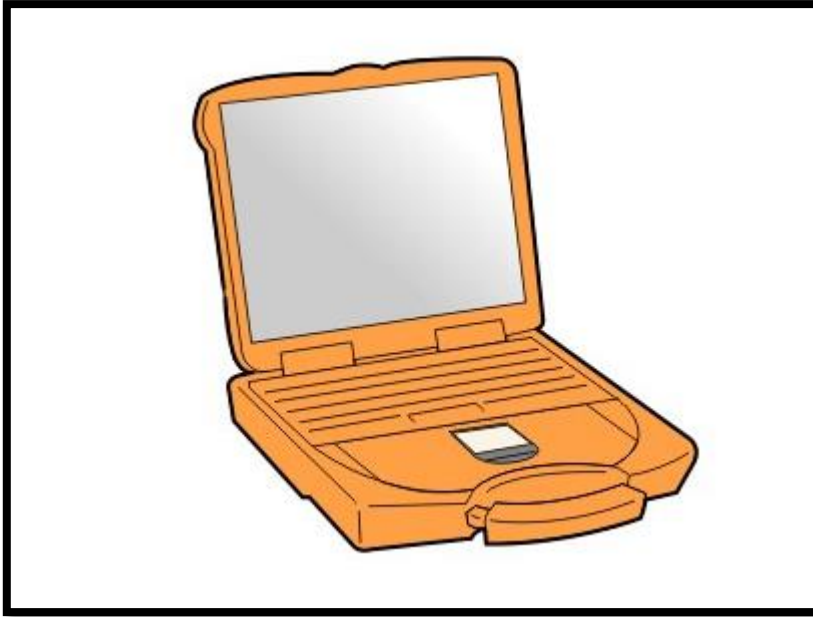
5. Connect the vehicle to Premium Tech Tool.

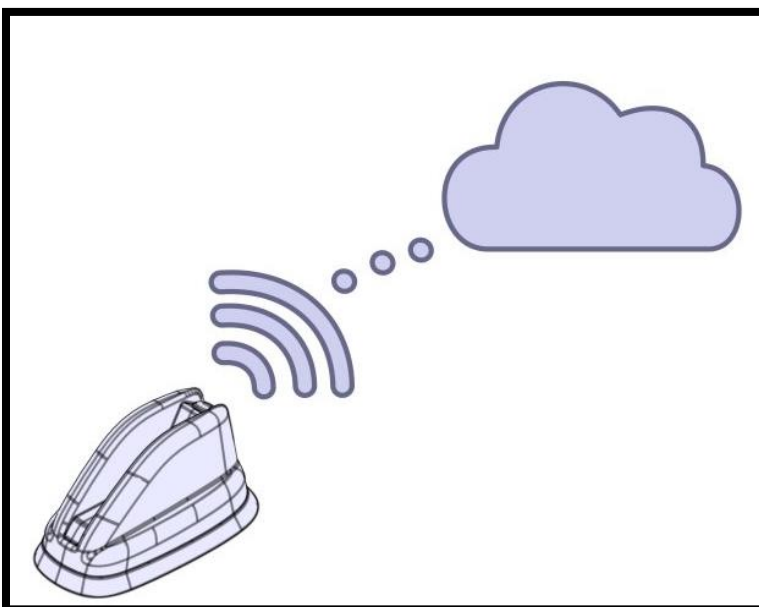
6. Perform PTT operation **1700-08-03-39, Program Electronic Control Unit – Telematic Gateway TGW.**
7. Perform PTT Operation **3979-07-03-02, Telematics system SIM ID, Calibration.**
8. Let the vehicle wait for 30 minutes with the power turned on.

**NOTE:** Ensure that there is adequate cellular reception in the area where the vehicle is waiting.

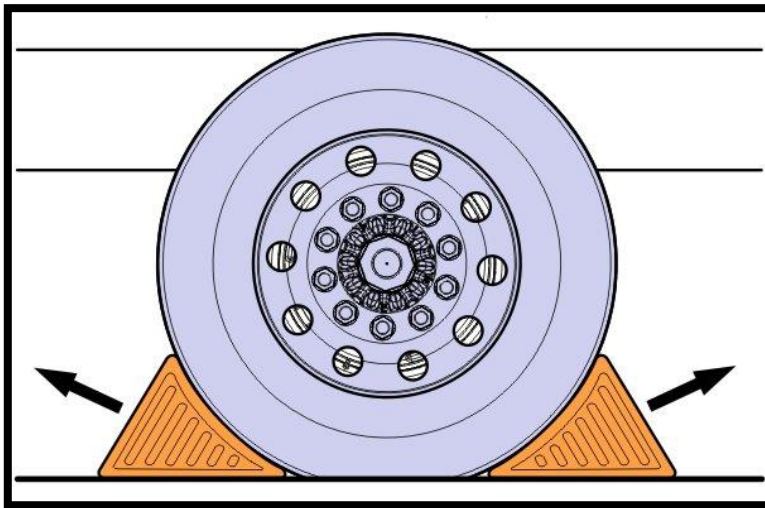
11. Disconnect the vehicle from Premium Tech Tool.
12. Remove the wheel chocks.
