## WRM0 – Update to Software Network VR28.11 (Stop Delivery)

**Model Year:** 2024

**Model Line:** Macan Electric (XAB)

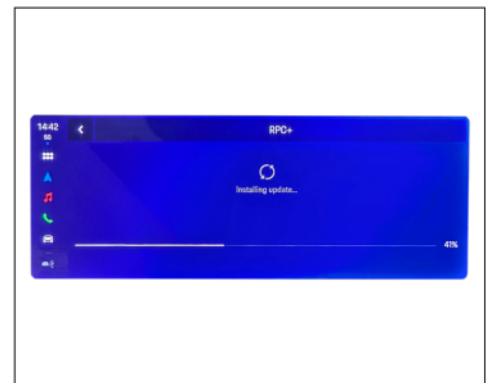
If WiFi coverage is insufficient, the connection between the PIWIS Tester and VCI can be interrupted (battery charge indicator inactive on the Tester display at the top right). The vehicle will nevertheless continue programming **independently**. In the meantime, no entry must be made on the PIWIS Tester, and the programming must not be restarted. In such a case, the progress of the update can still be followed inside the vehicle via the central display by activating the **"Messages"** tile.

Update progress on the central display

During the update process, all displays in the vehicle (instrument cluster, central display and passenger display) are occasionally switched off. Programming nevertheless continues. **The ignition sequence must not be changed.**
