March 2024
SF681 A-C
(Revised September 2024)

Subject: eCascadia Software Package Update

Models Affected: Specific model years 2023-2024 Freightliner eCascadia vehicles, manufactured May 16, 2022, through September 19, 2023.

SF681 A: Replacement of Direct Current Box (DCB) Modules & Coolant Plumbing Update

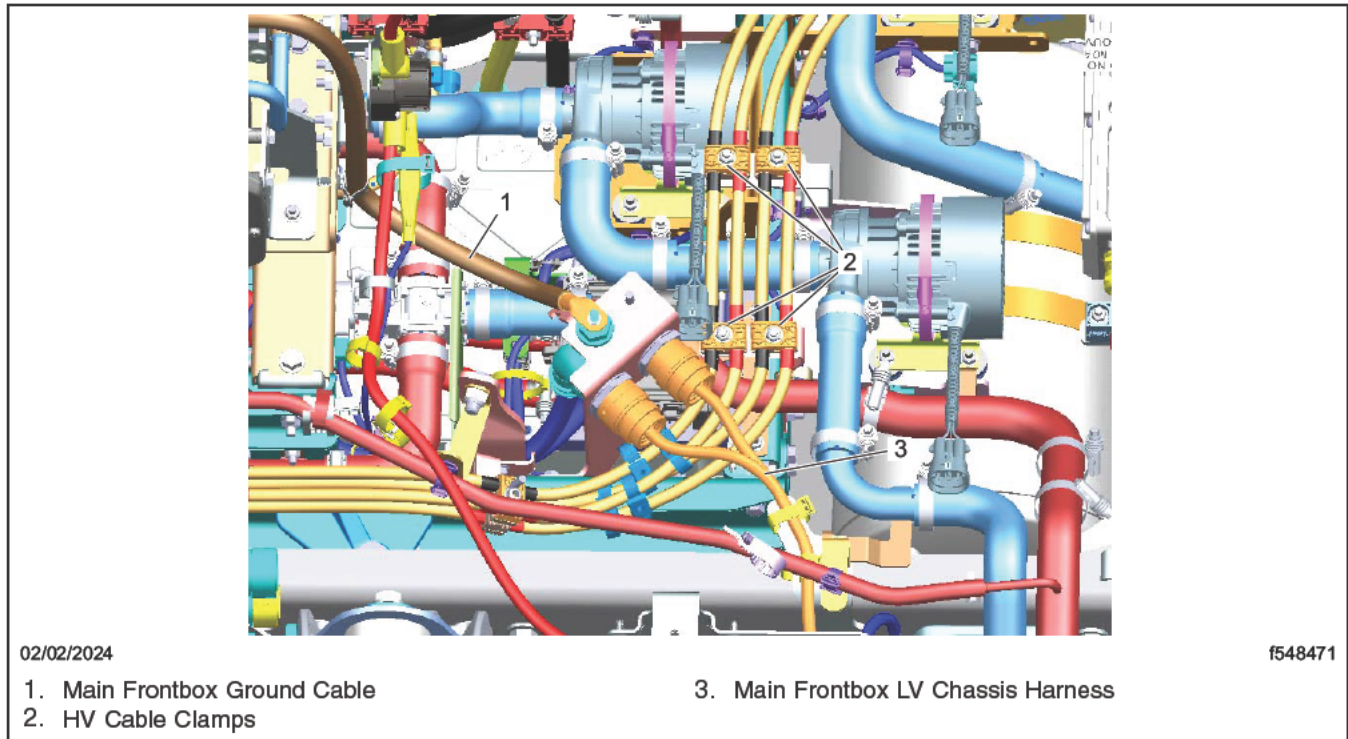
Fig. 6, Frontbox Wiring Harness Connections

20. Disconnect the frontbox ground cables See [Fig. 6](#), on the next page.
21. Disconnect the main low voltage harness from the frontbox. Disconnect the LV harness from the coolant pump. See [Fig. 6](#).
22. Remove the high voltage cable clamps in the hardline area, and gently move the high voltage cables out of the way. See [Fig. 6](#).

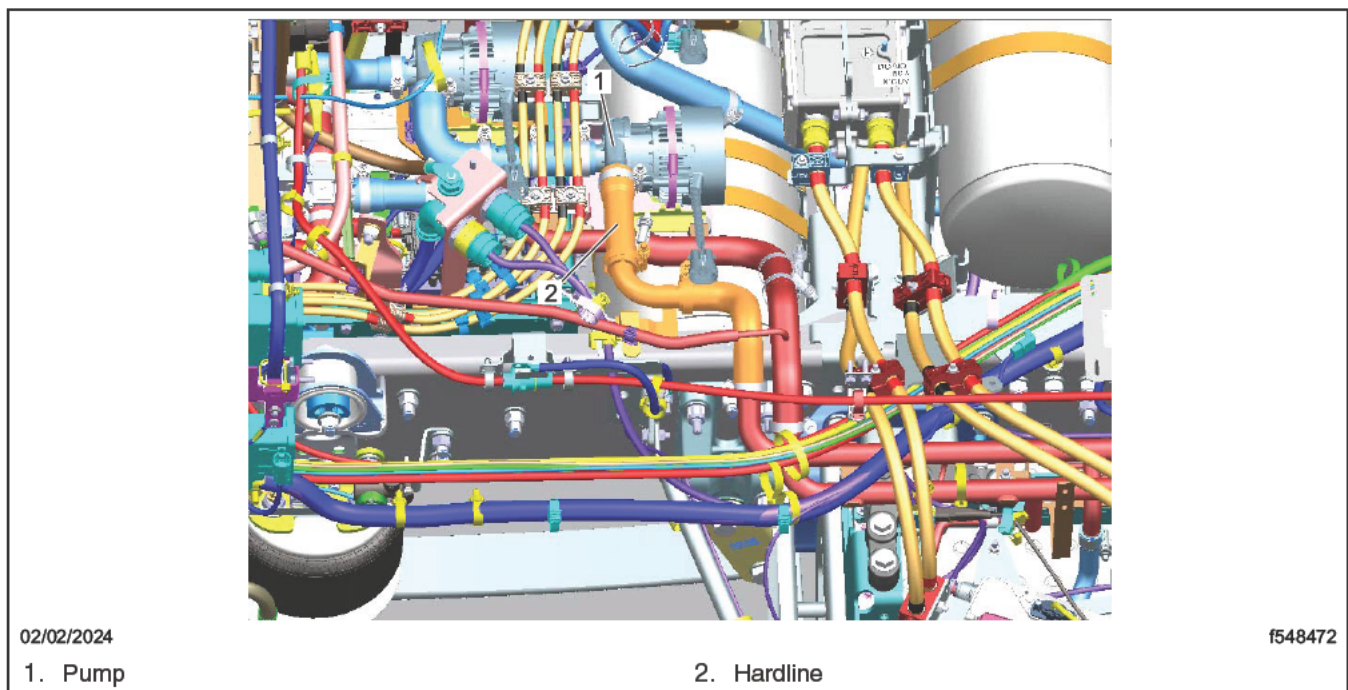
Fig. 7, Disconnecting Hardline from Pump

23. Remove the mounting fasteners that attach the hardline to the pump, then disconnect the hardline from the pump. See [Fig. 7](#).

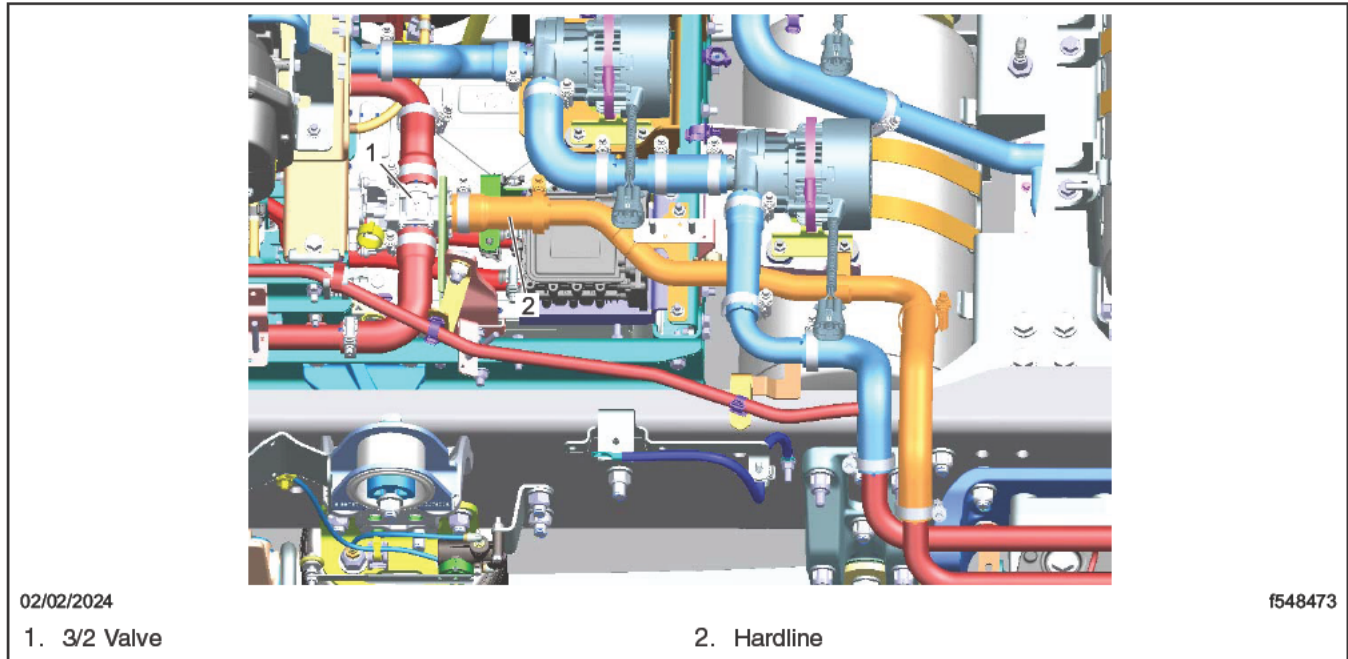
Fig. 8, Disconnecting Hardline from 3/2 Valve

24. Remove the mounting fasteners that attach the hardline to the 3/2 valve, then disconnect the hardline from the 3/2 valve. See [Fig. 8](#).

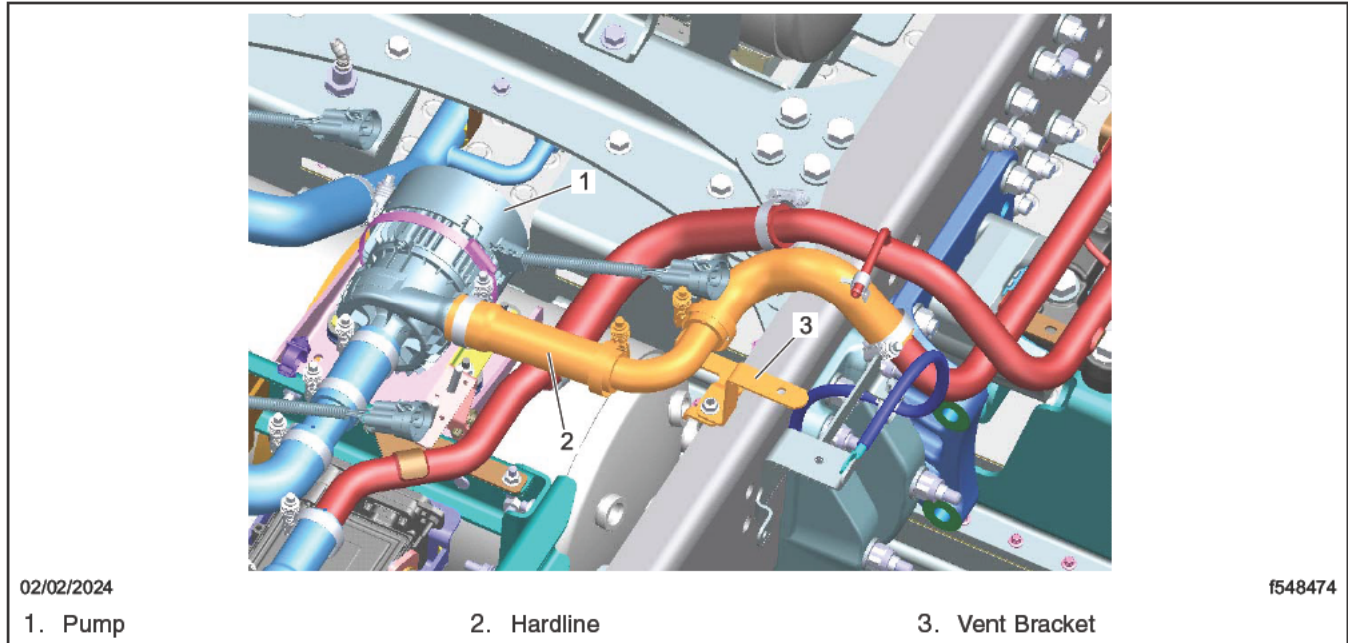
Fig. 9, Connecting Hardline to Pump

27. Install the vent bracket, and install the mounting fasteners. See [Fig. 9](#).

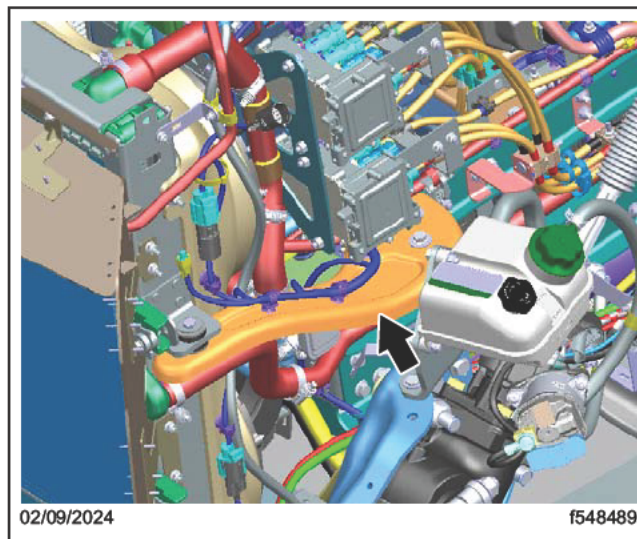
Fig. 11, Left-Hand Side Radiator Support

35. Remove the left-hand side radiator support and fasteners to get access to cut the vent line. See [Fig. 11](#).

39. Install the left-hand side radiator support and fasteners. Tighten the three rear fasteners 35 lbf·ft (48 N·m) and the front isolated fastener 59 lbf·ft (80 N·m).
40. Clean any spilled coolant from the top of the battery.
41. Install the ground cable support bracket.
42. Transfer the high voltage connector protective caps from the old DC boxes to the new DC boxes.
43. Install the DC boxes on the mounting bracket, and install the fasteners that attach the DC boxes to the mounting bracket. Tighten the fasteners 115 lbf·in (1300 N·cm). See [Fig. 3](#).

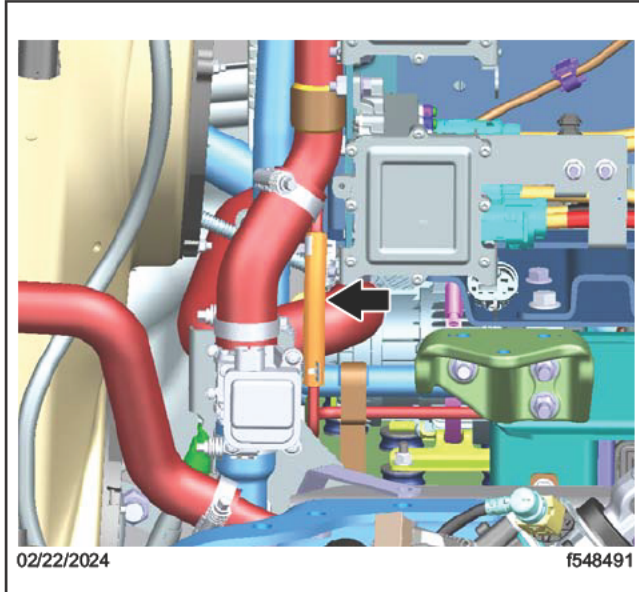
Fig. 12, Vent Line to Cut

36. Cut the front portion of the vent line hose, and install the Y-fitting. See [Fig. 12](#) and [Fig. 13](#).

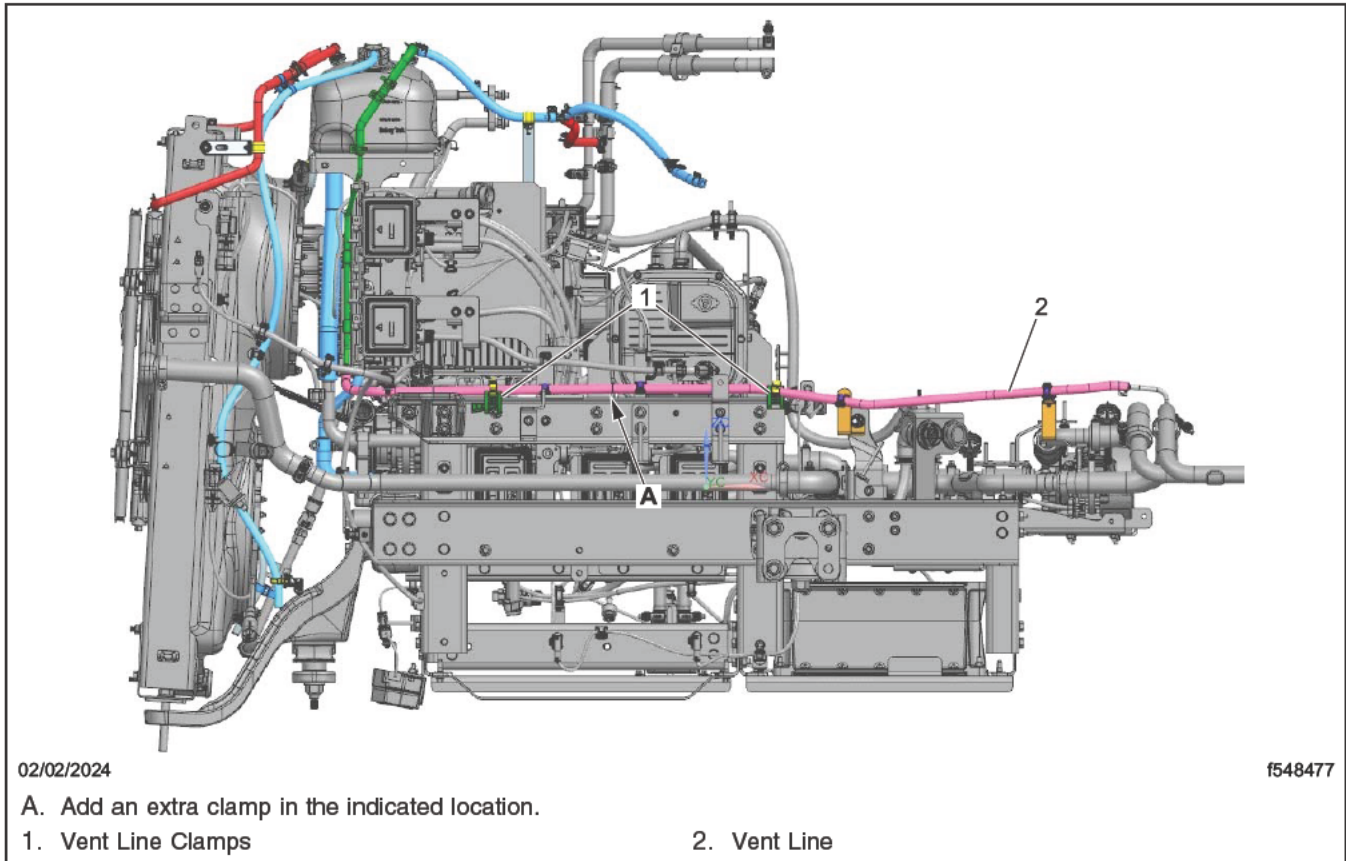
Fig. 14, Vent Line Routing

37. Install and route the vent line. See [Fig. 14](#).
38. Install the frame clamps, and secure the vent line with a cable tie. See [Fig. 14](#) and [Fig. 15](#).

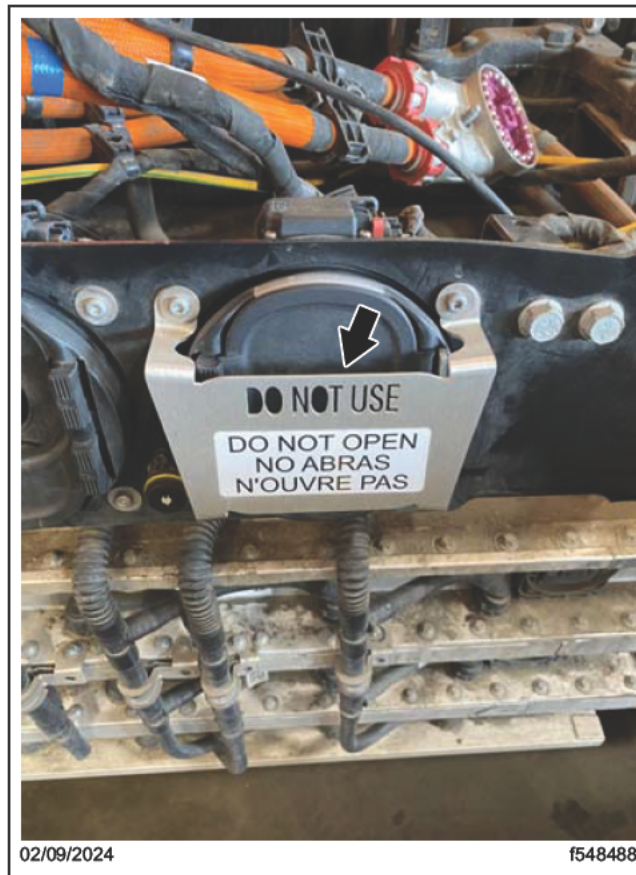
Fig. 16, Location of the Block Off Plate

50. To ensure the high voltage connectors are installed vertically during installation, use the tool (DSNEMG022008) to connect the three high voltage connectors.
51. Remove the alignment pin, and install the high voltage connector mounting fasteners.
52. Install the high voltage cable clamps, and tighten the fasteners.
53. Tighten the high voltage connector fasteners 14 lbf·ft (19 N·m).
54. Secure the low voltage harnesses and the ground cables with cable ties.
55. Install the side impact protection. For instructions, see **Section 31.03, Subject 100** of the *eCascadia Workshop Manual*.
56. Remove the block off plate of the dual port charger. See **Fig. 16**.

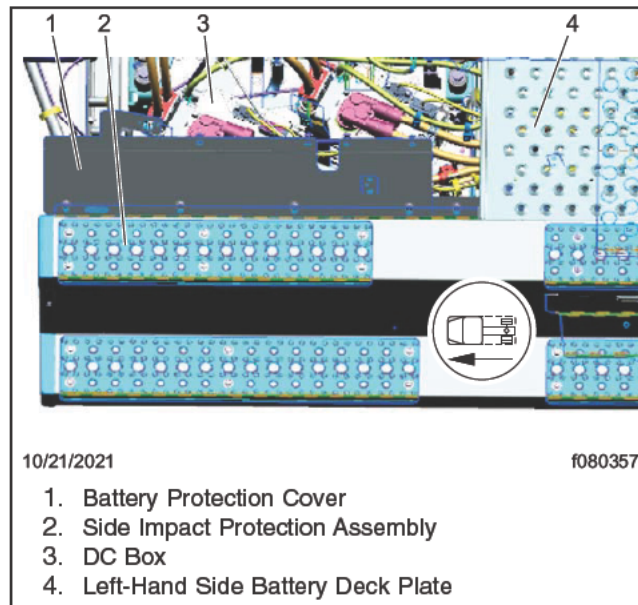
Fig. 17, Removal of Battery Protection Cover

3. Decommission the vehicle. For instructions, see **Section 08.08** of the *eCascadia Workshop Manual*.
4. Remove the left-hand side battery deck plate. See **Fig. 17**. For instructions, see **Section 31.05** of the *eCascadia Workshop Manual*.
5. Remove the left-hand side battery protection cover that is attached to the side impact protection assembly. See **Fig. 17**.

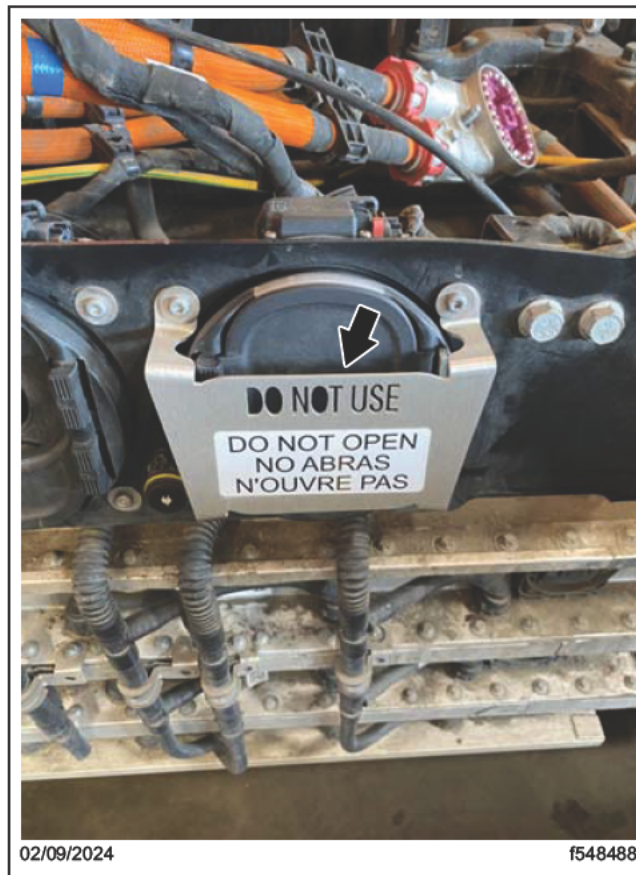
Fig. 20, Location of the Block Off Plate

27. To ensure the high voltage connectors are installed vertically during installation, use the tool (DSNEMG022008) to connect the three high voltage connectors.
28. Remove the alignment pin, and install the high voltage connector mounting fasteners.
29. Install the high voltage cable clamps, and tighten the fasteners.
30. Tighten the high voltage connector fasteners 14 lbf·ft (19 N·m).
31. Secure the low voltage harnesses and the ground cables with cable ties.
32. Install the side impact protection. For instructions, see **Section 31.03, Subject 100** of the *eCascadia Workshop Manual*.
33. Remove the block off plate of the dual port charger. See **Fig. 20**.

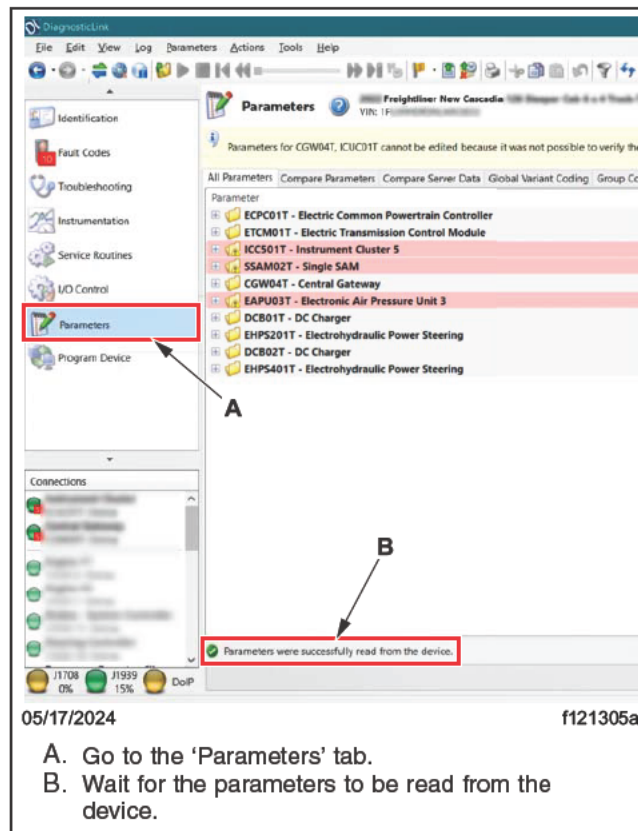
Fig. 21, Reading the ECU Parameters

5. Go to the 'Parameters' tab. See [Fig. 21](#).

DiagnosticLink will read the parameters of the connected electronic control units (ECUs). Wait for the message 'Parameters were successfully read from the device' to be displayed.

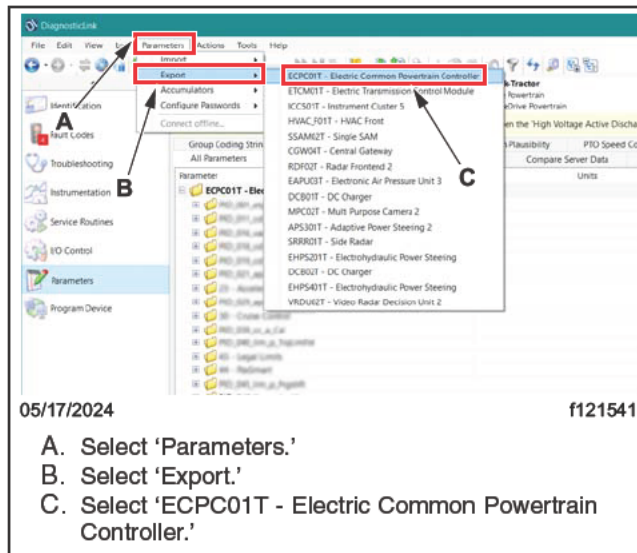
Fig. 22, Exporting the ECPC01T Parameters

6. Export the ECPC01T parameters to a folder on the local drive where it can be retrieved if necessary. See [Fig. 22](#).
 - 6.1 From the menu bar, select 'Parameters.'
 - 6.2 Select 'Export' from the dropdown menu.
 - 6.3 Go to 'ECPC01T - Electric Common Powertrain Controller.'
 - 6.4 Choose the location where the exported parameters are to be saved.

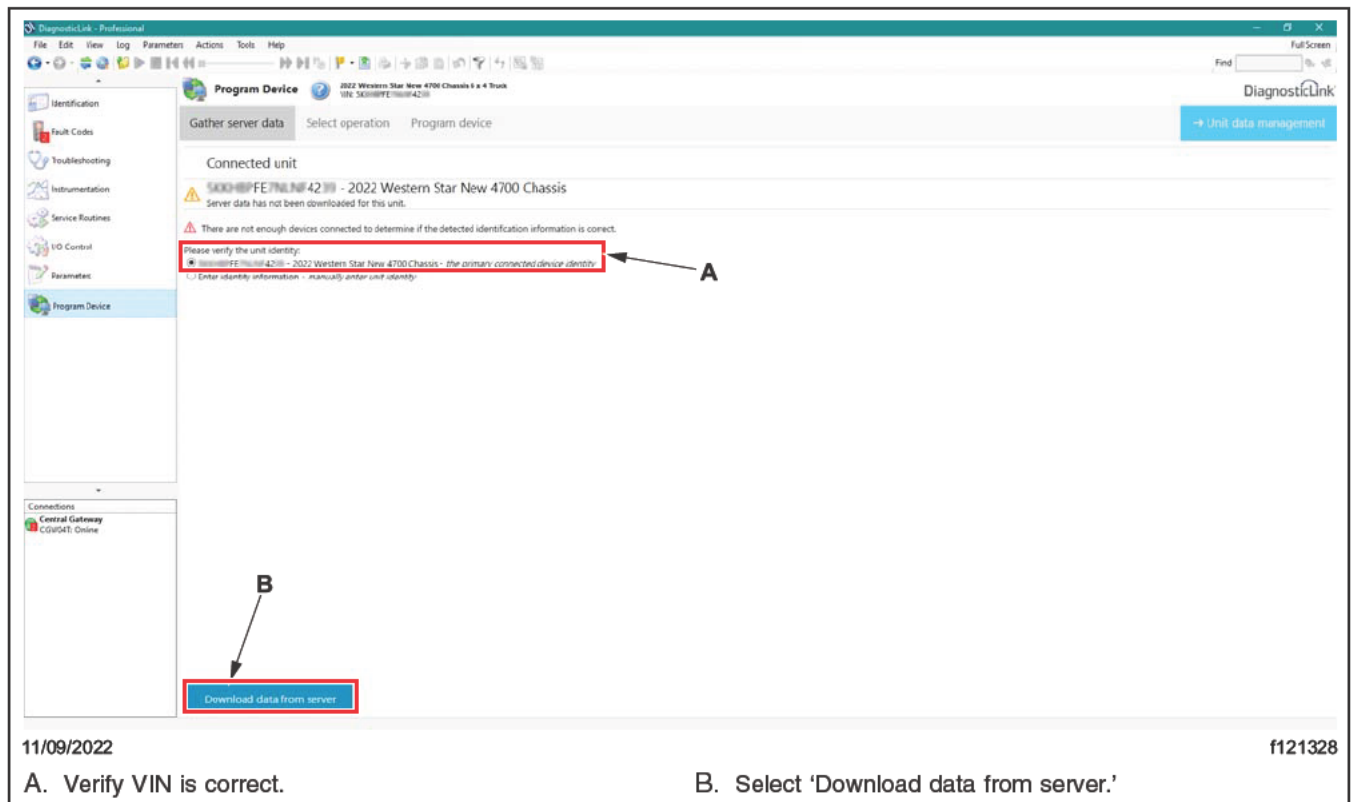
Fig. 23, Downloading Data from Server

- Go to the 'Program Device' tab, and make sure the vehicle identification number (VIN) that appears is correct. Select 'Download data from server.' See Fig. 23.

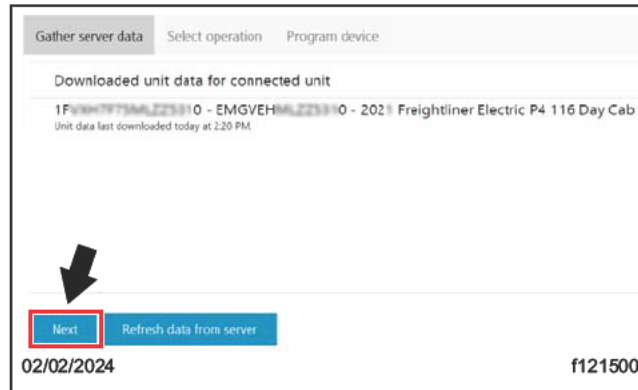
Fig. 24, Downloaded Data for Connected Unit

8. Once the data download is complete, select 'Next.' See [Fig. 24](#).
The devices with available software are listed.

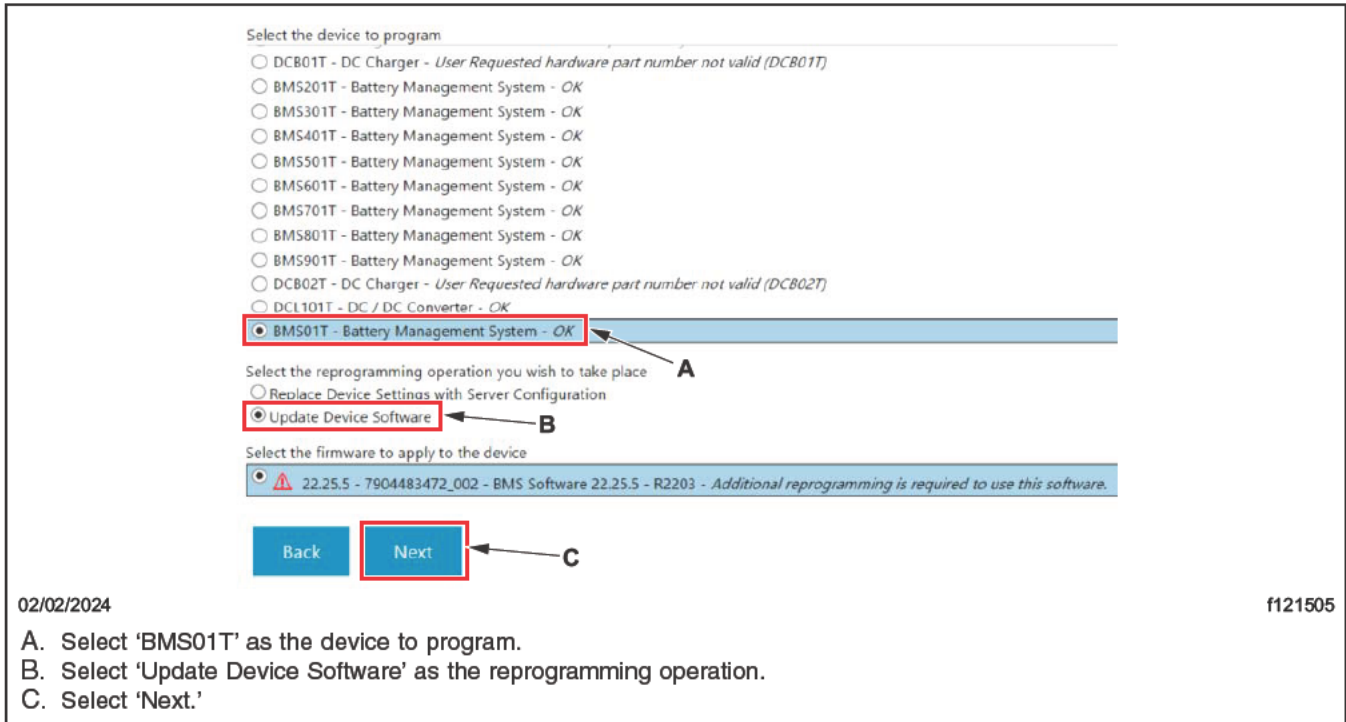
Fig. 28, Updating the BMS01T Device Software

13.1 Select 'BMS01T' as the device to program. See Fig. 28.

13.2 Select 'Update Device Software' as the reprogramming operation. See Fig. 28.

13.3 '22.25.5' is selected as the firmware to apply to the device. Select 'Next.' See Fig. 28.

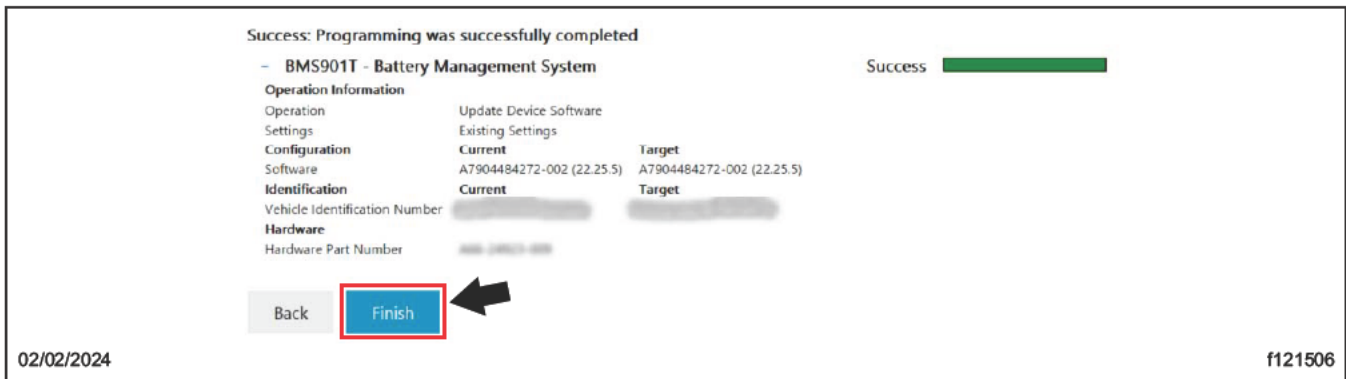
Fig. 29, Programming Successful for BMS901T

13.5 Once the programming is complete, a message is displayed: 'Programming was successfully completed.' Select 'Finish.' See Fig. 29.

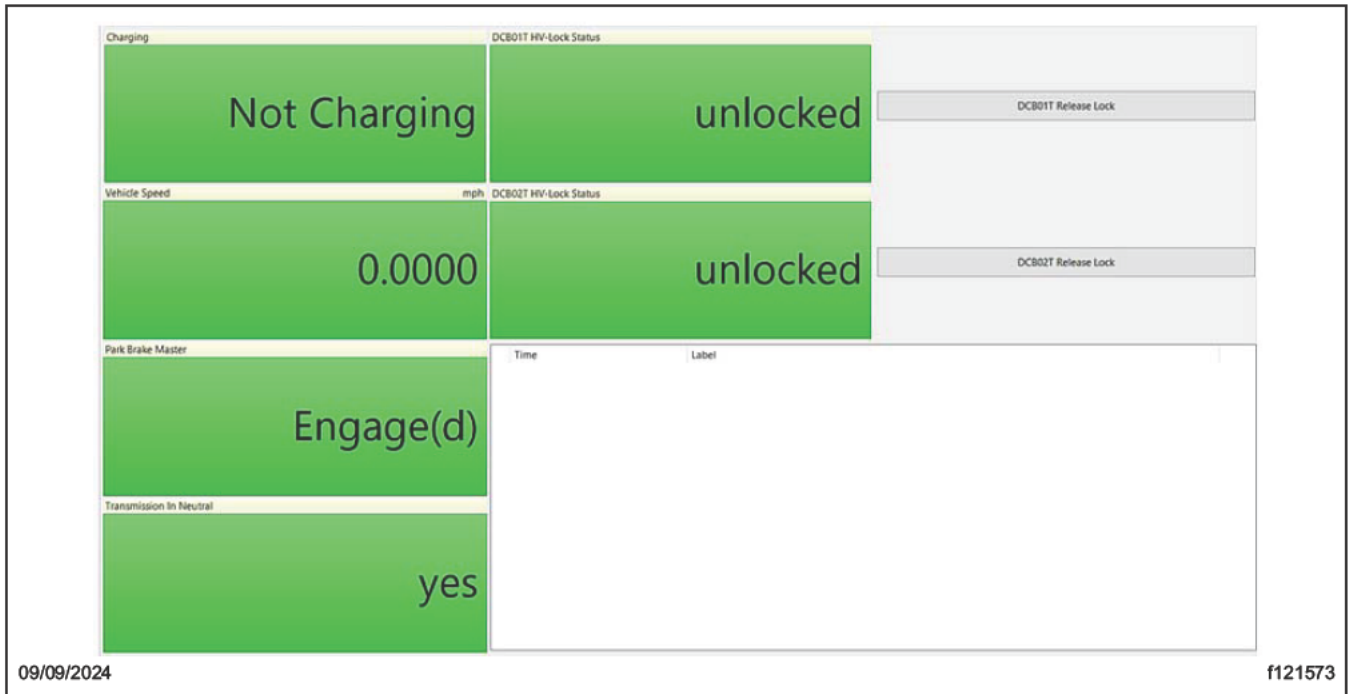
Fig. 38, DCB Lock Release Panel

19. Go to the 'Service Routines' tab, and launch the 'DCB Lock Release' panel.
 - 19.1 If the 'DCB HV-Lock Status' does not show as 'unlocked,' select the 'DCB Release Lock' button, and allow the procedure to complete. See [Fig. 38](#).

REVISION: Steps 19 & 20 have been added to ensure the DCB is unlocked.
