Technical Service Bulletin

"TELEMATICS MALFUNCTION" MESSAGE WITH DTC U3000:00-TCU OR U3000:04-TCU

Bulletin No.: 09-001/24

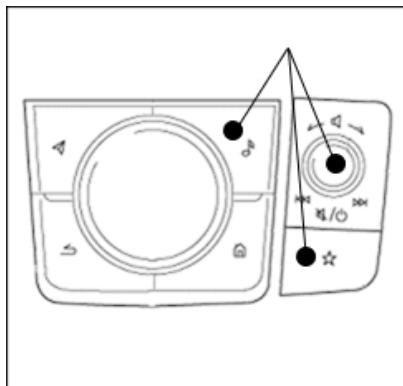
[MAZDA3, MX-30, CX-30, CX-50, CX-90, CX-70]

g. Press and hold the Volume knob, then press and hold the Entertainment and Favorites buttons at the same time for 3-5 seconds and the Factory/Service Inspection screen will appear.

q. Perform step g to move to the Factory/Service Inspection screen and select "Service Information".

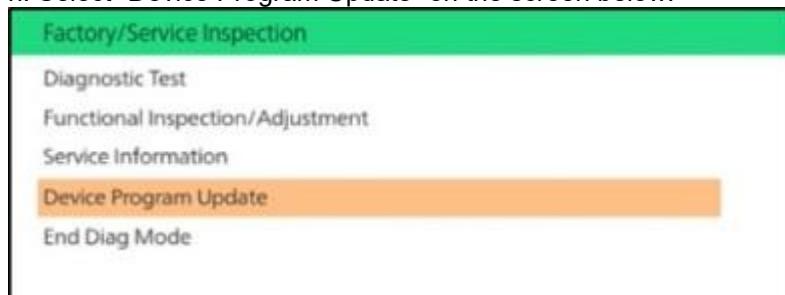
h. Select "Device Program Update" on the screen below.

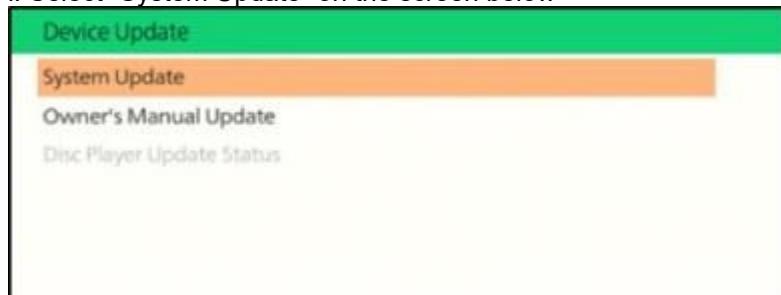
i. Select "System Update" on the screen below

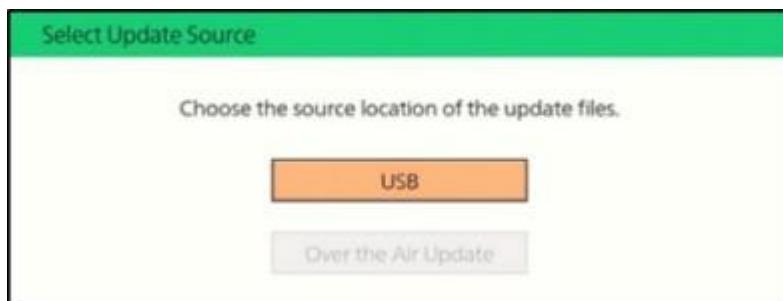
j. Select "USB" on the screen below to start checking for the update file.

NOTE: If "Update file(s) not found" message appears, the wrong file may be stored on the USB memory stick or the vehicle has already been updated.

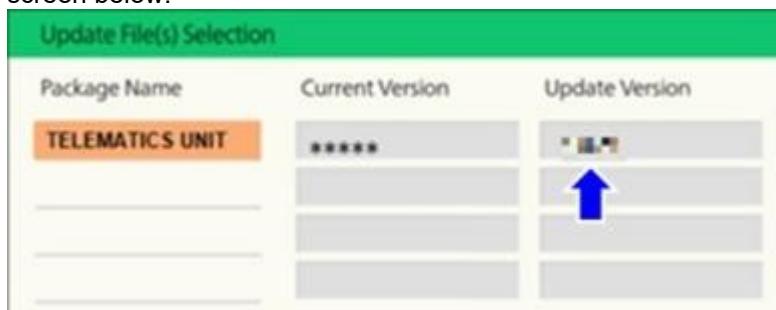
k. Confirm the correct software version is shown under "Update Version" and select "TELEMATICS UNIT" on the screen below.

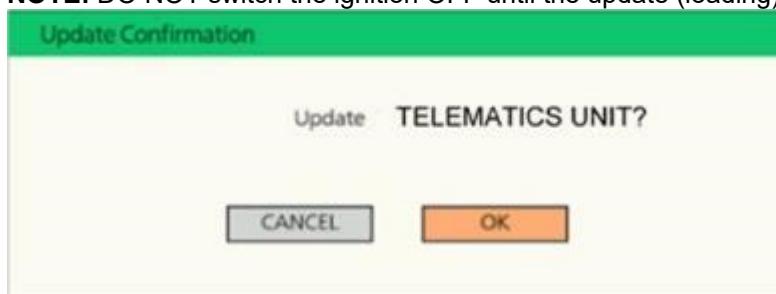
l. Select "OK" on the screen below and wait until the update (loading) is completed.

NOTE: DO NOT switch the ignition OFF until the update (loading) is completed.

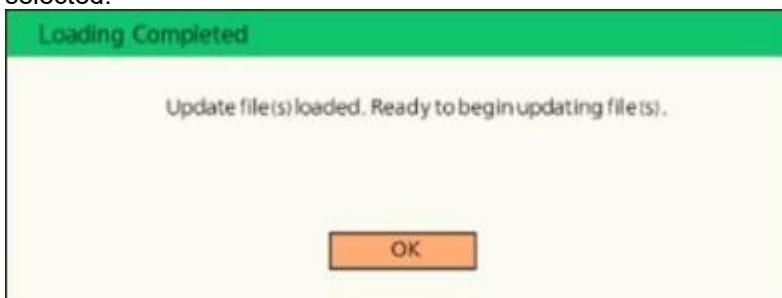
m. Select "OK" on the screen below or the data update will start automatically after 10 seconds if "OK" is not selected.

NOTE: After selecting "OK", the system will reboot and the display will turn black, followed by the screens below:

- Sending update file(s)
- Checking update file(s)
- Installing update file(s)
- Completed

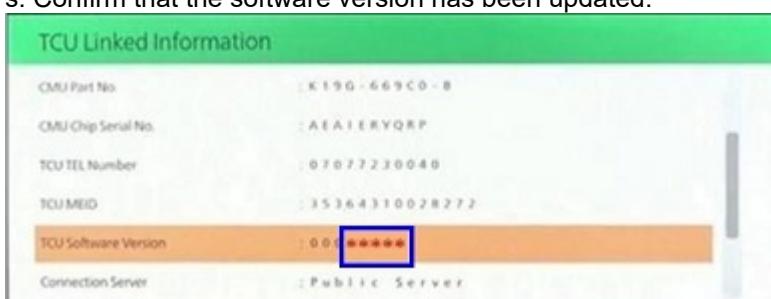
r. Select "TCU Linked Information", then scroll down to TCU Software Version.

s. Confirm that the software version has been updated.
