WRM0 – Update to Software Network VR28.11 (Stop Delivery)

Model Year: **2024**

Model Line: **Macan Electric (XAB)**

Concerns: **Software update (software version VR28.11)**

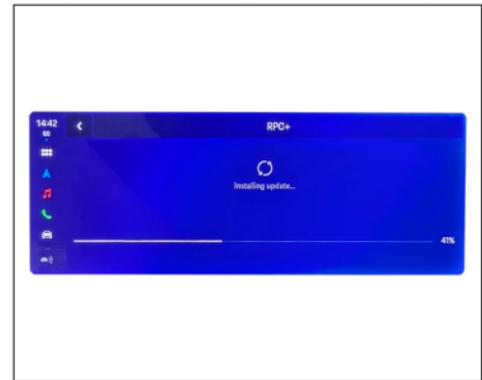
If WiFi coverage is insufficient, the connection between the PIWIS Tester and VCI can be interrupted (battery charge indicator inactive on the Tester display at the top right). The vehicle will nevertheless continue programming **independently**. In the meantime, no entry must be made on the PIWIS Tester, and the programming must not be restarted. In such a case, the progress of the update can still be followed inside the vehicle via the central display by activating the "**Messages**" tile.

Update progress on the central display

During the update process, all displays in the vehicle (instrument cluster, central display and passenger display) are occasionally switched off. Programming nevertheless continues. **The ignition sequence must not be changed.**
