01-24-05 - ID. Software (ID.S) Compatibility for Service Part Replacement

Condition

- The parts catalog (ETKA) advises to follow this technical bulletin for certain service parts.
- The usage of these service parts requires that an available “ID. Software” (ID.S) compound update has been completed.

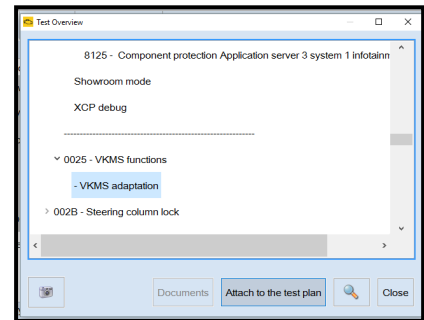
After selecting “Self Test,” use the search function and enter “VKMS” to aid in finding the test plan.

- Follow the on-screen prompts.
- Pay close attention to all steps outlined in the test plan and follow them exactly as described.
- Continue to Step 7.
