Release Date	05/30/2024	Technical Service Bulletin		
93N6 UPDATE

Audi
Software Update for Battery Modules Control Unit – (High-Voltage Battery Warranty)

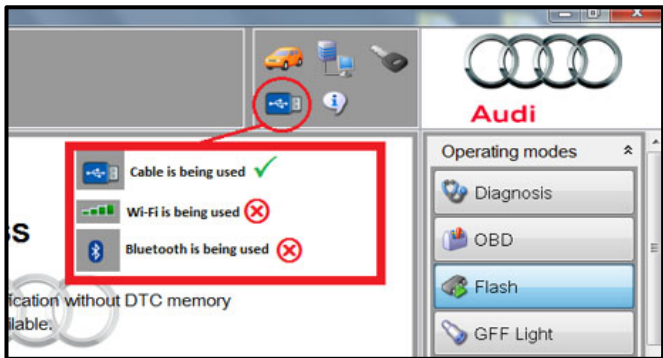
- Connect the VAS6150X/VAS6160X Diagnostic Tester to the vehicle.
- Start the ODIS program.
- Confirm that scan tool is communicating with the diagnostic head by USB cable.
 - If the Bluetooth or WiFi symbol is shown, then disconnect the diagnostic head from the vehicle and reconnect the USB cable to the diagnostic head and then reattach to the vehicle.

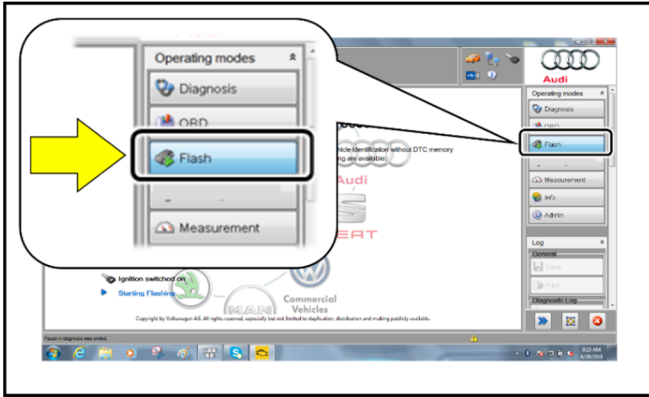
- From the home screen of the scan tool highlight “Flash” <1>.
- Follow the on-screen prompts.

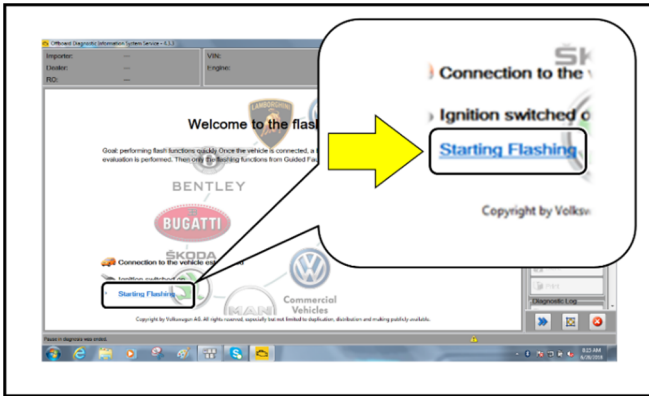
- Select “Starting Flashing” and follow the on-screen prompts.

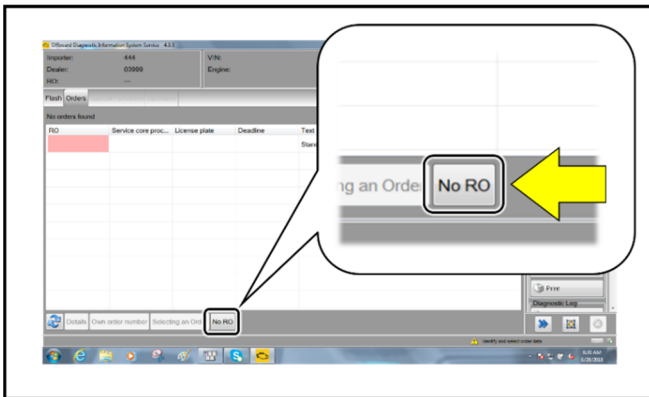
- Select “No RO”.

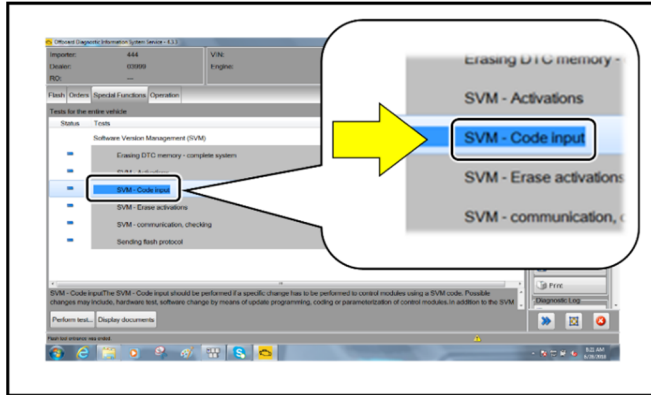
- Highlight “SVM – Code Input”.

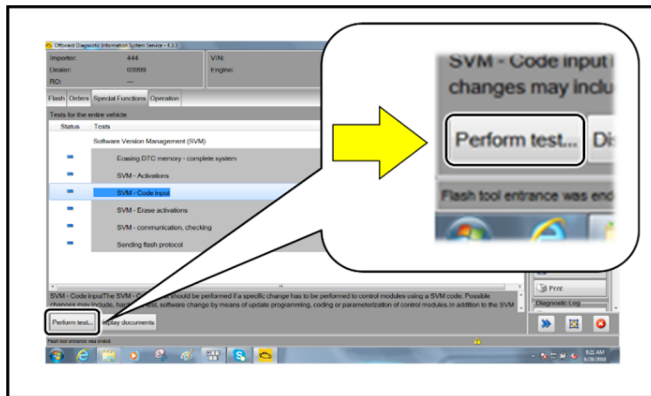
- Select “Perform test”.

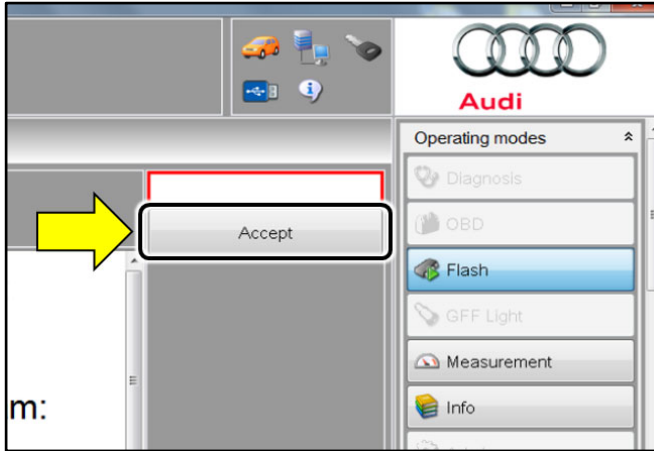
SVM code
93N6A268

- Enter the corrective action code (SVM code) as listed above.
- Select "Accept" <arrow>.
- Follow the on-screen prompts.

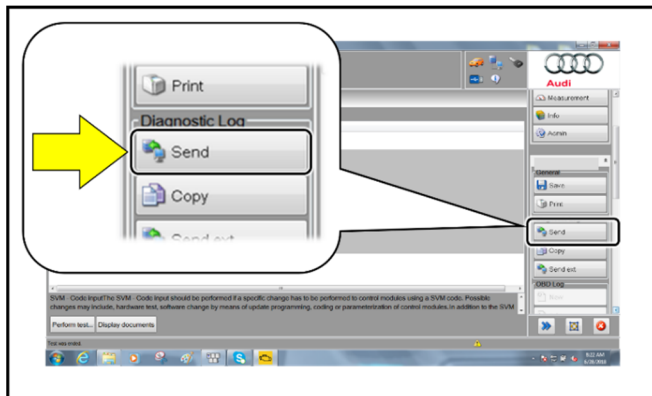
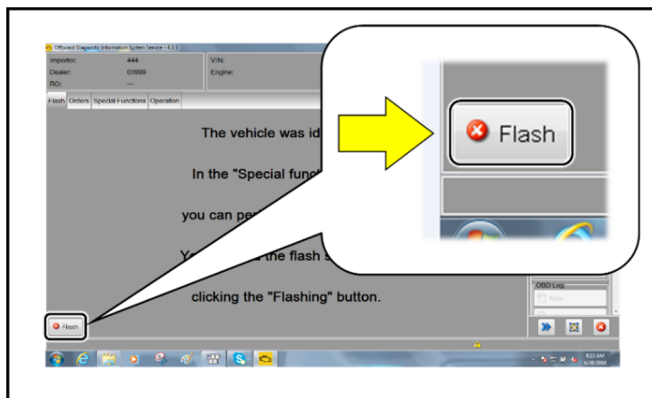
- After receiving confirmation that the flash completed successfully, select “Send” <arrow> to send the diagnostic protocol online.
- Follow the on-screen prompts.
- Click “Flash” <arrow> to exit the flash session.
- Various event memory entries may be generated after the flashing procedure on some vehicles. Put the vehicle in a corresponding bus sleep mode after performing the update in order to clear the faults.
- To put the vehicle in bus sleep mode, disconnect the diagnostic tester, remove the key from the vehicle and lock the vehicle with the remote for 6 minutes.
