Service Bulletin

Bulletin No.: 24-NA-203

Subject: Steering Wheel Oscillation in Super Cruise Mode

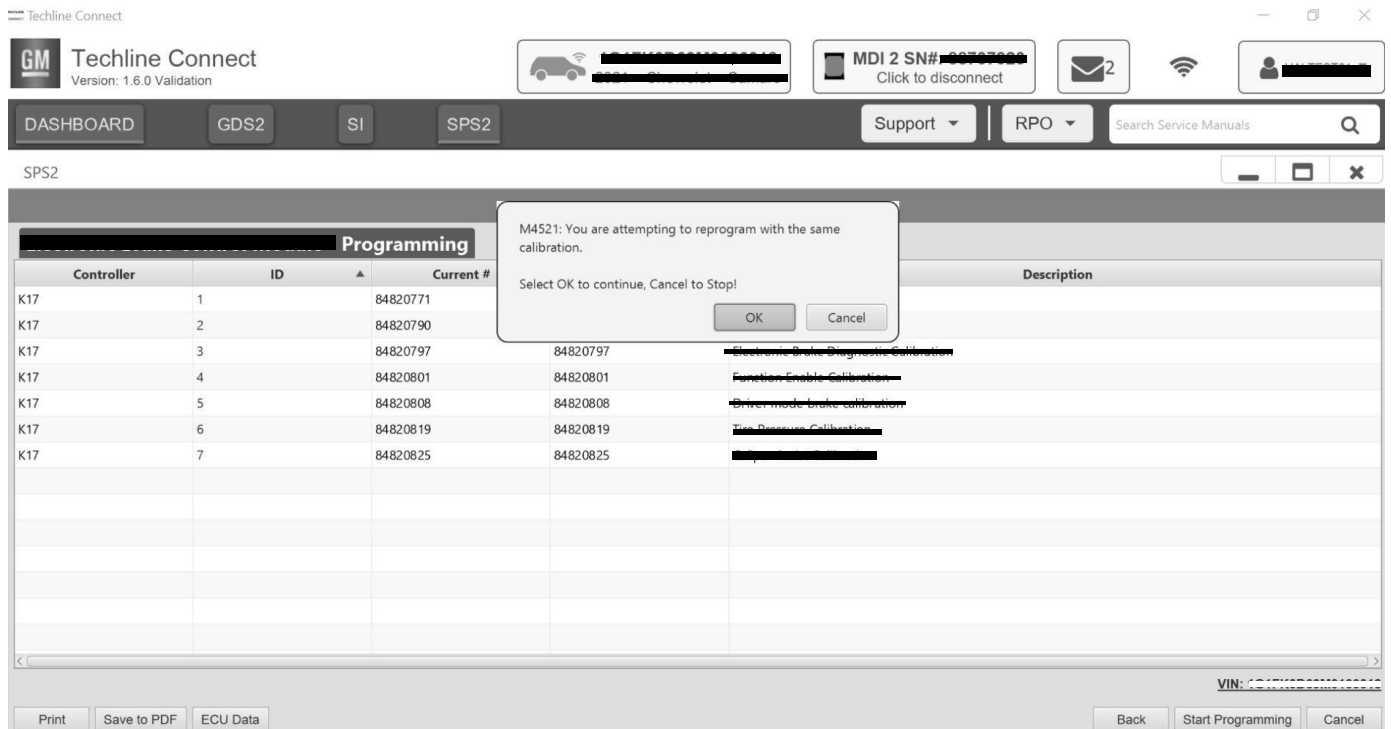
5644477

Important: Techline Connect screen shown above.

Important: If the same calibration/software warning is noted on the TLC Summary screen, select OK and follow screen instructions. After a successful programming event, the WCC is located in the Service Programming System dialogue box of the SPS Summary screen. Record the WCC on the job card. No further action is required. Refer to the Warranty Information section of this bulletin.

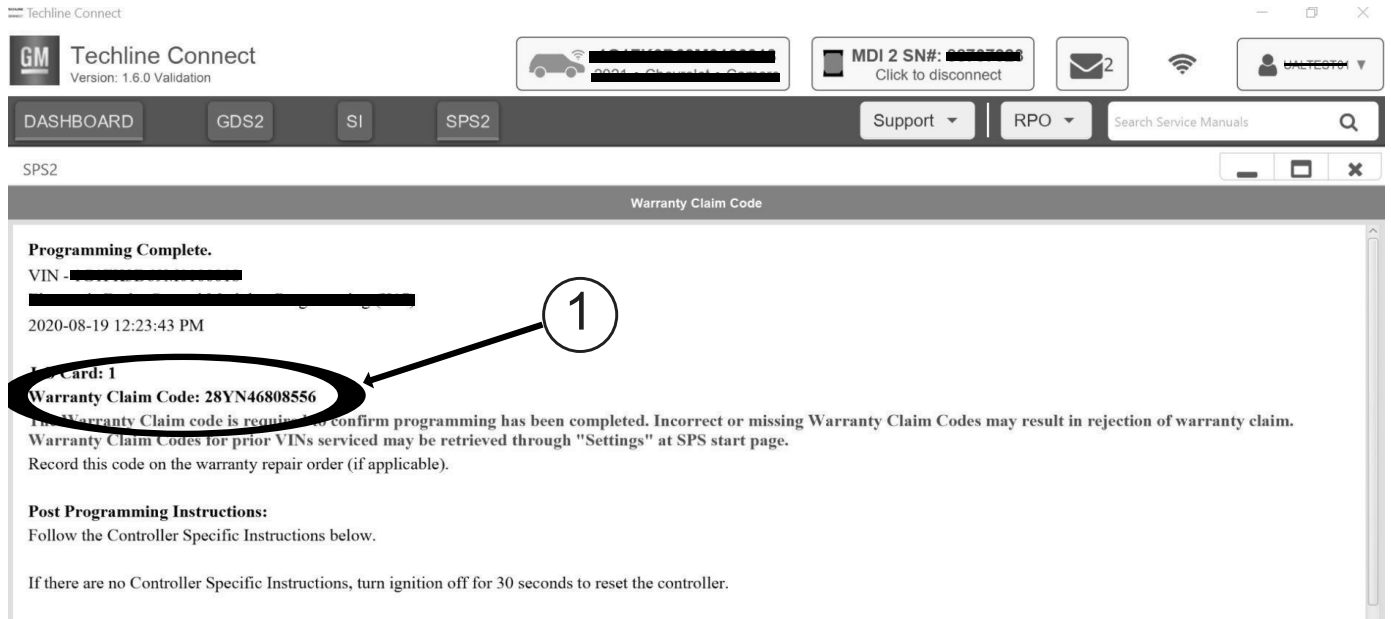
5644478

1. Reprogram both Image Processing Modules One and Two. Refer to *K124 Image Processing Module: Programming and Setup*.

Note: The screenshot above is an example of module programming and may not be indicative of the specific module that is being programmed. Module selection and VIN information have been blacked out.
