GROUP	MODEL
ELE	2024MY EV9 (MV)
NUMBER	DATE
326 (Rev 2, 10/25/2024)	January 2024

## TECHNICAL SERVICE BULLETIN

### SERVICE ACTION: POWER SEAT MODULE OPERATION LOGIC IMPROVEMENT (SA557)

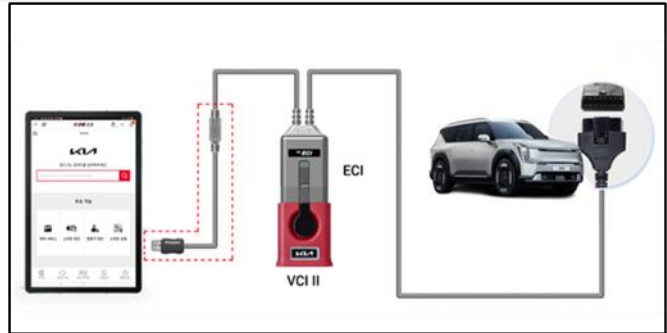
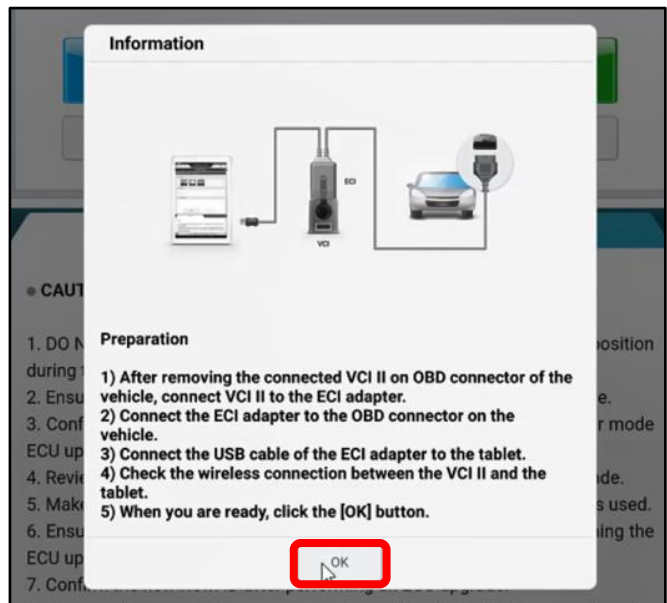
- 1a. Connect the ECI DLC connector to the OBD-II connector, located under the driver’s side of the instrument panel.
- 1b. Connect the ECI USB C connector to the KDS tablet.
- 1c. Connect the VCI II to the ECI OBD-II connector
- 2. Select ‘OK’.

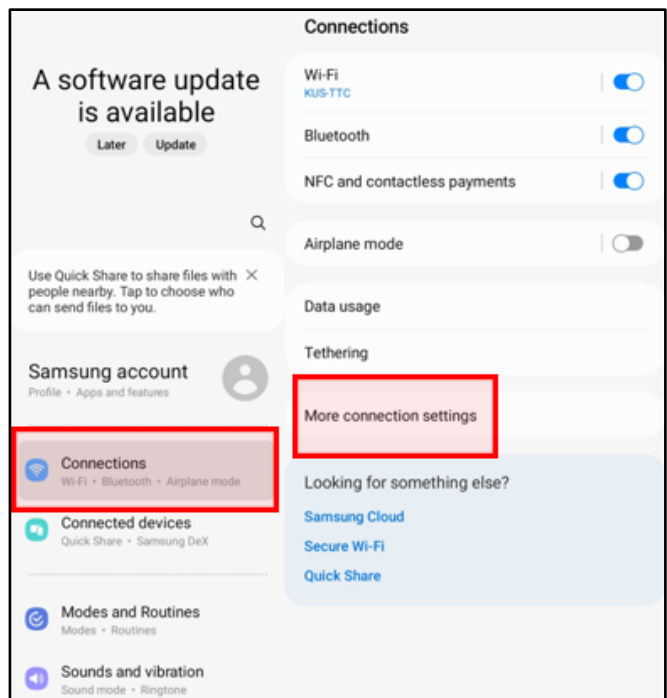
- 3a. Select ‘Settings’ on the KDS tablet.
- 3b. Select ‘Connections’.
- 3c. Select ‘More connection settings’.

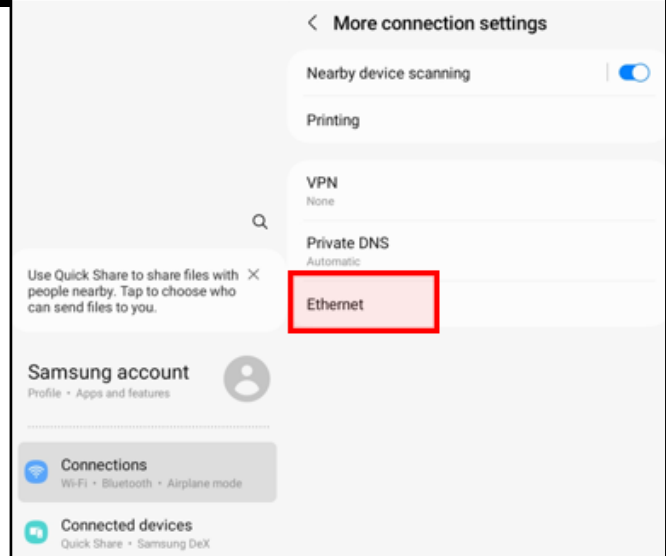
4. Select 'Ethernet'.

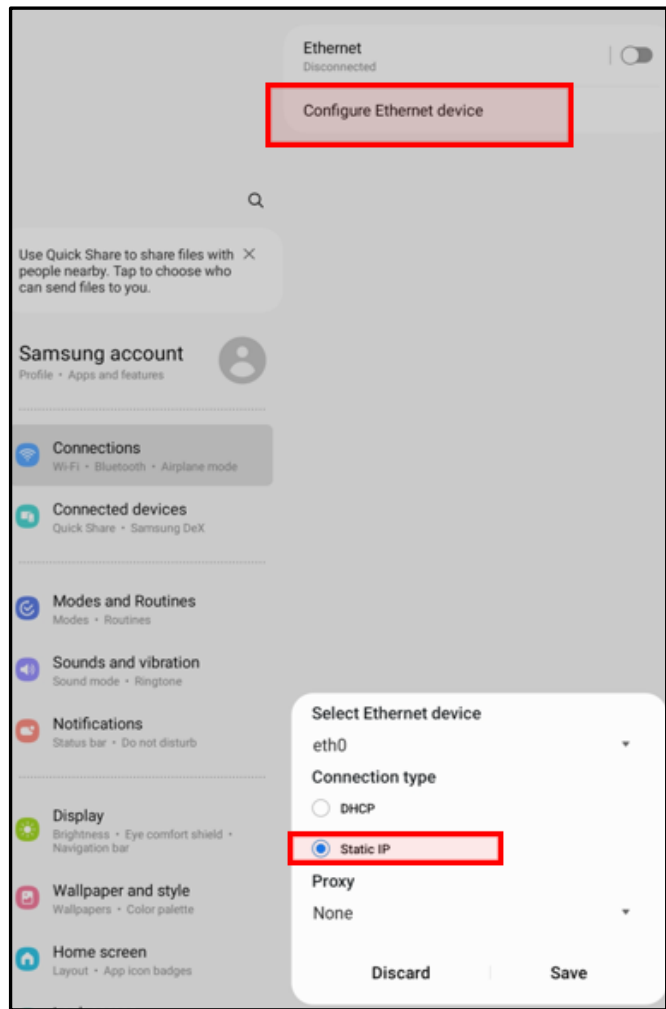
5. Select 'Configure Ethernet device'.

6. Select 'Static IP'.

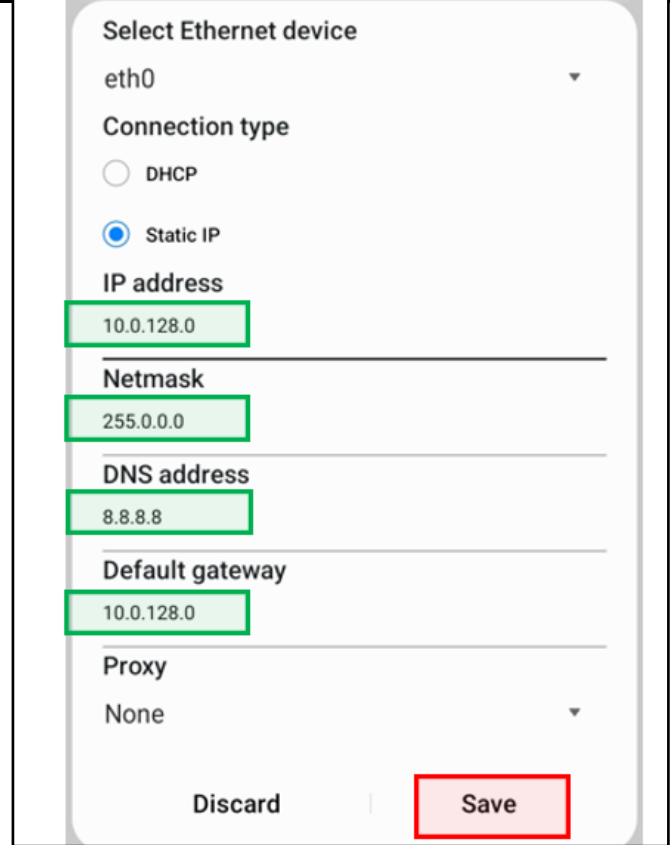
- 7a. Input 10.0.128.0 under 'IP address'.
- 7b. Input 255.0.0.0 under 'Netmask'.
- 7c. Input 8.8.8.8 under 'DNS address'.
- 7d. Input 10.0.128.0 under 'Default gateway'.
- 8. Select 'Save'.

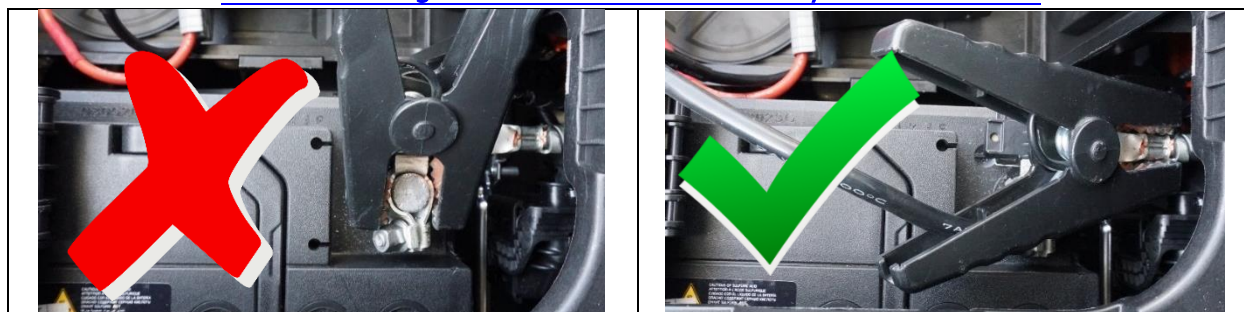
Connect the negative (-) terminal to the battery as shown below.

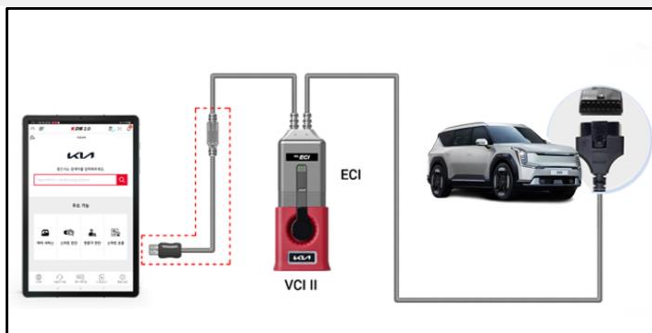
- 1a. Connect the ECI DLC connector to the OBD-II connector, located under the driver's side of the instrument panel.
- 1b. Connect the ECI USB C connector to the KDS tablet.
- 1c. Connect the VCI II to the ECI OBD-II connector

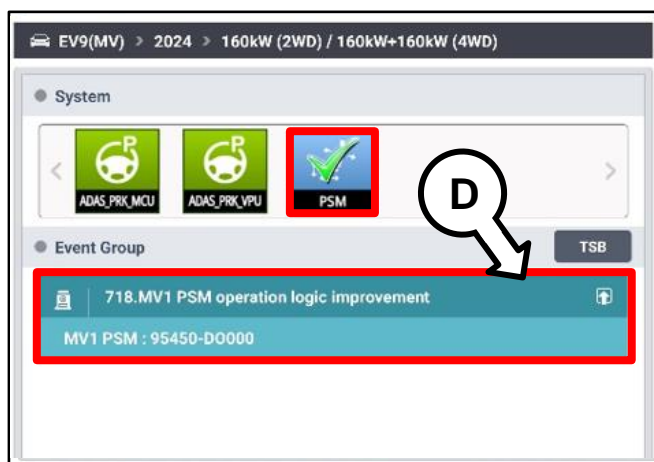
2. **UPGRADE EVENT:**

718.MV1 PSM operation logic improvement
