GROUP	MODEL
ELE	2024MY EV9 (MV)
NUMBER	DATE
327 (Rev 2, 10/25/2024)	June 2024

## TECHNICAL SERVICE BULLETIN

### SERVICE ACTION: RSPA LOGIC IMPROVEMENT (SA558)

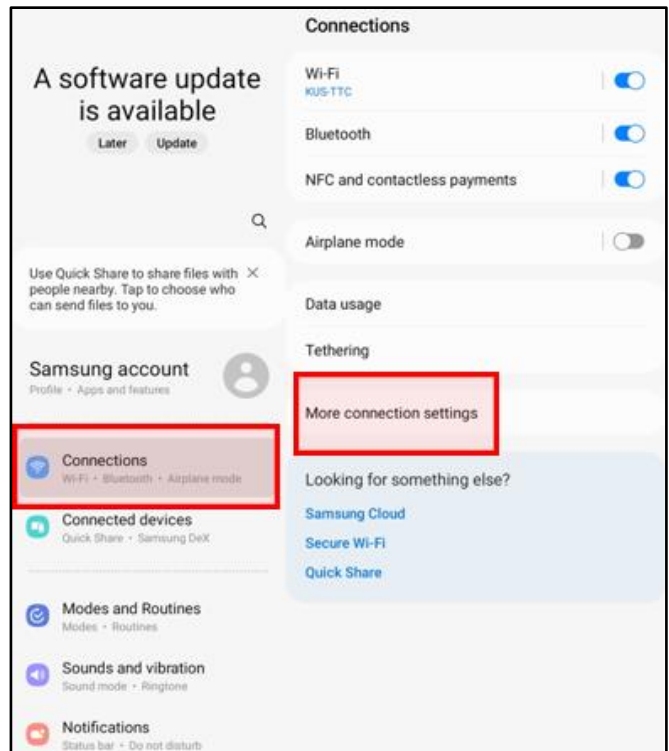
- 3a. Select 'Settings' on the KDS tablet.
- 3b. Select 'Connections'.
- 3c. Select 'More connection settings'.

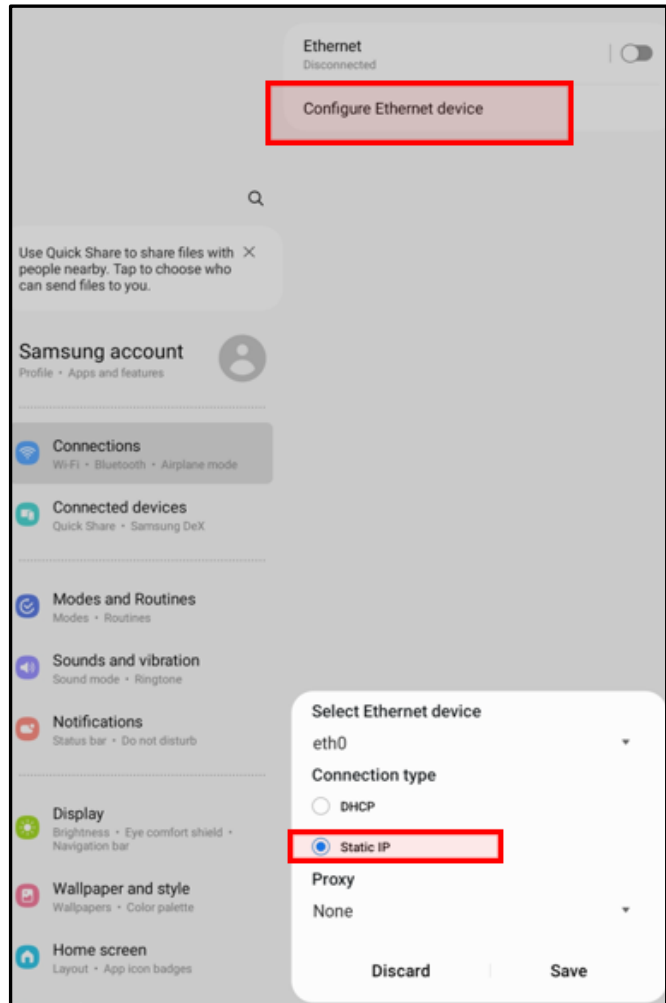
5. Select 'Configure Ethernet device'.

6. Select 'Static IP'.

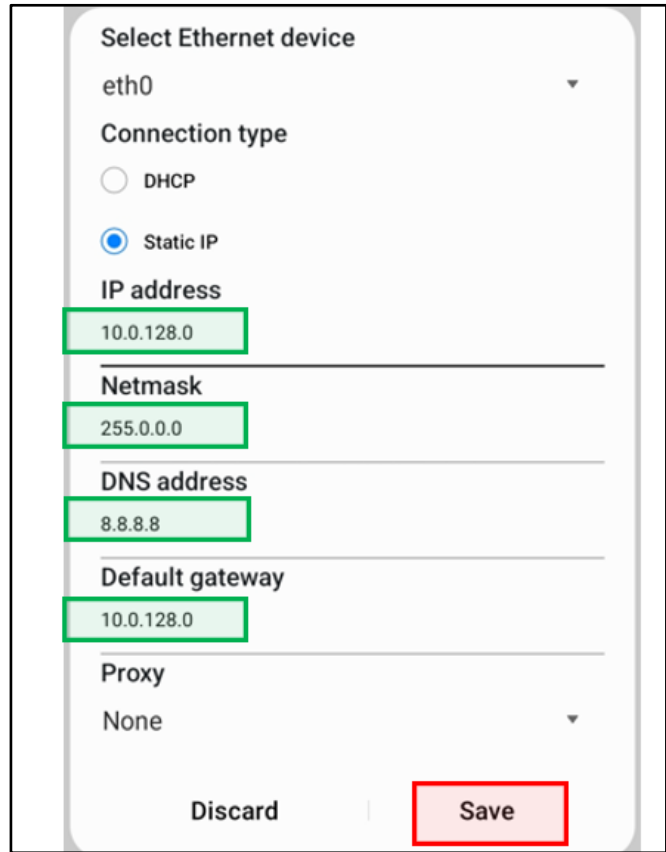
- 7a. Input 10.0.128.0 under 'IP address'.
- 7b. Input 255.0.0.0 under 'Netmask'.
- 7c. Input 8.8.8.8 under 'DNS address'.
- 7d. Input 10.0.128.0 under 'Default gateway'.
- 8. Select 'Save'.

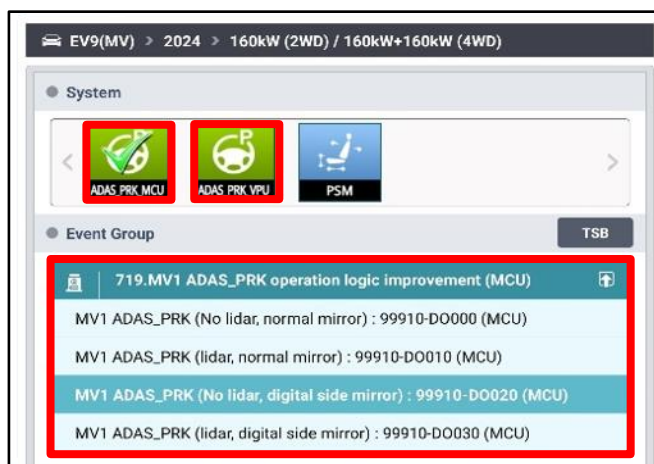
**UPGRADE BOTH EVENTS:**

- 719.MV1 ADAS\_PRK Operation Logic Improvement (MCU)
- 720.MV1 ADAS\_PRK Operation Logic Improvement (VPU)
