## Technical product information

<b>Topic</b>	HVAC intermittently not cooling Diagnostic Trouble Code(s) U1A2900 and / or U1A2A00 evident
<b>Market area</b>	Bentley: worldwide (2WBE),China 796 VW Import Comp. Ltd (Vico), Beijing (6796)
<b>Brand</b>	Bentley
<b>Transaction No.</b>	2075481/1
<b>Level</b>	EH
<b>Status</b>	Approval
<b>Release date</b>

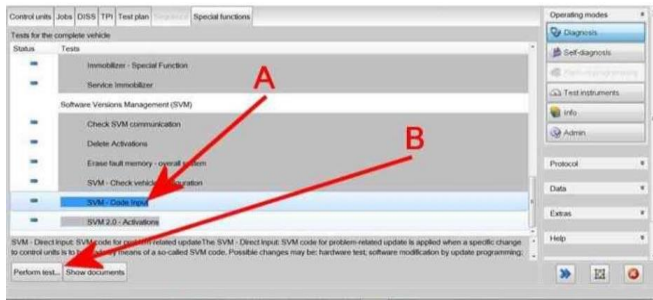
- Referring to Figure 1 - Within the Special functions tab select SVM - Code Input (A) then select Perform test (B)

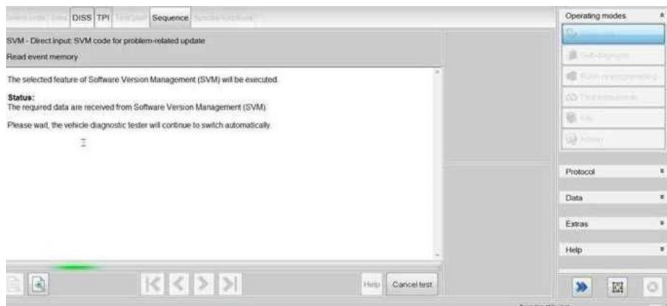
Figure 2

2) On the next screen enter the correct SVM code (Figure 2) depending on model as shown below

New Continental GT and New Continental GTC - 37008SW3075

New Flying Spur - 37108SW3075
