<b>Authored Date</b>	03/10/2024	
<b>Doc No.</b>	IATSB003368v2	
<b>Title</b>	Software Update for Fuel Plausibility - US MY24.1 only	
<b>Affected Vehicle(s)</b>	Grenadier	RF005988 - RF017814
This Technical Service Bulletin (TSB) should only apply to vehicles that demonstrate the described issue below.

### Reason for this document

#### Software Update – US Vehicles only.

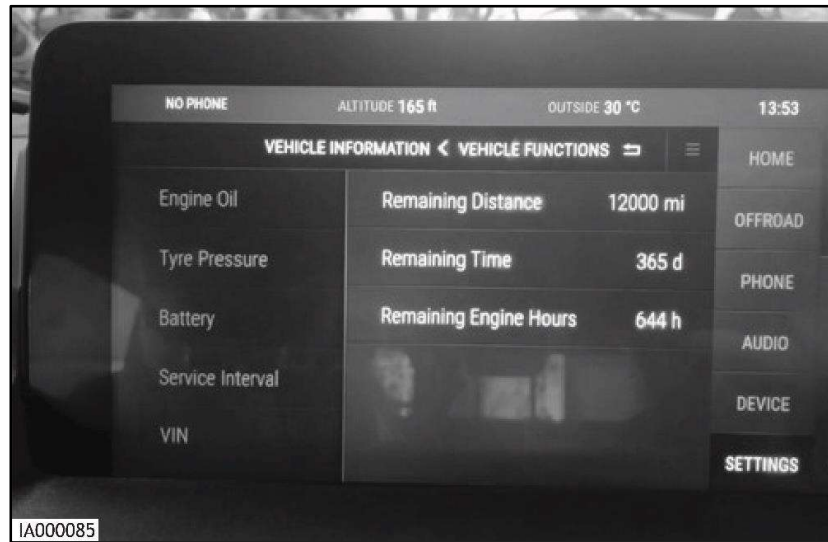
2.

Before the head unit is flashed, Write down the service interval information.

- Distance (Miles/Kilometres).
- Date.
- Engine running time.

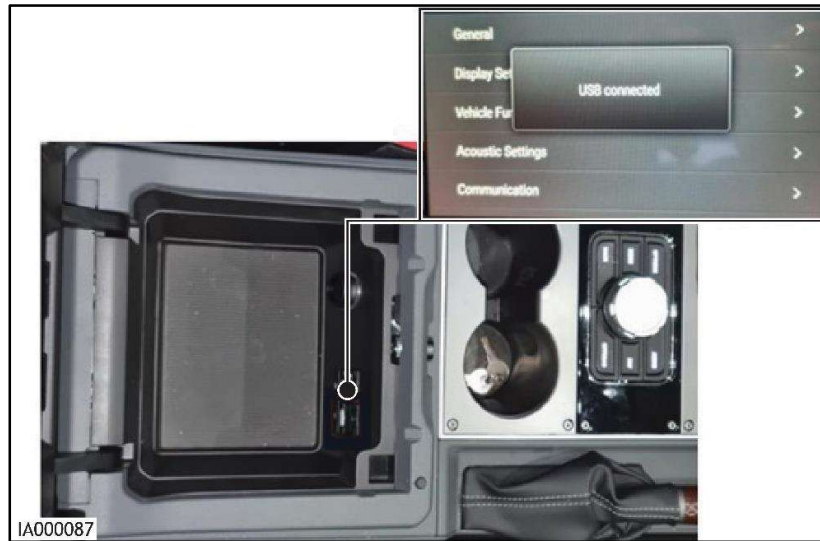
4.

Insert the USB stick into USB-A connection in the center console storage area with Head Unit (HU) 'update' software data from software pack SW-0000000773 (HU). A notification will display stating 'USB connected'

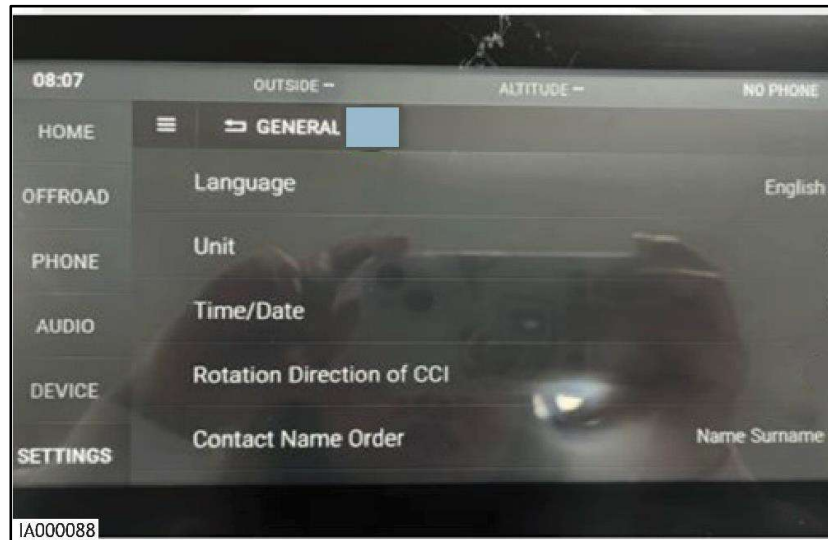
5.

- On the central display select '**SETTINGS – GENERAL**'.
- On the touchscreen, press and hold the area to the right of the '**GENERAL**' title for approximately 8 seconds. A screen will appear for PIN input.

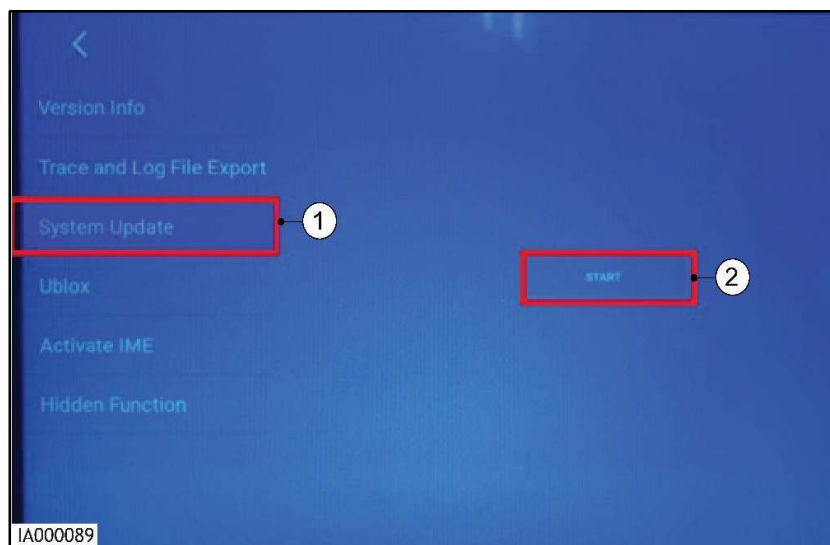
7.

- 1) Select '**System Update**'.
  - 2) Select '**Start**'.
-

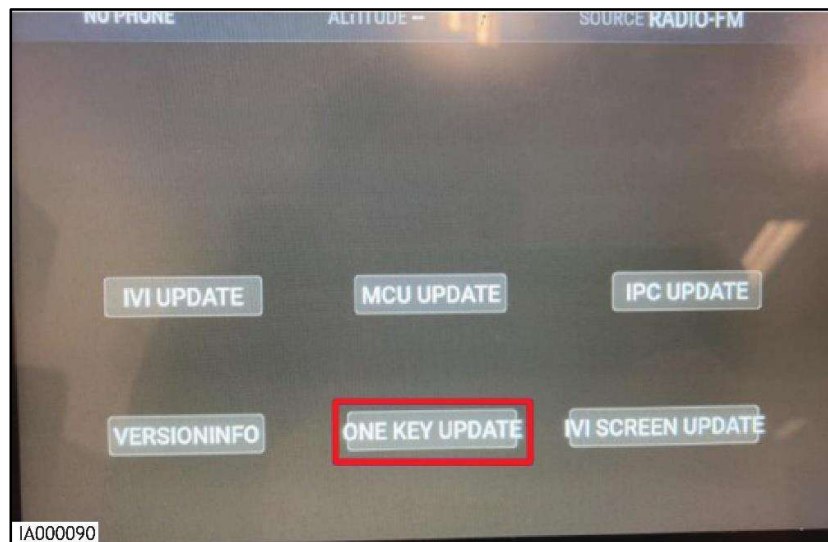
8.

- The software update takes approximately 40 minutes to complete.
- Place the vehicle on charge ensuring the vehicle battery charger can output up to 40 Amps.
- The technician is NOT required to be with the vehicle during this time.
- The software update no longer requires each application to be selected individually.
- Do not switch off the ignition or stop the process unless there is a notification is displayed in the central display.
- The ONE KEY UPDATE will flash all applications of the Head unit (i.e., IVI UPDATE / MCU UPDATE / IPC UPDATE / IVI SCREEN UPDATE)

Select '**ONE KEY UPDATE**'

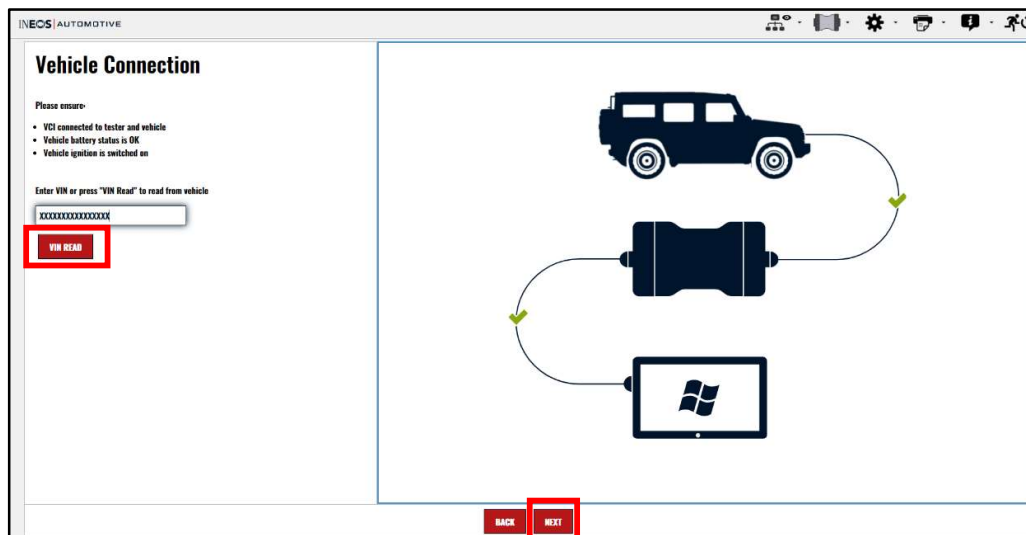
9.

Connect the vehicle to Grade-X using the VCI connected to the OBD port in the driver's footwell.

- 1) Select '**VIN READ**'.
- 2) Select '**NEXT**'.

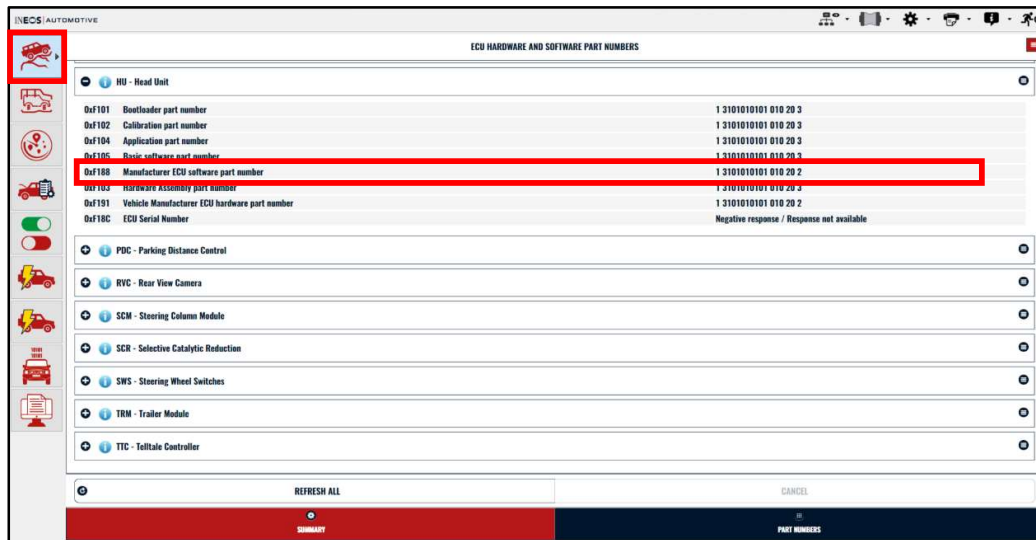
10.

- Open the vehicle summary page.
- Select '**PART NUMBERS**'.
- Select '**HU- Head Unit**'.
- Review the '**F188 - Manufacturers ECU software part number**' check and ensure SW-0000000773 (HU) is displayed as the part number.

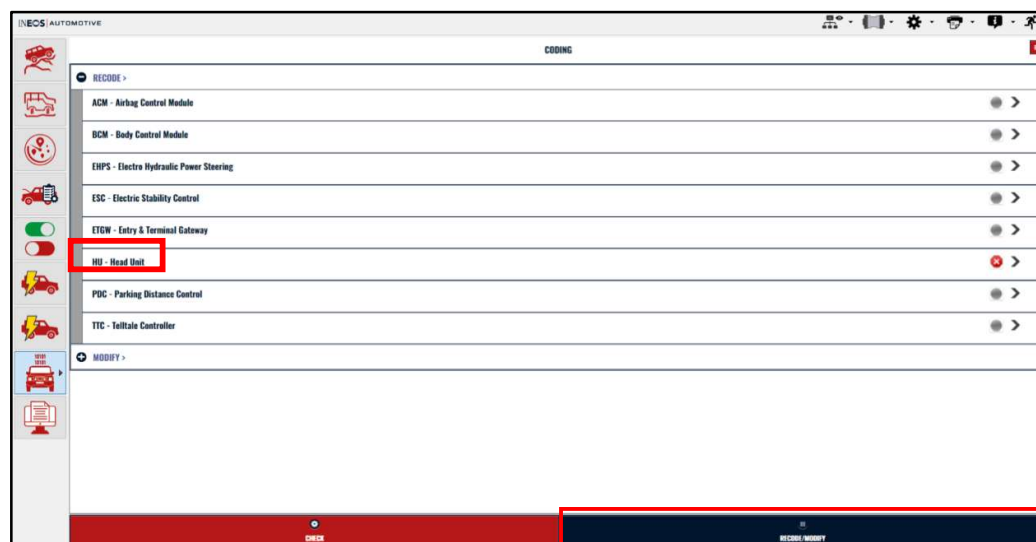
11.

- Select the coding tab
- Select '**HU - Head Unit**'.

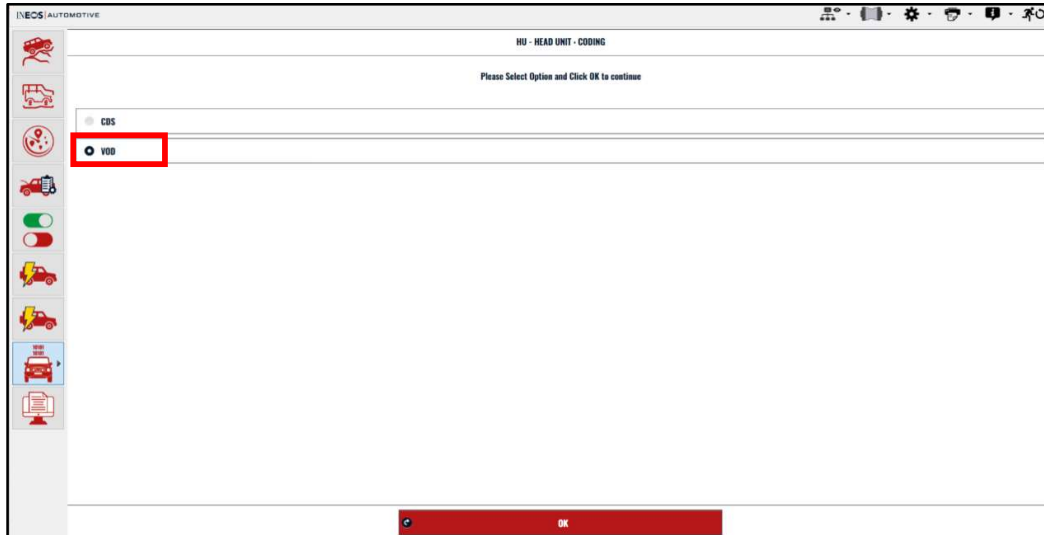
12.

- Select '**VOD**' and the '**OK**'.
  - Code the VOD to the Head Unit with Grade-X
  - Repeat this step for '**CDS**' on the Head Unit.
-

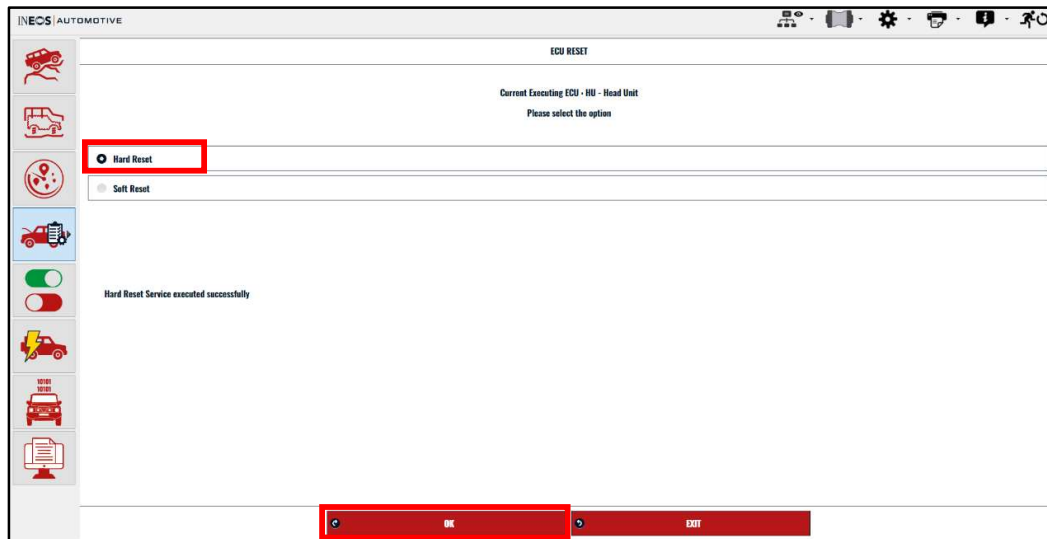
13.

The head unit will reboot. This will take a few minutes. Allow the head unit to complete the reboot process.

- Click 'Hard Reset'
- Click 'OK'

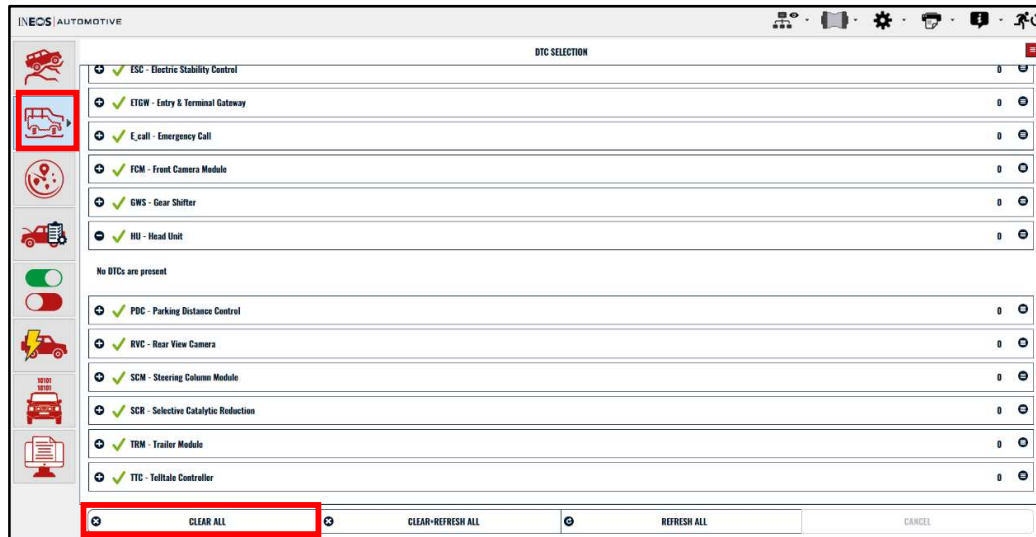
14.

- Select '**DTC Memory**' tab.
- Grade -X will start to read the ECU DTCs.
- Select '**CLEAR ALL**'.
- Grade - X will clear and read the vehicles DTCs.

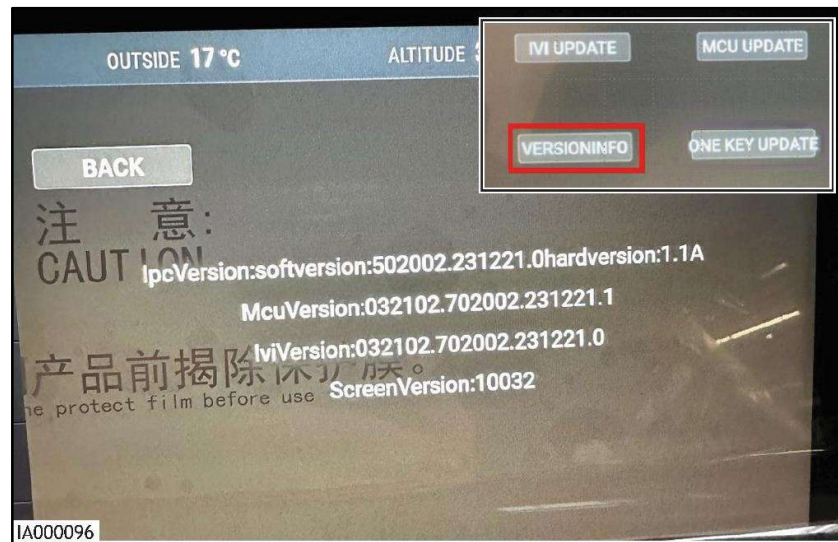
15.

Select '**VERSIONINFO**' and check that all 3 dates are exactly the same.

To identify the dates, the information is written in the below format (Image shown for illustration purposes)

IpcVersion:Softversion: XXXXXX.**YYMMDD**.0hardversion:1.1A

McuVersion: XXXXXX.XXXXXX.**YYMMDD**.X

IviVersion: XXXXXX.XXXXXX.**YYMMDD**.X

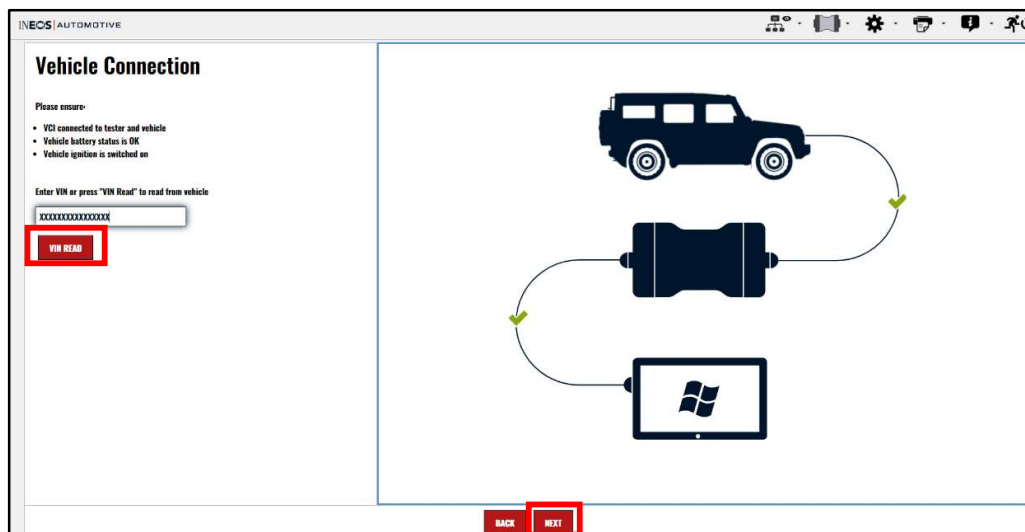
1.

Connect the vehicle to Grade-X using the VCI connected to the OBD port in the driver's footwell.

- 1) Select '**VIN READ**'.
- 2) Select '**NEXT**'.

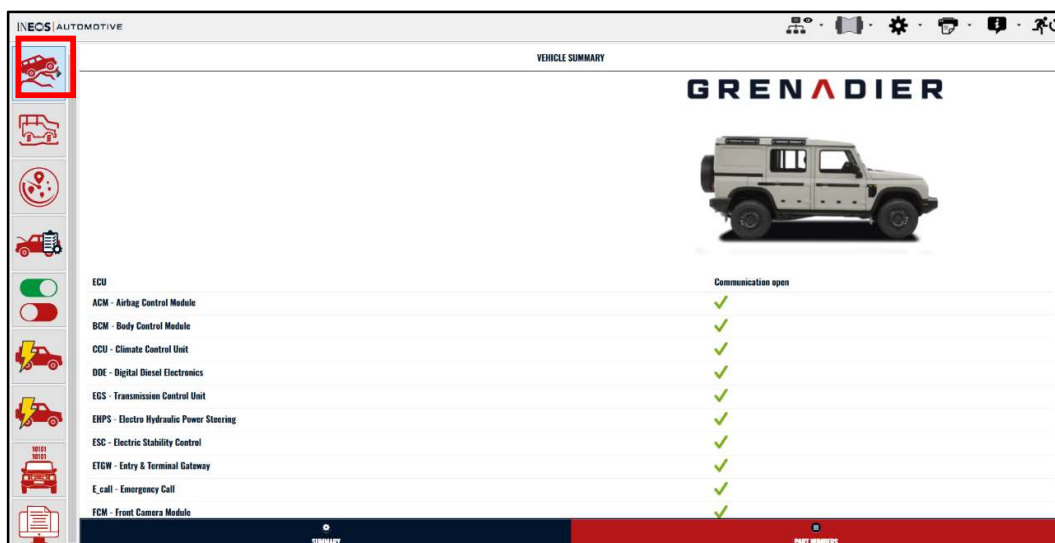
2.

- If an installed ECU is not listed as communicating, carry out a battery rest for 10 minutes.
- Ignore FCM, and other ECUs not installed as these will display as red crosses.

Within the 'Vehicle Summary' check all installed ECUs have an open communication displaying a green tick.

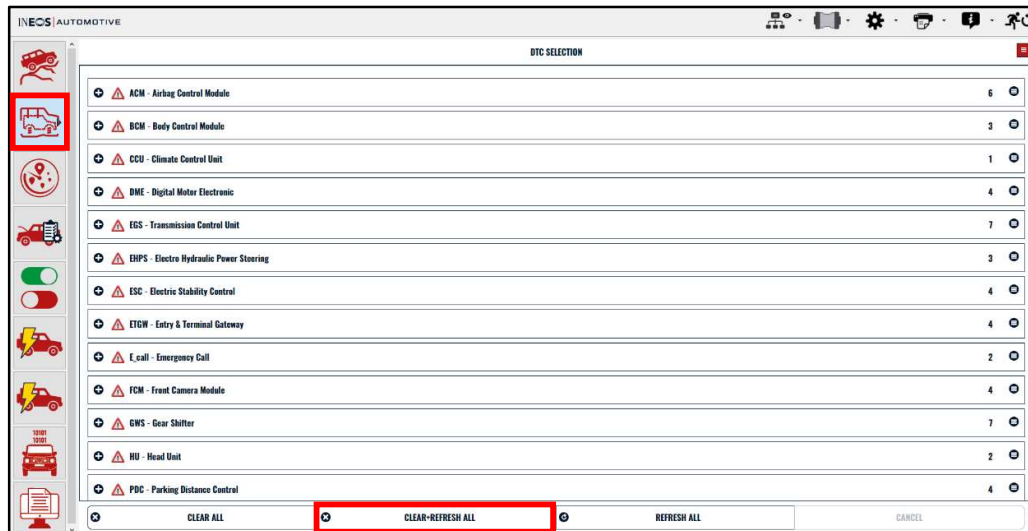
3.

- Select '**Fault Memory**' Tab.
- Select '**CLEAR + Refresh All**' once all DTCs have been read.

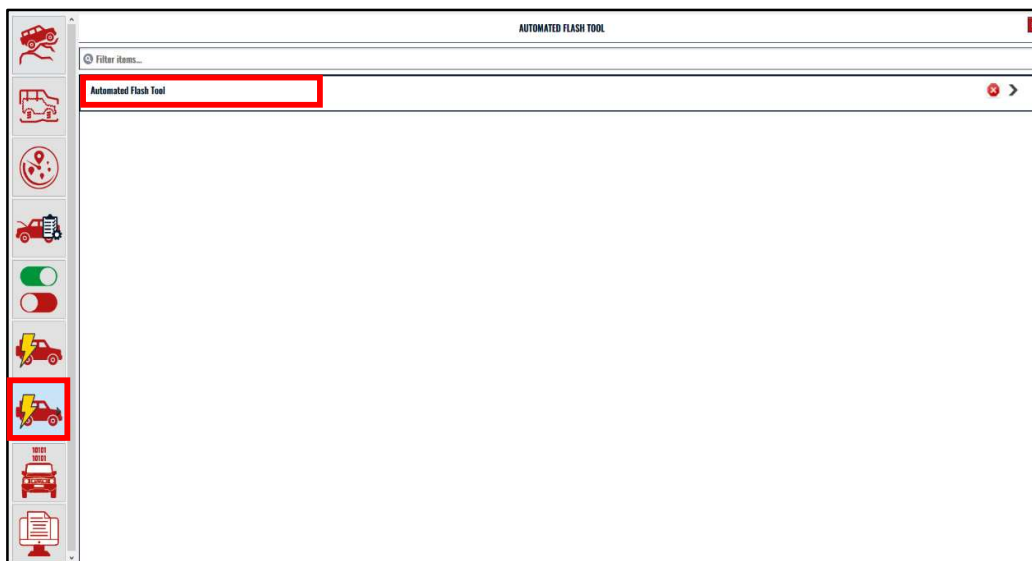
4.

- Select '**Automated Flash Tool**' tab.
- Select '**Automated Flash Tool**' action.

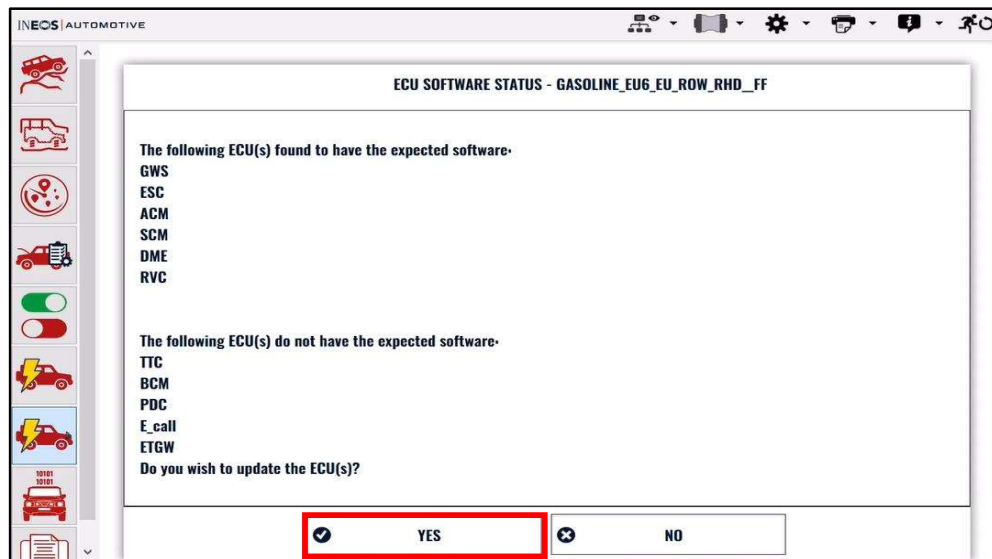
5.

- There should be a list of ECUs requiring update that include **ECALL**. If the ECUs are not displayed, the software of the ECU is up to date.
- Image above is an example only, each vehicle might show different ECUs requiring to be updated.

- Grade-X Automated Flash will assess the ECU software part numbers of the ECUs, displaying the ECUs requiring a software update.
- Select '**YES**' to update the ECUs software to the latest level.

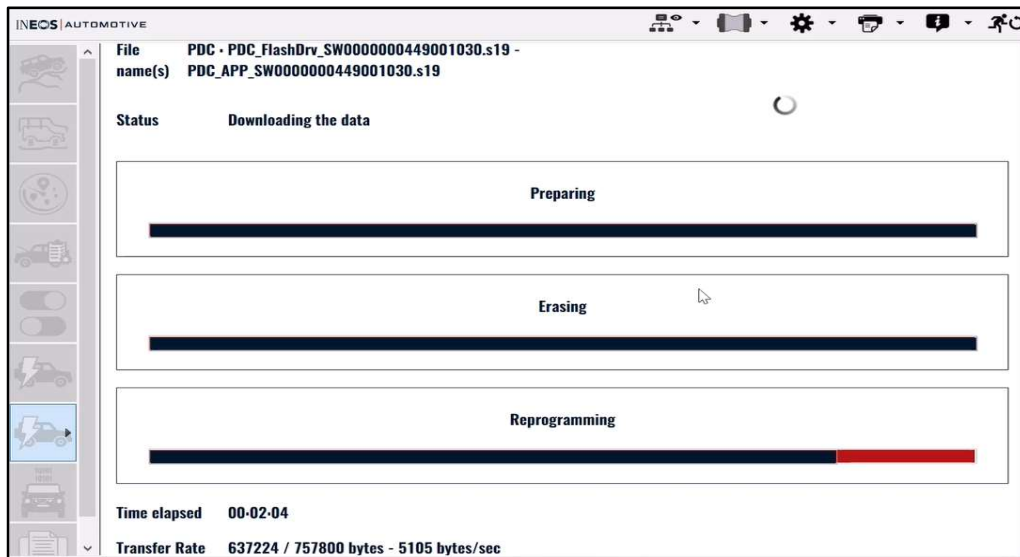
6.

Allow Grade-X to update all ECUs until the update is completed.

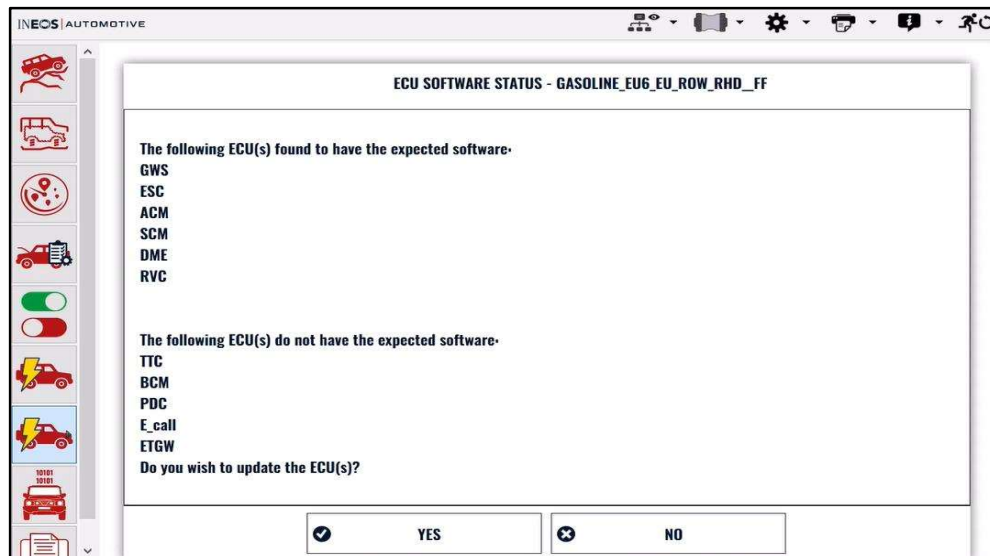
7.

If the flash fails due to the following reason, carry out the check, and attempt the update again:

- Checksum error
- Pre-conditions failed – check preconditions in step 1.
