Release Date	10/15/2024	Technical Service Bulletin	
OIJ9 - Over-the-Air (OTA) Software Update (SW Level 3.2.13) Dealer Recovery Process - OTA Software Update Not Successful

Applicable Vehicles			
Country	Beginning Model Year	Ending Model Year	Vehicle
USA	2021	2022	ID.4
CAN	2021	2022	ID.4

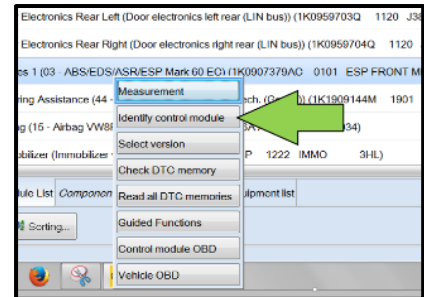
- The above module(s) are updated during the OTA update.
- Select the control module tab.
- Find the listed control module(s) in the control module list.
- Right click on the module(s) and select “Identify control module” for all modules listed above.
- Continue to Step 3.

Control Unit	Diagnostic address	New Part Number	New Software Version
Application Server 1 System 1 Adaptive	8123	V04-007-006	0299
Application Server 1 System 2 Java	8124	V04-007-006-A	0299
Software Cluster Embedded 1	C002	V04-007-006-B	0299
Software Cluster Housekeeping 1	C003	V04-007-006-C	0299
Data Bus OBD Interface	0019	1EA-937-012-AB	0299
