**TECHNICAL INSTRUCTIONS**  
**FOR**  
**SPECIAL SERVICE CAMPAIGN 24TC05**  
**MALFUNCTION INDICATOR LAMP (MIL) IS ON WITH DTC P05CE00**  
**SOFTWARE UPDATE**

**CERTAIN 2023 & 2024 HIGHLANDER VEHICLES**  
**CERTAIN 2024 GRAND HIGHLANDER VEHICLES**

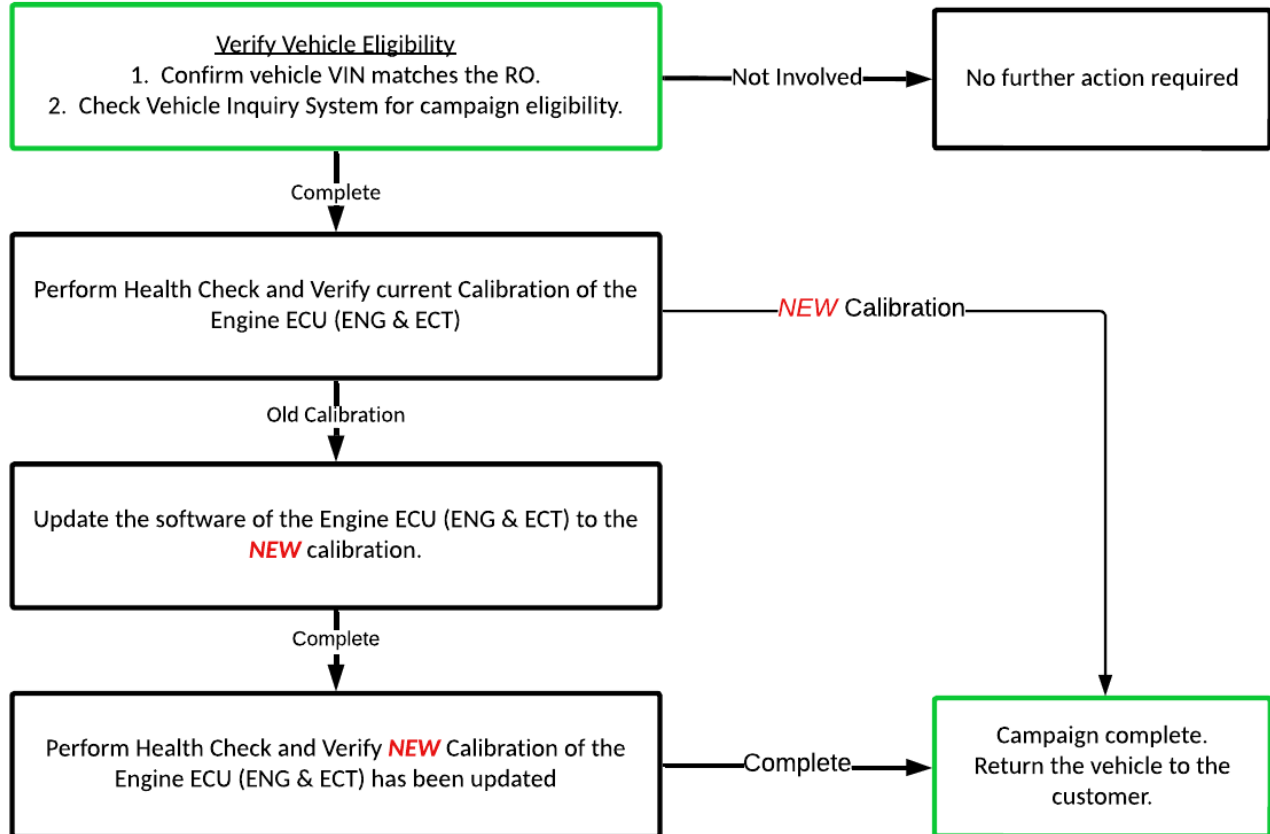
## I. OPERATION FLOW CHART

The flowchart is for reference only. DO NOT use it in place of the full technical instructions. Follow ALL steps as outlined in the full technical instructions to confirm the campaign is completed correctly.

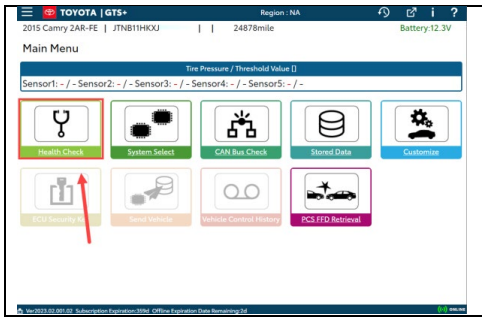
## VI. ENGINE SYSTEM CALIBRATION ID VERIFICATION

- Using GTS+, click the "Health Check" button on the Main Menu
- \*NOTE – If P05CE00 is present, disregard, and proceed with the procedure.

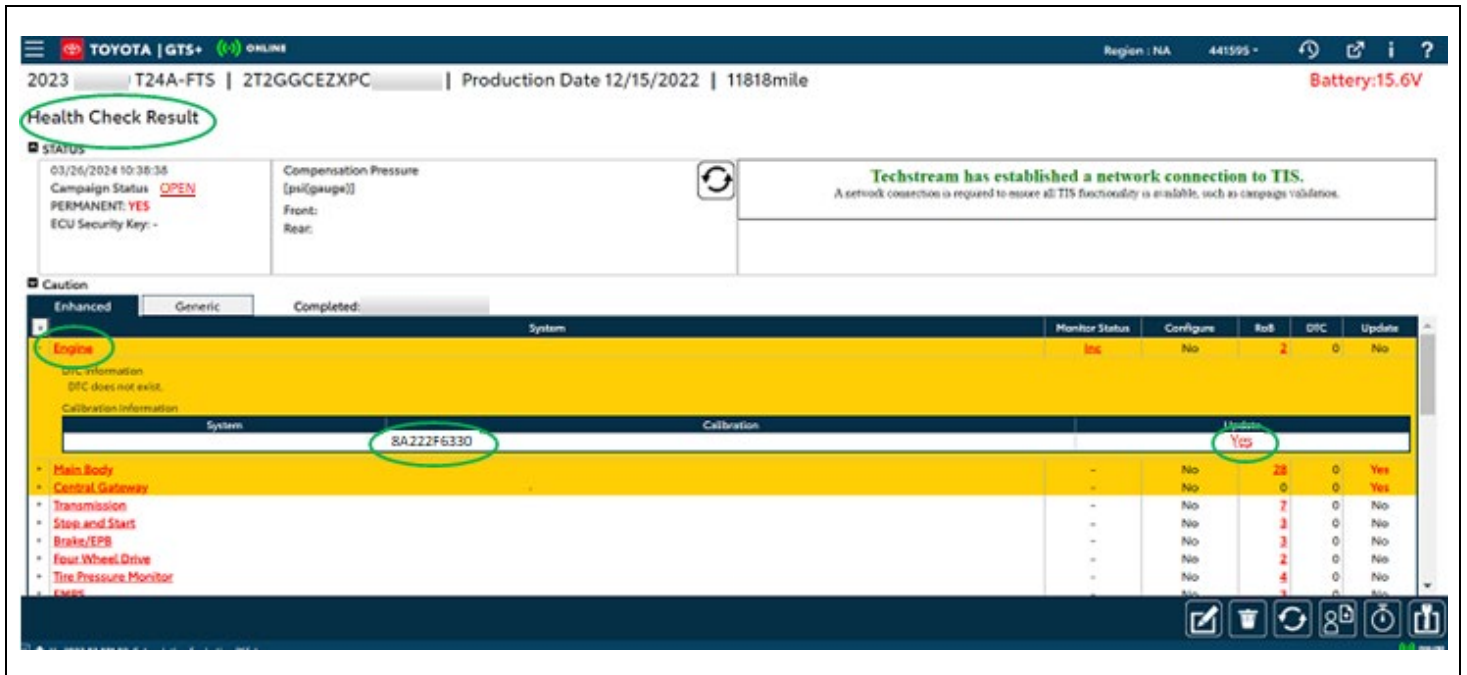
### 1. CONFIRM THE CALIBRATION ID

- a) Confirm the current calibration ID in the Engine System.

If the Engine Control Computer has the **New CIDs**, no update is necessary.
