October 2024
SF693 A

Subject: Boom Out of Stow Indicator

Models Affected: Specific model year 2024 Freightliner 114SD, and Business Class M2 vehicles, manufactured April 3, 2023 , through October 6, 2023.

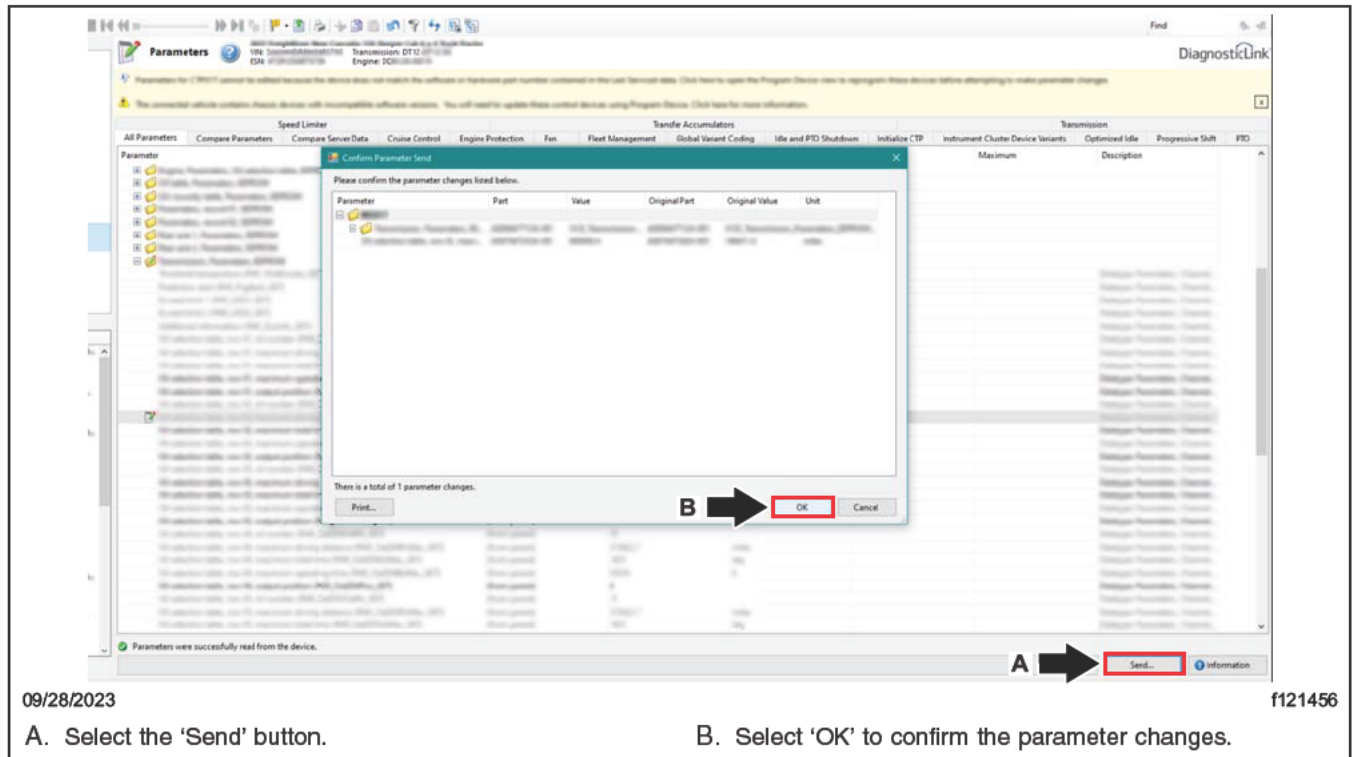
Fig. 3, Writing the Parameter Changes to the Vehicle

12. Select the 'Send' button to write the parameter changes to the SSAM02T electronic control unit (ECU) in the vehicle. A pop-up window appears asking to confirm the parameter changes. Select 'OK.' See Fig. 3.

A. Select the 'Send' button.

B. Select 'OK' to confirm the parameter changes.
