<b>REFERENCE:</b>	<b>TSB:</b> 08-228-24 <b>GROUP:</b> 08 - Electrical	<b>Date:</b>	November 1, 2024	<b>REVISION:</b>	-						
<b>VEHICLES AFFECTED:</b>	<p><b>2021 - 2023 (WL) Jeep Grand Cherokee / Grand Cherokee L</b>  <b>2022 - 2023 (WS) Grand Wagoneer / Wagoneer</b>  <b>This bulletin applies to vehicles built equipped with one of the following radios:</b></p> <ul style="list-style-type: none"> <li>● Uconnect 5 Nav w 8.4" Display (JPN) (Sales Code UTL).</li> <li>● Uconnect 5 Nav w 8.4" Display (KOR) (Sales Code URL).</li> <li>● Uconnect 5 Nav w 10.1" Display (JPN) (Sales Code UTN).</li> <li>● Uconnect 5 Nav w 10.1" Display (KOR) (Sales Code URN).</li> <li>● Uconnect 5 Nav w 12.0" Display (JAP) (Sales Code URQ).</li> <li>● Uconnect 5 Nav w 12.0" Display (KOR) (Sales Code UTQ).</li> </ul>			<p><b>MARKET APPLICABILITY:</b></p>

This bulletin involves updating the R1H radio software level to T27.38.

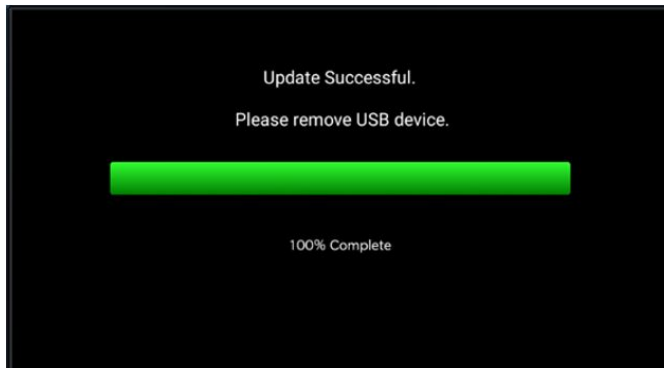
15. The radio will reboot and the software update will begin. The software update should only take 30 minutes [Fig 5](#).

**Fig. 5**  
Update Successful

**NOTE: DO NOT turn off the vehicle when the software update is completed and told to remove the USB flash drive.**
